Observation Report

August 5, 2019

Re: Meadow Creek Condominiums, Vail, CO
(Building A)
Project No. 0307-19 A

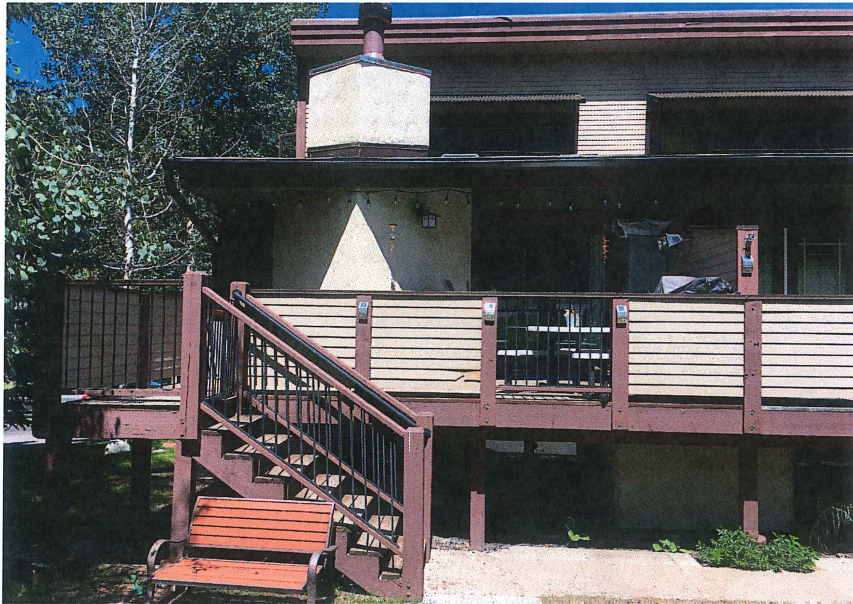
(Image A)

Building A consists of six units in total and appear to stagger two units at a time from the northwest towards the southeast approximately 8'-6" starting with units A1 and A2 on the east side. The exterior decks are located on the southeast side of the building and are approximately 5 feet above the finished grade. They extend approximately 10 feet from the building and the length of the units that are approximately 40 feet being divided by a framed partition wall that divides the deck in half. This partition wall appears to be located between the two units at the party wall. The decks can either be accessed by an exterior door located on the southeast side of each individual unit or by individual exterior stairs to the southeast of the deck. The exterior decks appear to be framed with 2x wood decking on a combination of 2x10 dimensional treated lumber joists, timber beams and posts. Most of the joists bear on mechanical steel hangers on the northwest end and cantilever approximately 14" for units A1, A2, A5, and A6 and 20" for Units A3 and A4 on the southeast end over a timber beam. The northeast end hangers are nailed to either a 2x10 ledger, that is perpendicular with the deck joists or a 3x10 ledger that is on an approximate 45 degree angle to the deck joists. The 2x10 ledger appears to be nailed to the side of the building and the 3x10 ledger appear to be lagged or through-bolted to the bottom of an exterior wall that is cantilevered out from above every 24" along the length of the ledger. The nails that were used on the ledger and the mechanical steel hangers appear to have a rust coating on the heads indicating to me that they are not to be used for treated lumber. The cantilevered deck joists bear on a dropped 6x8 beam that spans continuously over four separate 6x6 posts. The posts are spaced out randomly with the largest spacing being approximately 9'-0" and smallest spacing being approximately 3'-6" located at the stair landing. It appears that where the 6x8 beams bear on a 6x6 post there is either a mechanical steel cap on one side of the beam or a lag that appears to go through the top of the beam into the 6x6 post below. Some of the 6x6 posts bear on a mechanical steel base plate on a concrete circular pier and some of the 6x6 posts appear to be set into the ground. The stairs appear to be framed with three 3x12 stringers, one on each side of the stairs and one located in the middle, with 2x decking treads. The stringers appear to be lagged into a timber beam at the top of the landing and bear on a concrete slab at the bottom. On each side of the stair stringer at the bottom there are 6x6 newel posts that are bolted or lagged to them. These newel posts appear to be the support for the open steel railing of each side of the stairs. The concrete slab appears to have been an existing walk way prior to the modified deck layout. The stair landing is approximately 3'-6" x 3'-6" in size at the top of the stairs. The landing appears to be an extension of the deck joists mentioned above that are bearing on mechanical steel hangers that are nailed to a timber beam. (See image A, B and attached layout).
