## Observation Report

August 12, 2019

Re: Meadow Creek Condominiums, Vail, CO  
(Building B)  
Project No. 0307-19 B

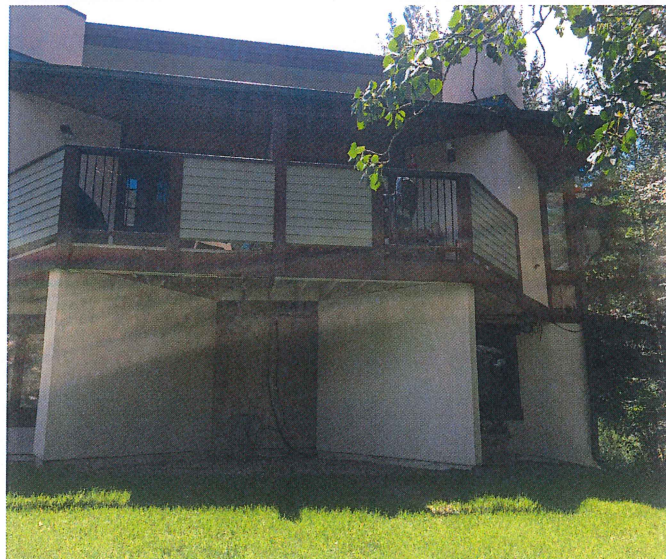
(Image A)

Building B consists of six units and stagger two units at a time from the northeast towards the southwest approximately 12 feet starting with units B6 and B5 on the northeast side. The exterior decks are located on the northwest side of the building and are approximately 7 to 8 feet above the finished grade. They extend approximately 9 feet from the building and the length between the cantilevered fireboxes of the units that are approximately 26 feet in length divided by a framed partition wall. This partition wall appears to be located between the two units at the party wall. The decks are accessed by an exterior door located on the west side of each individual unit. The exterior decks appear to be framed with 2x wood decking on a combination of 2x8 dimensional lumber joists, built up of either 2x8 or 2x10 dimensional beams and what appears to be a 2x6 framed wall with a stucco finish. At the bottom of the framed wall it appears that treated plywood sheathing was used along all sides of the wall prior to the stucco finish being applied. I was not able to see if there was any type of concrete or concrete block foundation wall below the framed wall. The 2x8 deck joists were either supported by a mechanical steel hanger, toe-nailed to a 2x rim board, or were bearing on the 2x6 wall. The 2x8 ledgers along the building and the cantilevered fireboxes that supported some of the deck joists were nailed along their length. (See Image A & B and attached layout)

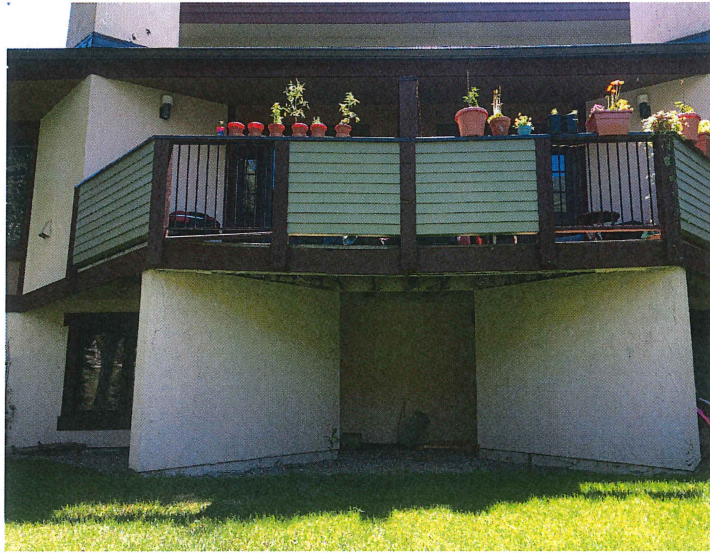
(Image C)

Unit B3 & B4: These two unit decks are separated in the middle by a framed partition wall. The paint that was applied to the underside of these decks and structural members has mostly peeled away. Some of the mechanical steel hangers and nails appear to be weathered and show signs of rust. Some of the deck joists are cracking in areas and they appear to be taking on a blackish/gray weathered look. The supporting (3)-2x10 along the west edge of these decks appear to be sagging at the middle span. Upon placing a 6 foot level to the underside of this beam it was measured to be sagging approximately 1 1/2 to 2 inches over 6 feet. There was a separation between the fascia boards where they butted up against each other. It appears that a new 2x6 deck joist was added just below the partition wall. It appears that Unit B3 had replaced their decking surface to a composite material. (See picture C & D)

I do believe that the exterior decks for Units B3 and B4 should not be used. I feel that the existing (3)-2x10 beam along the exterior edge of the deck has been compromised of its structural integrity and needs to be replaced. It is showing signs of cracking along the bottom face and extensive deflection.

1. Replace all the (3)-2x10 beams along the exterior edge of the deck with a member that can support the current Town of Vail design loading criteria. This must be completed on Units B3 and B4 as soon as possible.
2. Add (3)-4" x 3/16" diameter Timber-Lok screws at 16" on center to all existing 2x10 ledgers that are attached to the building rim-board.

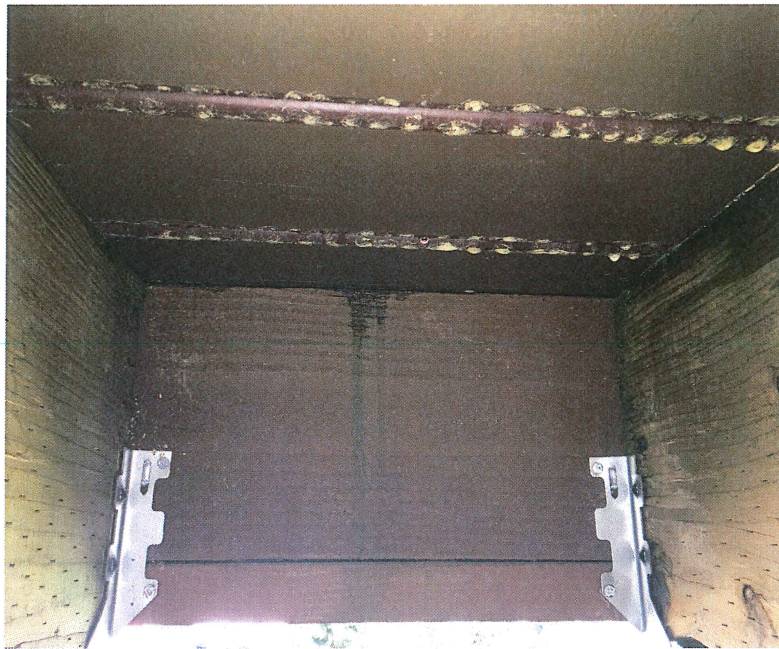
(Image E)

Unit B5: The deck for this unit appears to have been remodeled at some point in time. The decking surface is a composite material. The deck also was made larger to the south by squaring off the angled section of deck to the unit B4's exterior wall to the north. There was a (2)-2x10 ledger along the wall of unit B4 and approximately 2'-6" to the north were (3)-2x10's that appeared to align with another partition wall from above. Located on the south side of the framed stucco wall the deck was framed with a 6x8 timber beam with a 2x6 that was nailed to the bottom of it so that the mechanical steel hangers that supported the new treated 2x10 joists could be nailed too. (See Image E).

The 6x8 was bearing on the ledger to the south and the 2x6 stucco wall to the north. There was a 4x10 ledger attached to the cantilevered angled firebox with what appears to be two timber screws at 2 feet on center along the top edge of the ledger. The 2x10 treated joists were attached to the 4x10 ledger with a mechanical steel angled bracket on one side of the joist. On the north side of the framed stucco wall there were 2x6's added against some of the existing 2x8 deck joists.

3. Add (2)-4" x 3/16" diameter Timber-Lok screws at 16" on center along the length of the 2x6 that was added to the bottom of the 6x8 timber on Unit B5.
4. Provide a Simpson LS90 hanger to the inside face where the south end of the 6x8 timber bears on the 2x10 ledger on Unit B5.
5. Replace all deck joists that have cracks and or signs of rot on them.
