## Observation Report

August 15, 2019

Re: Meadow Creek Condominiums, Vail, CO  
(Building C)  
Project No. 0307-19 C

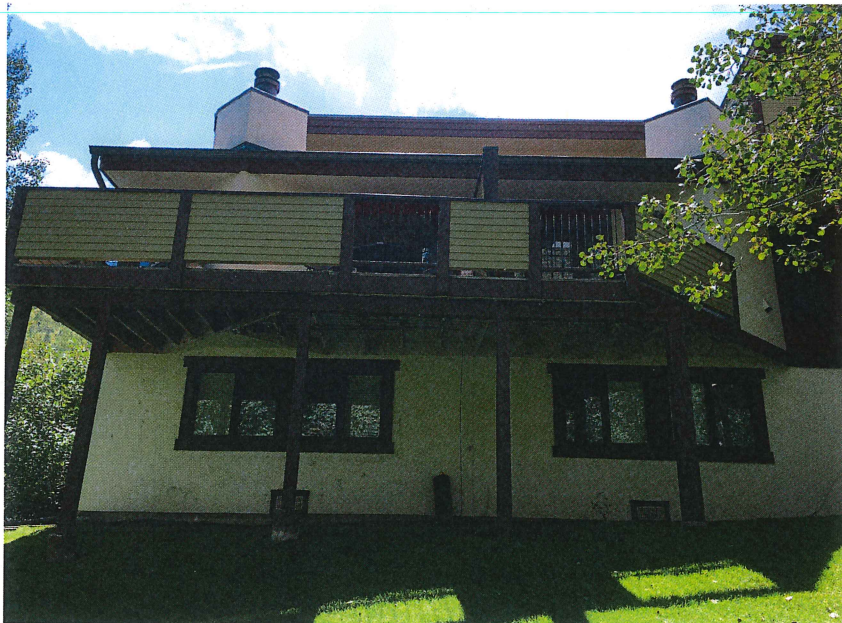
(Image A)

Building C consists of six units and stagger two units at a time from the northeast towards the southwest approximately 8 feet starting with units C6 and C5 on the northeast side. The exterior decks are located on the northwest side of the building and are approximately 11 to 13 feet above the finished grade. They extend approximately 9 feet from the building and the lengths of the decks vary from unit to unit. There is a framed partition wall that divides the decks in half. This partition wall appears to be located between the two units at the party wall. The decks are accessed by an exterior door located on the west side of each individual unit and an exterior set of stairs for Unit C1. The exterior decks appear to be framed with 2x wood decking, except for Unit C3 which has a composite material decking, on a combination of 2x10 dimensional lumber joists, timber beams and posts. (See Image A and attached layouts)

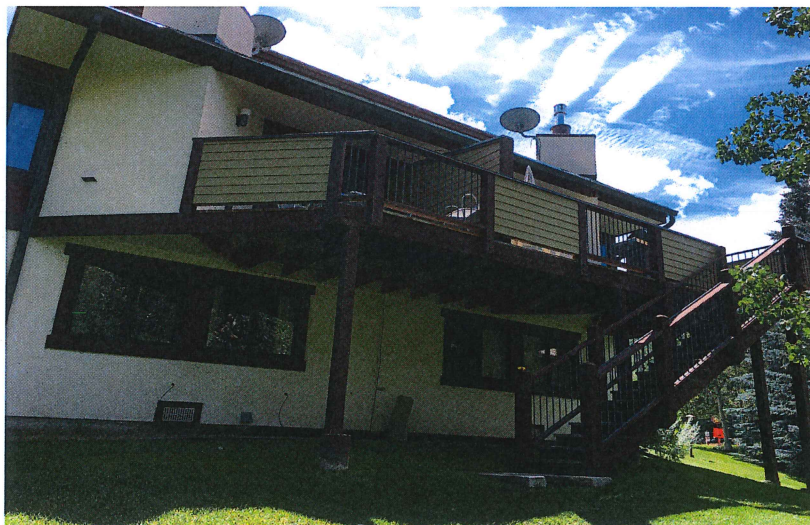
(Image B)

Unit C1 & C2: The decks for these units appear to have been remodeled at some point in time. These two unit decks are separated in the middle by a framed partition wall. The deck joists are 2x10's at 24" on center spacing with 2x6 wood decking. The deck joists bear on mechanical steel hangers. The east end hangers are nailed to either a 2x10 ledger, that is perpendicular with the deck joists or a 2x10 ledger that is on an approximate 45 degree angle to the deck joists. The 2x10 ledgers appear to be nailed to the side of the building and to the bottom of an exterior wall that is cantilevered out from above. The west sides of the joists bear on a mechanical steel hanger that are nailed to a flush framed 6x12 rough sawn timber beam. The 6x12 beam spans continuously over two separate 6x6 posts. The 6x6 posts for these units bear on circular concrete piers. The 6x6 post to the far north bears on the concrete pier to the outside edge. The spans for the 6x12 beam are approximately 15'-6" and 12'-0". The stairs appear to be framed with three 3x12 stringers, one on each side of the stairs and one located in the middle, with 2x decking treads. Two of the three stair stringers appear to be attached to a (2)-2x10 beam at the top with a mechanical steel L-bracket on one side and bear on a concrete slab landing at the bottom. On each side of the stair stringer at the bottom there are 6x6 newel posts that are bolted or lagged to them. These newel posts appear to be the support for the open steel railing on each side of the stairs. The newel post located to the east side has soil and grass around the bottom. The stair landing at the top of the stairs is approximately 3'-6" x 3'-0" in size. The landing appears to be framed with 2x10 joists and 6x12 timbers that bear on 6x6 posts at each corner of the landing. (See Images B, C, & D)

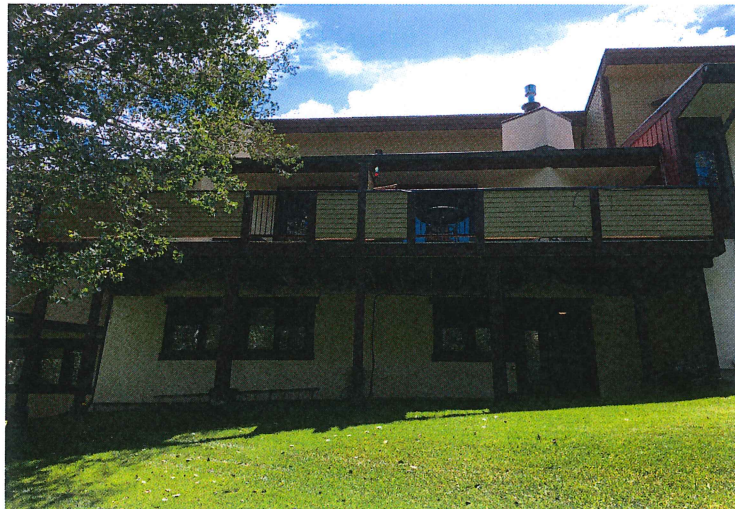
(Image E)

Unit C3 & C4: The decks for these units appear to have been remodeled at some point in time. These two unit decks are separated in the middle by a framed partition wall. The decking surface for unit C3 is a composite material and 2x6 wood decking for unit C4. The deck joists are a combination of older 2x10 and newer 2x10 with an on center spacing of either 12", 16" or 24", refer to layout. Most of the joists bear on mechanical steel hangers or are toe-nailed on the east end and cantilever approximately 8" on the west end. The east end hangers are nailed to either a 2x10 ledger that is perpendicular with the deck joists or toe-nailed to a 3x10 ledger that is on an approximate 45 degree angle to the deck joists. The 2x10 ledger appears to be nailed to the side of the building and the 3x10 ledger appears to be lagged or through-bolted to the bottom of an exterior wall that is cantilevered out from above every 24" along the length of the ledger. (See Image C) The cantilevered ends of the joists bear on a dropped 6x8 beam that spans continuously over three separate 6x6 posts. The posts are spaced out randomly with the largest spacing being approximately 8'-6" and smallest spacing being approximately 3'-6" located at the ends of the deck. Some of the 6x6 posts appear to have a treated 2x6 stud nailed to each side of it and the 6x6 post appears to have some rot on the bottom. It appears that where the 6x8 beams bear on a 6x6 post there is a mechanical steel cap on one side. Some of the 6x6 posts bear on a mechanical steel base plate on a concrete circular pier. Some of the piers are above the grade and some are flush or below the grade. The paint has mostly peeled off the older deck joist where it had been applied. Some of the deck joists appear to be taking on a grayish weathered look. (See Image E & F)

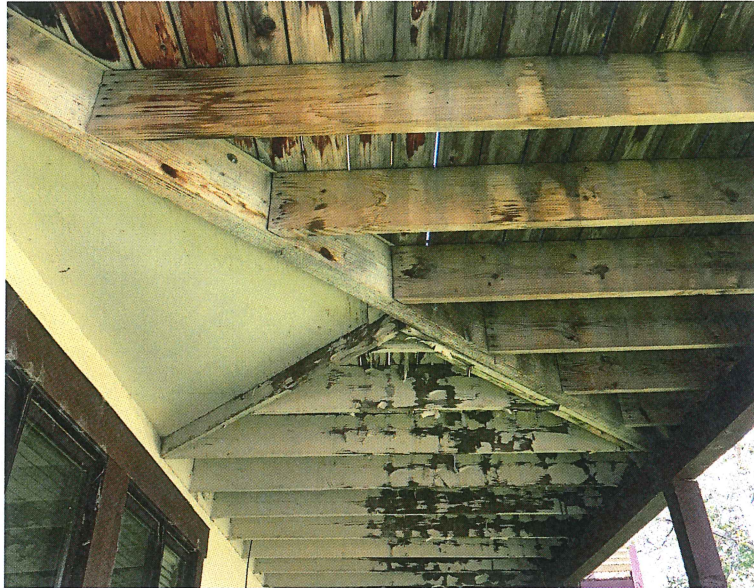
(Image G)

Unit C5: The deck for this unit appears to be similar to the plans dated 01-02-1981. The deck joists are 2x10's at 24" on center spacing with 2x6 wood decking. Most of the joists bear on mechanical steel hangers or are toe-nailed on the east end and cantilever approximately 8" on the west. The east end hangers are nailed to either a 2x10 ledger, that is perpendicular with the deck joists or a 2x10 ledger that is on an approximate 45 degree angle to the deck joists. The 2x10 ledgers appear to be nailed to the side of the building and to the bottom of an exterior wall that is cantilevered out from above. The cantilevered ends of the joists bear on a dropped 6x8 beam that spans continuously over three separate 6x6 posts. The posts are spaced out randomly with the largest spacing being approximately 8'-6". Some of the 6x6 posts to the far south appear to have a treated 2x6 stud nailed to each side of it and the 6x6 post appears to have some rot on the bottom. It appears that where the 6x8 beams bear on a 6x6 post there is a mechanical steel cap on one side. Some of the 6x6 posts bear on a mechanical steel base plate on a concrete circular pier. Some of the piers are above the grade and some are flush or below the grade. The paint has mostly peeled off the deck joist where it had been applied. Some of the deck joists appear to be taking on a grayish weathered look. (See Image G)

Unit C6: This deck appears to have been remodeled at some point in time. The deck joists are a combination of older 2x10 and newer 2x10 at 24" on center spacing with 2x6 wood decking. Most of the joists bear on mechanical steel hangers or are toe-nailed on the east end and cantilever approximately 8" on the west. The east end hangers are nailed to either a 2x10 ledger that is perpendicular with the deck joists or toe-nailed to a 3x10 ledger that is on an approximate 45 degree angle to the deck joists. The 2x10 ledger appears to be nailed to the side of the building and the 3x10 ledger appears to be lagged or through-bolted to the bottom of an exterior wall that is cantilevered out from above every 24" along the length of the ledger. The cantilevered ends of the joists bear on a dropped 6x8 beam that spans continuously over three separate 6x6 posts. The posts are spaced out randomly with the largest spacing being approximately 8'-6" and smallest spacing being approximately 3'-6" located at the north end of the deck. It appears that where the 6x8 beams bear on a 6x6 post there is a mechanical steel cap on one side. Some of the 6x6 posts bear on a mechanical steel base plate on a concrete circular pier. Some of the piers are above the grade and some are flush or below the grade. The paint has mostly peeled off the deck joist where it had been applied. Some of the deck joists appear to be taking on a grayish weathered look. (See Image G)
