Observation Report

August 22, 2019

Re: Meadow Creek Condominiums, Vail, CO
(Building D)
Project No. 0307-19 D

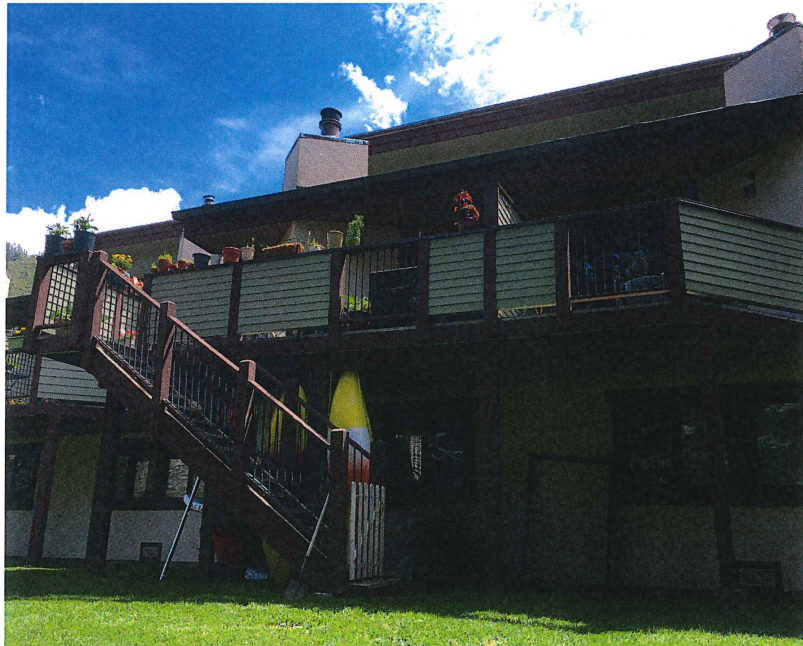
(Image A)

Building D consists of four units and staggers two units at a time from the northeast towards the southwest approximately 8 feet starting with units D4 and D3 on the northeast side. The exterior decks are located on the northwest side of the building and are approximately 10 feet above the finished grade. They extend approximately 10 feet from the building and the lengths of the decks vary from unit to unit. There is a framed partition wall that divides the decks in half. This partition wall appears to be located between the two units at the party wall. The decks are accessed by an exterior door located on the west side of each individual unit and an exterior set of stairs for Unit D2. The exterior decks appear to be framed with 2x wood decking on a combination of 2x8 dimensional lumber joists, timber beams and posts. (See Image A and attached layouts)

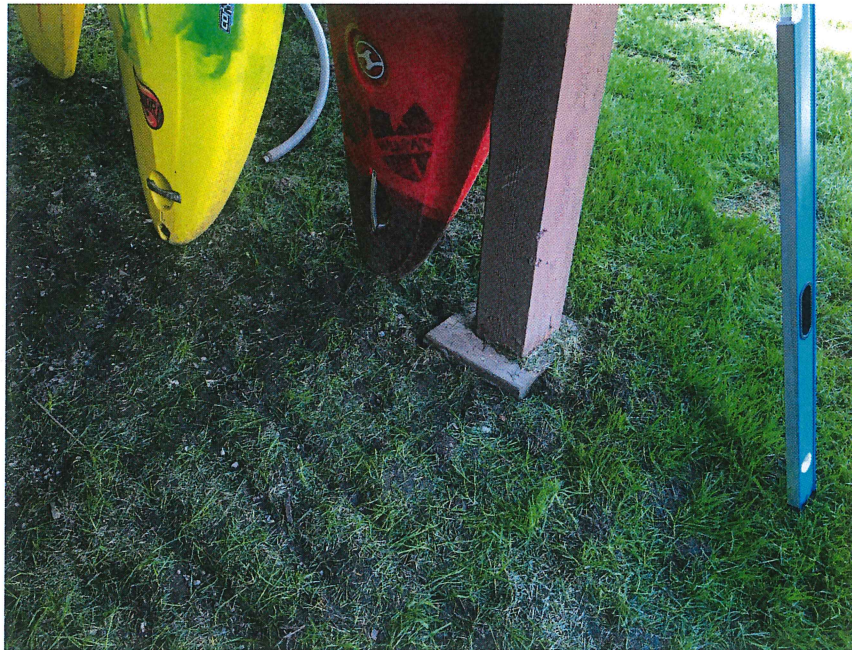
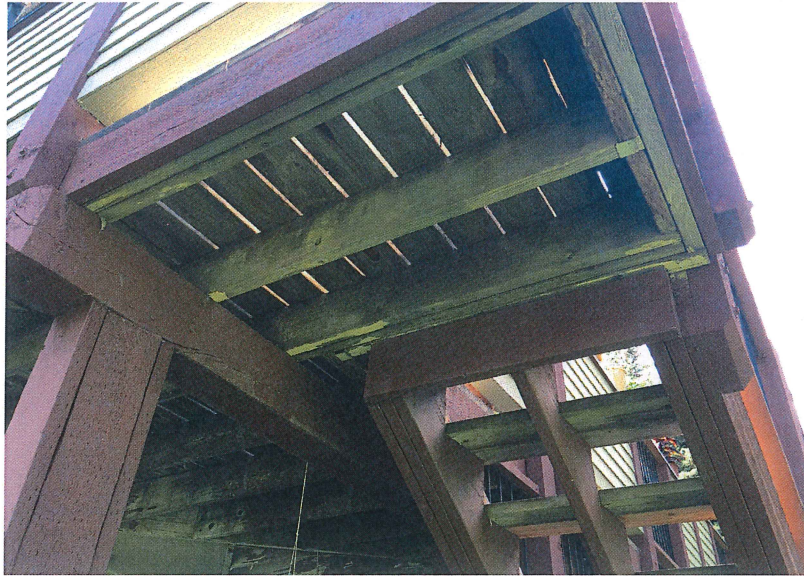
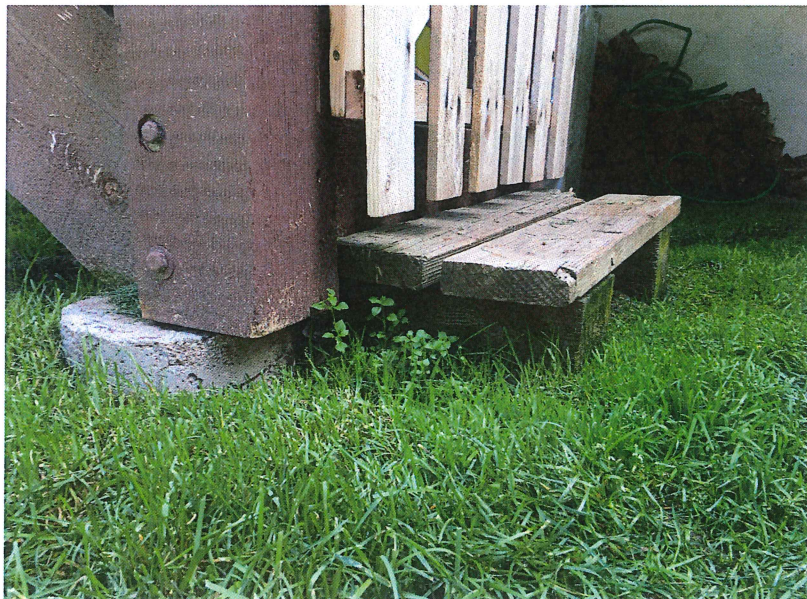
Unit D2: The deck for this unit appears to have been remodeled at some point in time. This unit deck is connected to unit D1 and is separated in the middle by a framed partition wall. The majority of the deck is framed similar to unit D1 except for the addition to the north of the cantilevered wall from above and the stairs that have been added to access the deck from the finished grade below. The addition appears to have been framed with 2x8 deck joists spaced at 16" on center. Most of the joists bear on mechanical steel hangers or are toe-nailed on the east end and cantilever approximately 8" on the west end. The east end hangers are nailed to either a 2x8 ledger that is perpendicular with the deck joists or toe-nailed to a (2)-2x8 ledger that is on an approximate 45 degree angle to the deck joists. The 2x8 ledgers appear to be nailed to the side of the building or to the cantilevered floor from above. The paint that was applied to the underside of this decking and joists has mostly peeled away. Some of the nails appear to be weathered and show signs of rust. Some of the deck joists appear to be taking on a blackish/gray weathered look. The cantilevered ends of the joists bear on a dropped 6x8 beam that spans continuously over three separate 6x6 posts. The posts are spaced out approximately 6'-0". It appears that where the 6x8 beams

bear on a 6x6 post there are some mechanical steel caps on one side. The 6x6 post to the south also supports the 6x8 beam from unit D1 and is described as the third 6x6 post. The middle 6x6 post appears to bear on a 2x piece of wood that lays flat on the ground. The next 6x6 post to the north of that appears to have a treated 2x6 stud nailed to each side of it and also bears on a concrete circular pier with no apparent base connection. The stairs appear to be framed with three separated stair stringers. The two stringers on the outsides of the stairs appear to be (3)-2x12 stringers, and one located in the middle appears to be (1)-2X12, with 2x decking treads. The two outside stringers appear to be attached to the (2)-2x8 cantilevered deck joist at the top with a mechanical steel hanger that was notched into the top quarter depth of the stringer. The stringer located in the middle was nailed from the back side of 2x8 into to the end grain of the stringer. On each side of the stair stringer at the bottom there are 6x6 newel posts that are bolted or lagged to them. These newel posts appear to be the support for the open steel railing on each side of the stairs. It appears the first riser at the bottom of the stairs has been framed on the finished ground with treated 6x6 blocks. The stair landing at the top of the stairs is approximately 2'-6" x 3'-6" in size. The landing appears to be framed from the extended cantilevered ends of the 2x8 deck joists mentioned above. (See Images B, C, & D)

I do believe that the exterior decks for Units D1 and D2 have structural issues and should be attended to as soon as possible. I feel that the existing 6x8 supporting beam is deflecting beyond its allowable limits and should be replaced. It is also showing signs of cracking along the horizontal face.

1. Replace the 6x8 support beam for units D1 & D2 with a 6x10 beam prior to it failing. This will also be structurally adequate to support the current Town of Vail design loading criteria.
2. All load bearing 6x6 posts should bear on a concrete pier and footing. The bottom of the footing should be a minimum of 48" below grade for frost protection. The size of the footing can be determined by our office and is based on the load it is supporting and upon the soil bearing conditions. By code the bottom of a wood post should be a minimum of 8" from the

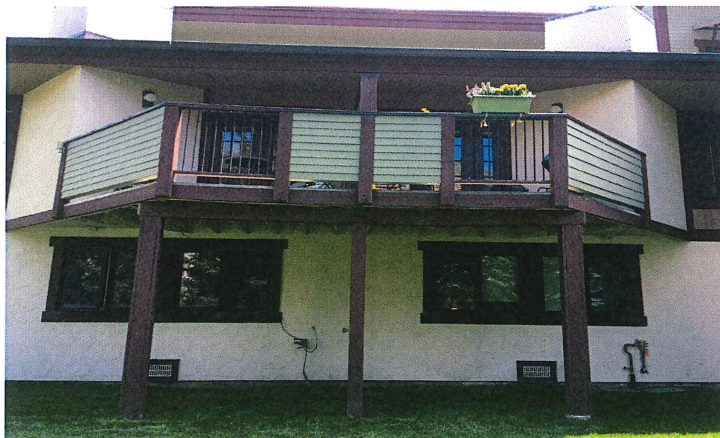
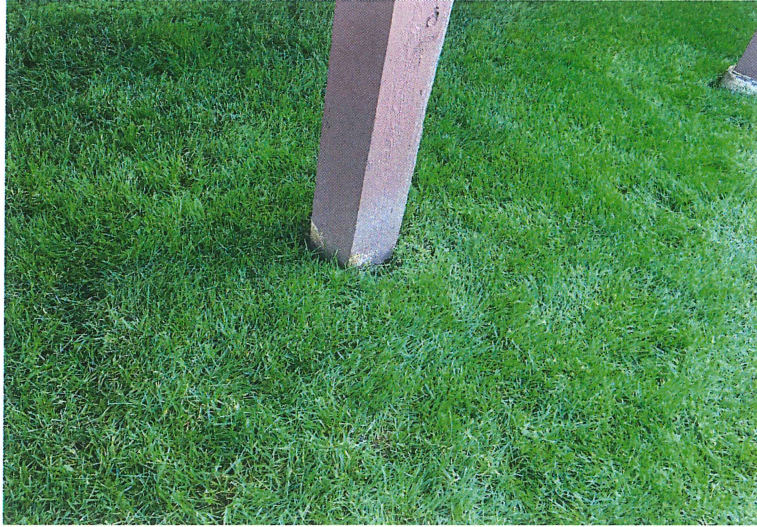
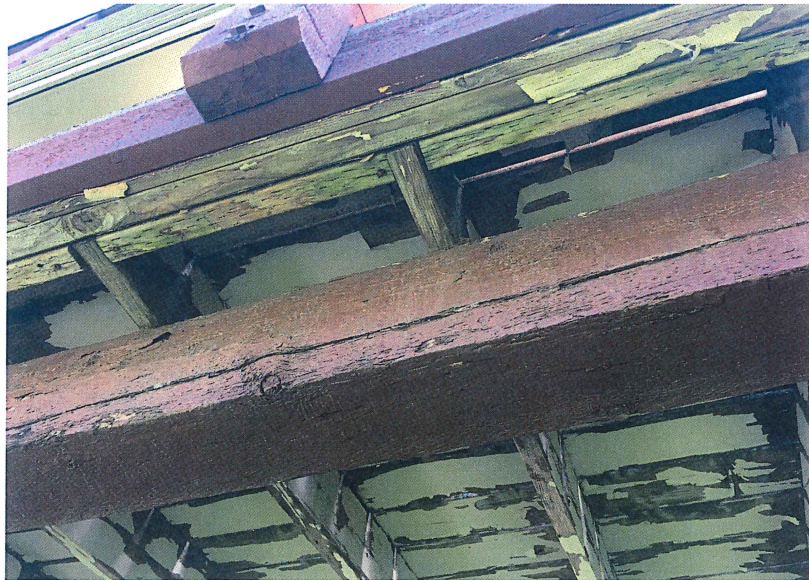
Unit D3 & D4: These decks appear to be framed with 2x wood decking on 2x8 deck joists spaced at 16" on center that are separated in the middle by a framed partition wall. Most of the joists bear on mechanical steel hangers or are toe-nailed on the east end and cantilever approximately 8" on the west end. The east end hangers are nailed to either a 2x8 ledger that is perpendicular with the deck joists or toe-nailed to a 2x8 ledger that is on an approximate 45 degree angle to the deck joists. The 2x8 ledger appears to be nailed to the side of the building or to the cantilevered floor from above. The paint that was applied to the underside of this decking and joists has mostly peeled away. Some nails appear to be weathered and show signs of rust. Some of the deck joists are cracking in areas and they appear to be taking on a blackish/gray weathered look. The cantilevered ends of the joists bear on a dropped 6x8 beam that spans continuously over three separate 6x6 posts. The 6x8 beam appears to be sagging at the middle span. Upon placing a 6 foot level to the underside of this beam it was measured to be sagging approximately 1 inch over 6 feet. The south side of the 6x8 beam appears to have a horizontal crack along the bottom third of its depth. The posts that support the 6x8 beam are spaced out approximately 7'-6". It appears that where the 6x8 beams bear on a 6x6 post there are some mechanical steel caps on one side. The 6x6 post to the south appears to have a treated 2x6 stud nailed to each side of it and bears on a concrete circular pier that is just above the ground with no apparent base connection. The 6x6 post in the middle appears to be aligned with the partition wall that separates the deck of the unit next to it and appears to bear on the on a 2x piece of wood that has split and lays flat on the ground. The 6x6 post to the north appears to also have a treated 2x6 stud nailed to each side of it and appears to bear on a concrete circular pier that is below the ground with no apparent base connection. (See Image E, F and G)

At this time, I do not believe that Units D3 and D4 exterior decks on the west side of Building D will fail structurally. Besides the deck being weathered in areas, there are no significant signs of rot or any indications of instability. Although I do not believe the decks will fail, I do feel that the existing decks are not constructed to today's building codes. I feel that the 6x8 supporting beams are not adequate to support the current Town of Vail design load criteria. I feel that the deck joists that are cracked and appear to be taking on a blackish/gray weathered look will eventually start to rot and will lose their structural integrity to support their imposed loads. I feel that the nails that are showing signs of rust may eventually become too corroded to support their imposed loads. I feel that the reason the wood wedge was installed between the deck joists and the 6x8 beam is due to the 6x6 post that is bearing on the 2x wood has settled. This post will continue to settle if not properly supported on a concrete pier.

3. Provide Simpson ABU66Z base plates and Simpson PC6Z to all 6x6 posts.
4. Add (3)-4" x 3/16" diameter Timber-Lok screws at 16" on center to all existing 2x10 ledgers that are attached to the building rim-board.

1. Install Simpson LS70 or Simpson LUS26 hangers on all deck joists that are missing them.
2. Provide the other half of the mechanical steel cap plates on all existing 6x6 posts where they are missing.
3. The area at the bottom of the stair landing should be re-graded so that there is proper clearance and drainage around the stair stinger and newel post. If this area continues to have moisture on it, it will begin to rot causing it to lose its structural integrity.
4. Install Simpson LS50 L-brackets to all sides of the stair stringers at the top landing of unit D2.
5. Maintain decks by regularly monitoring them, clearing them of snow and ice, and by resealing them with the proper stain/sealer and or paint.
