## Observation Report

August 29, 2019

Re: Meadow Creek Condominiums, Vail, CO  
(Building E)  
Project No. 0307-19 E

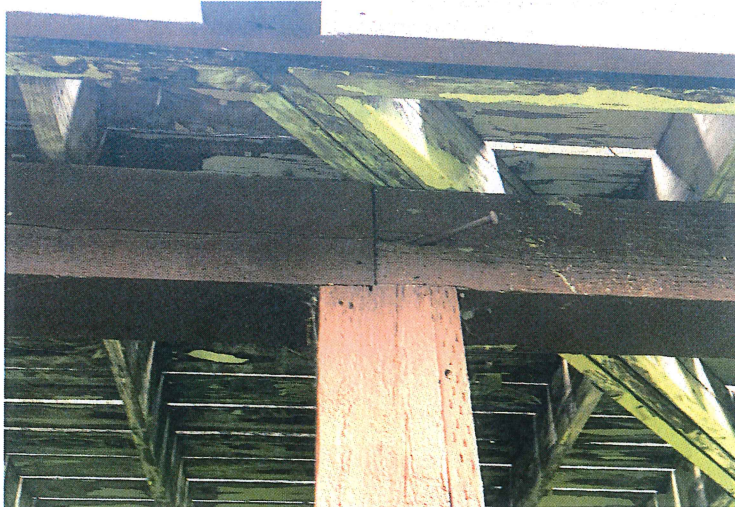
(Image D)

Unit E1: This deck appears to have been remodeled at some point in time. The deck is connected to unit E2 and is separated in the middle by a framed partition wall. It appears that the deck joists are 2x8's spaced at 20" on center with 2x6 wood decking. The paint that was applied to the underside of this decking and joists has mostly peeled away. Most of the joists bear on mechanical steel hangers or are toe-nailed on the east end and cantilever approximately 8" on the west. The east end hangers are nailed to either a 2x8 ledger that is perpendicular with the deck joists or toe-nailed to a (3)-2x8 ledger that is on an approximate 45 degree angle to the deck joists. The ledgers appear to be nailed to the side of the building. The cantilevered ends of the joists bear on dropped 6x8 beams. Some of the nails appear to be weathered and show signs of rust. Some of the deck joists are cracking in areas and they appear to be taking on a blackish/gray weathered look. The 6x8 beam to the south spans continuously over three separate 6x6 posts. The 6x8 beam to the north also spans continuously over three separate 6x6 posts that also supports some of the E2 unit deck. Some of the posts have a treated 2x6 nailed to them. The posts are spaced out randomly with the largest spacing being approximately 7'-6" and smallest spacing being approximately 5'-6". It appears that where the 6x8 beams bear on a 6x6 post there are some mechanical steel caps. In one location where the beam bears on the post it appears as though two steel spikes were used to connect the beams together but the spikes were not fully installed. (See Image D). The 6x6 posts bear on concrete circular piers and do not appear to have a mechanical steel base plate. The piers are about 3 to 8 inches above the grade.

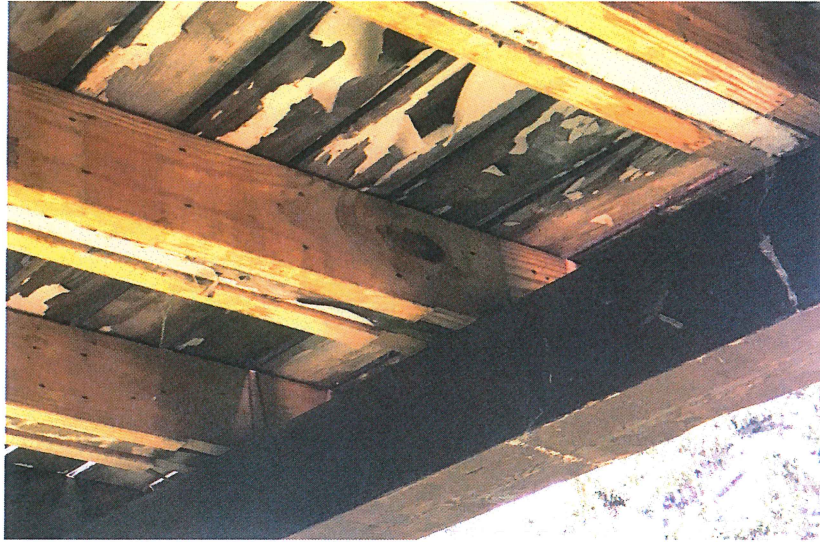
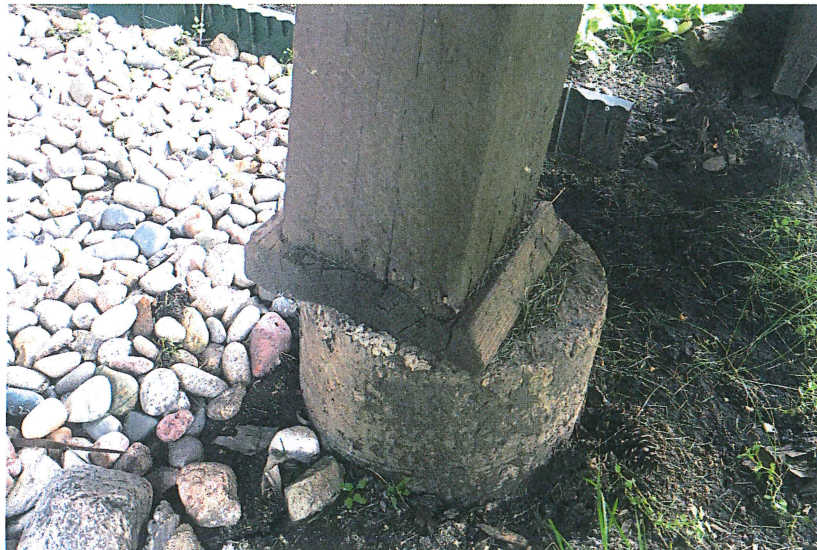
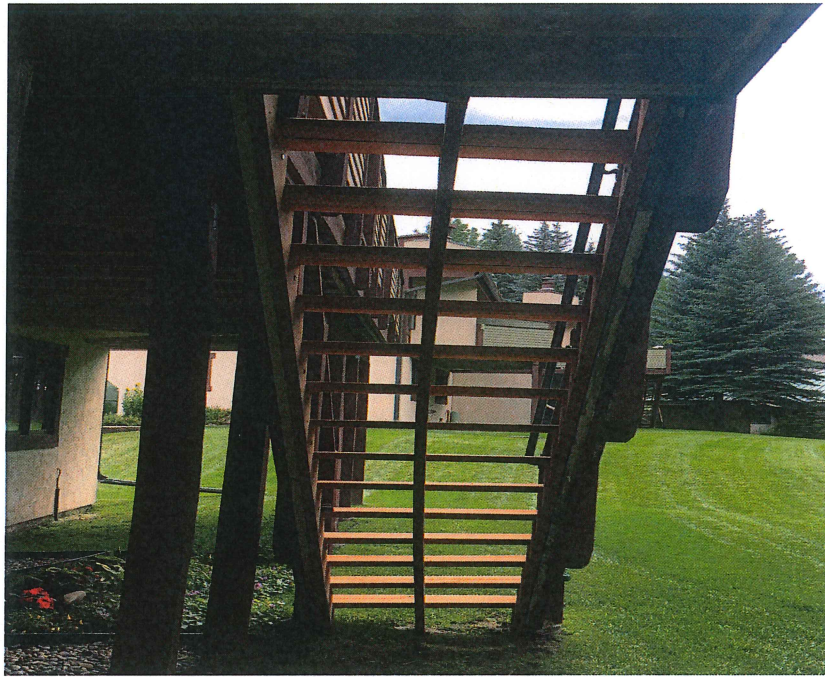
Unit E2: The deck for this unit appears to have been remodeled at some point in time. This unit deck is connected to unit E1 and is separated in the middle by a framed partition wall. It appears as though there were 2x8's nailed on to each side of the existing 2x8 deck joists at 20" on center spacing located from the partition wall to where the floor from above cantilevers out from the building. (See attached layout). The east end of the built up joist bear on mechanical steel hangers. On the west end they cantilever over a 6x8 dropped beam. It appears as though the new added joists have been notched on the bottom where they bear on the 6x8 beam. (See Image E) The remainder of the deck joists appears to be 2x8's spaced at 20" on center with 2x6 wood decking. The paint that was applied to the underside of this decking and joists has mostly peeled away. Most of the joists bear on mechanical steel hangers or are toe-nailed on the east end and cantilever approximately 8" on the west. The east end hangers are nailed to either a 2x8 ledger that is perpendicular with the deck joists or toe-nailed to a (3)-2x8 ledger that is on an approximate 45 degree angle to the deck joists. The ledgers appear to be nailed to the side of the building. The cantilevered ends of the joists bear on dropped 6x8 beams. Some of the nails appear to be weathered and show signs of rust. Some of the deck joists are cracking in areas and they appear to be taking on a blackish/gray weathered look. The 6x8 beam to the north spans continuously over three separate 6x6 posts. The 6x8 beam to the south spans continuously over three separate 6x6 posts that also supports some of the E1 unit deck. Some of the posts have a treated 2x6 nailed to them. The posts are spaced out randomly with the largest spacing being approximately 8'-4" and smallest spacing being approximately 5'-6". It appears that where the 6x8 beams bear on a 6x6 post there are some mechanical steel caps. The 6x6 posts bear on concrete circular piers and only some appear to have a mechanical steel base plate. One of the posts bears on a flat 2x that has been crushed between the post and the concrete pier. (See Image F) The top of the piers are about 2 to 5 inches above the grade. On this unit there is also a set of stairs that lead down the grade below. The stairs appear to be framed with three separated stair stringers. The two stringers on the outsides of the stairs appear to be (3)-2x12 stringers, and one located in the middle appears to be (1)-2x12, with 2x decking treads. The middle 2x12 stringer appears to be attached to the (2)-2x8 cantilevered deck joist with a mechanical steel hanger at the top of the stairs. I was unable to see how the two outside stringers were attached to the (2)-2x8 cantilevered deck joist. The stringer located in the middle appeared to have a bow in it at the middle span of the stairs and was bearing on what looked like a mound of concrete at the bottom. (See Image G) The outside stringers appear to bear on a circular concrete pier at the bottom. Also at the bottom of the two outside stair stringers there were 6x6 newel posts that are bolted or lagged to them. These newel posts appear to be the support for the open steel railing on each side of the stairs. The stair landing at the top is approximately 3'-0" x 4'-0"

in size. The landing appears to be framed from the extended cantilevered ends of the 2x8 deck joists mentioned above.

4. For unit E2, the middle stair stringer should bear on a treated plate that should be anchored to the existing concrete piers. Provide a solid treated blocking between all stringers. Verify that existing stairs meet current building code requirements.

5. For unit E2, add a new 6x6 post under the east cantilevered end of the existing (2)-2x8's and provide a new concrete pier and footing to support it.

6. Install Simpson LS50 L-brackets to all sides of the stair stringers at the top landing of unit E2.
7. Maintain decks by regularly monitoring them, clearing them of snow and ice, and by resealing them with the proper stain/sealer and or paint.

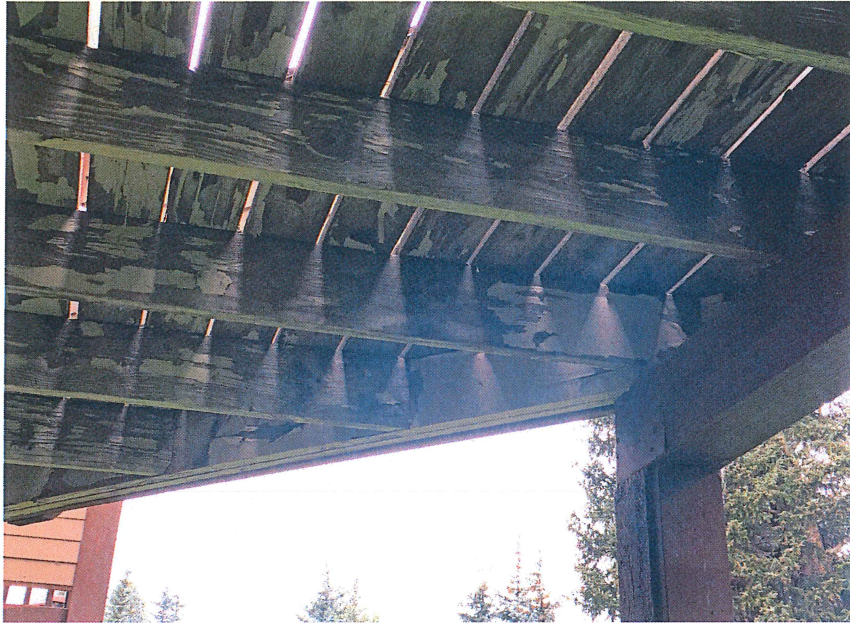
(Image H)

Unit E3 & E4: These decks appear to be framed with 2x wood decking on 2x8 deck joists spaced at 20" on center that are separated in the middle by a framed partition wall. Most of the joists bear on mechanical steel hangers or are toe-nailed on the east end and cantilever approximately 8" on the west end. The east end hangers are nailed to either a 2x8 ledger that is perpendicular with the deck joists or toe-nailed to a 2x8 ledger that is on an approximate 45 degree angle to the deck joists. The 2x8 ledger appears to be nailed to the side of the building or to the cantilevered floor from above. The paint that was applied to the underside of this decking and joists has mostly peeled away. Some nails appear to be weathered and show signs of rust. Some of the deck joists are cracking in areas and they appear to be taking on a blackish/gray weathered look. (See Image H) The cantilevered ends of the joists bear on a dropped 6x8 beam that spans continuously over three separate 6x6 posts. The posts that support the 6x8 beam are spaced out approximately 7'-8" and 8'-3". It appears that where the 6x8 beams bear on a 6x6 post there are some type of mechanical steel caps. The 6x6 post to the south and north appear to have a treated 2x6 stud nailed to one side of it and bears on a concrete circular pier that are about 3 to 6 inches above the grade with no apparent base connection. The 6x6 post in the middle appears

to be offset to the south about 6" from the partition wall that separates the decks. This 6x6 post can be pushed away from the bottom where it bears on the circular concrete pier.

1. All load bearing 6x6 posts should bear on a concrete pier and footing. The bottom of the footing should be a minimum of 48" below grade for frost protection. The size of the footing can be determined by our office and is based on the load it is supporting and upon the soil bearing conditions. By code the bottom of a wood post should be a minimum of 8" from the finished grade or shall be of naturally durable or preservative-treated wood. This must be completed for the middle 6x6 post at units E3 and E4.

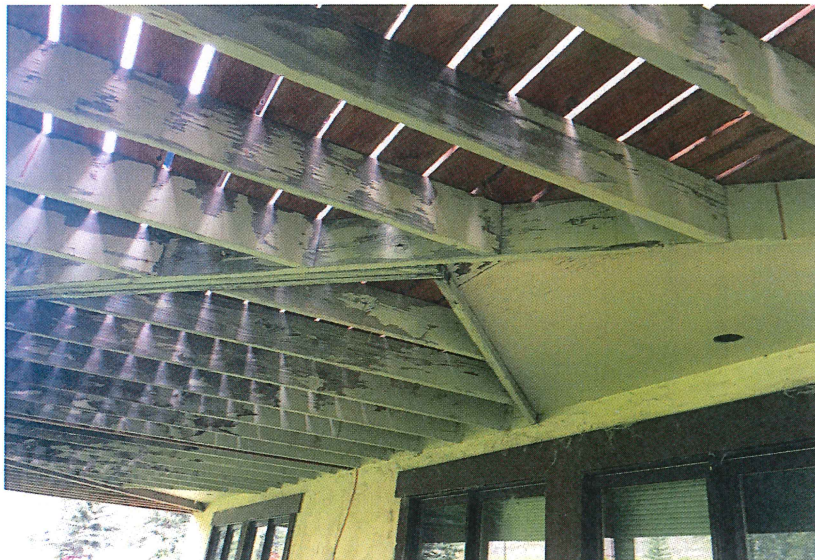
(Image I)

Unit E5: This deck appears to have been remodeled at some point in time. The deck is connected to unit E6 and is separated in the middle by a framed partition wall. The deck to the south of the cantilevered floor from above appears to be framed with 2x8 deck joists spaced at 16" on center and at 20" on center to the north of the cantilevered floor. The decking appears to be newer 2x6 wood decking. The paint that was applied to the joists has mostly peeled away. Most of the joists bear on mechanical steel hangers or are toe-nailed on the east end and cantilever approximately 10" on the west. The east end hangers are nailed to either a 2x8 ledger that is perpendicular with the deck joists or toe-nailed to a (3)-2x8 ledger that is on an approximate 45 degree angle to the deck joists. The ledgers to the south side of the cantilevered floor from above appear to be lagged into the side of the building or to the cantilevered floor from above at the top and nailed to the side of the building to the north of the cantilevered floor from above. The cantilevered ends of the joists bear on dropped 6x8 beams. Some of the nails appear to be weathered and show signs of rust. Some of the deck joists are cracking in areas and they appear to be taking on a blackish/gray weathered look. The 6x8 beam to the south spans continuously over two separate 6x6 posts

and cantilevers over the post to the south approximately 1'-8". The 6x8 beam to the north also spans continuously over three separate 6x6 posts that also supports some of the E6 unit deck. The posts are spaced out randomly with the largest spacing being approximately 10'-3" and smallest spacing being approximately 7'-7". It appears that where the 6x8 beams bear on a 6x6 post there are some mechanical steel caps. The 6x6 posts bear on concrete circular piers and do not appear to have a mechanical steel base plate. The piers are about 2 to 4 inches above the grade. (See Image I)

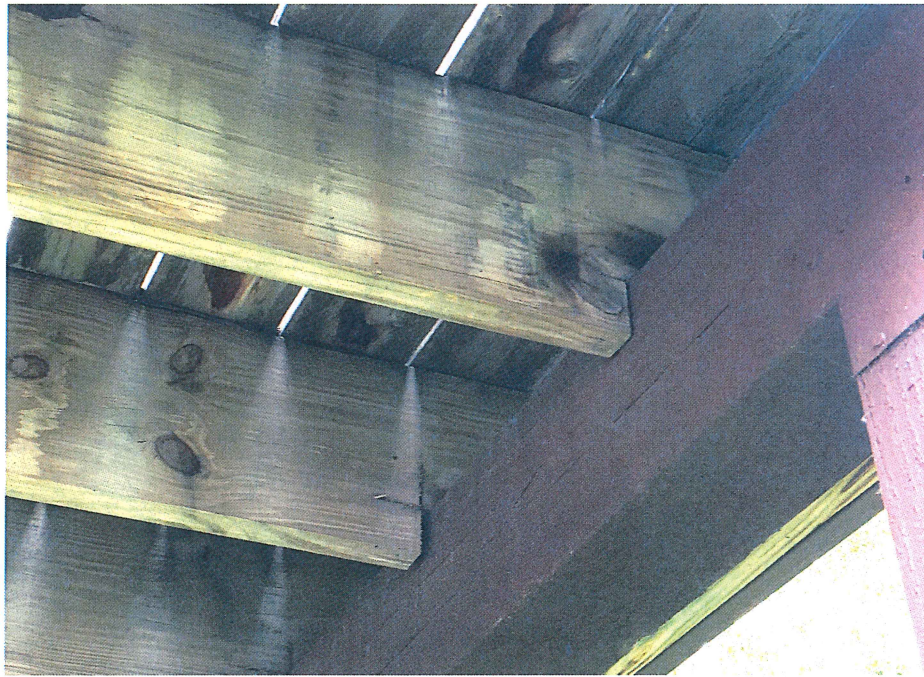
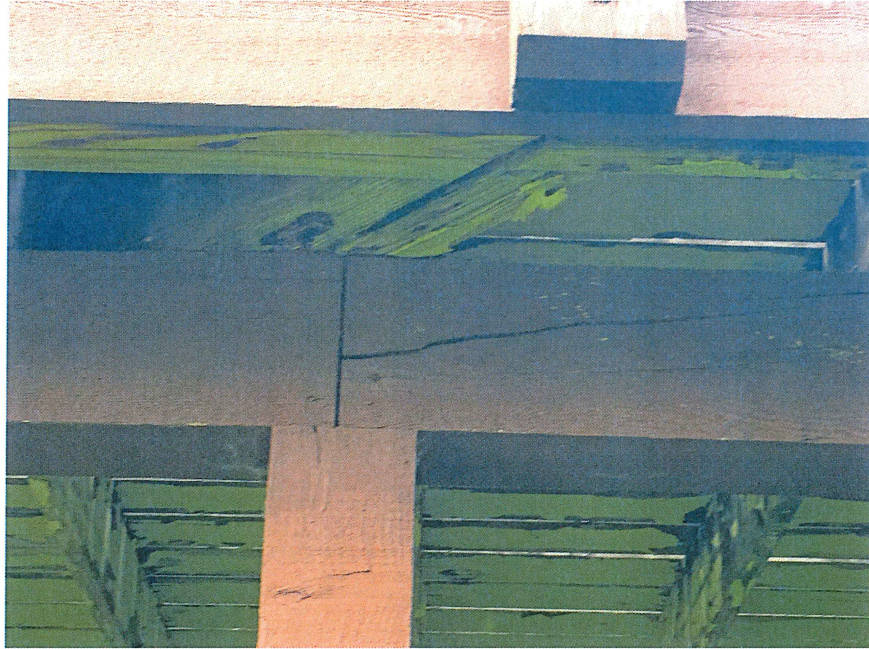
Unit E6: This deck appears to have been remodeled at some point in time. The deck is connected to unit E5 and is separated in the middle by a framed partition wall. The deck to the south of the cantilevered floor from above appears to be framed with 2x8 deck joists spaced at 20" on center with older 2x6 decking. The deck to the north of the cantilevered floor from above appears to be framed with 2x10 deck joists spaced at 16" on center with newer 2x6 decking. The paint that was applied to the underside of this decking and joists has mostly peeled away. Some nails appear to be weathered and show signs of rust. Some of the deck joists are cracking in areas and they appear to be taking on a blackish/gray weathered look. Most of the joists bear on mechanical steel hangers or are toe-nailed on the east end and cantilever approximately 10" on the west. The east end hangers are nailed to either a 2x8 or a 2x10 ledger that is perpendicular with the deck joists or toe-nailed to a 4x10 ledger that is on an approximate 45 degree angle to the deck joists. The 4x10 ledger to the north side of the cantilevered

floor from above appear to be lagged into the cantilevered floor from above at the top. The cantilevered ends of the deck joists bear on dropped 6x8 beams. It appears as though the 2x10 deck joists to the north of the cantilevered floor from above have been notched over the 6x8 dropped beam and some have been over cut in areas. (See Image J) The 6x8 beam to the south spans continuously over three separate 6x6 posts that also supports some of the E5 unit deck. Where the 6x8 beam bears on the 6x6 post there is a large diagonal crack. (See Image K) The 6x8 beam to the north spans continuously over two separate 6x6 posts and cantilevers over the post to the north approximately 8". The posts are spaced out randomly with the largest spacing being approximately 8'-2" and smallest spacing being approximately 3'-6". It appears that where the 6x8 beams bear on a 6x6 post there are some mechanical steel caps. The 6x6 posts bear on concrete circular piers and do not appear to have a mechanical steel base plate. The piers are about 3 to 8 inches above the grade.

6. For unit E6, sister a 2x8 to the existing 2x10 deck joists with three rows of 8d nails at 16" where they have been over cut.
