Observation Report

September 5, 2019

Re: Meadow Creek Condominiums, Vail, CO
(Building F)
Project No. 0307-19 F

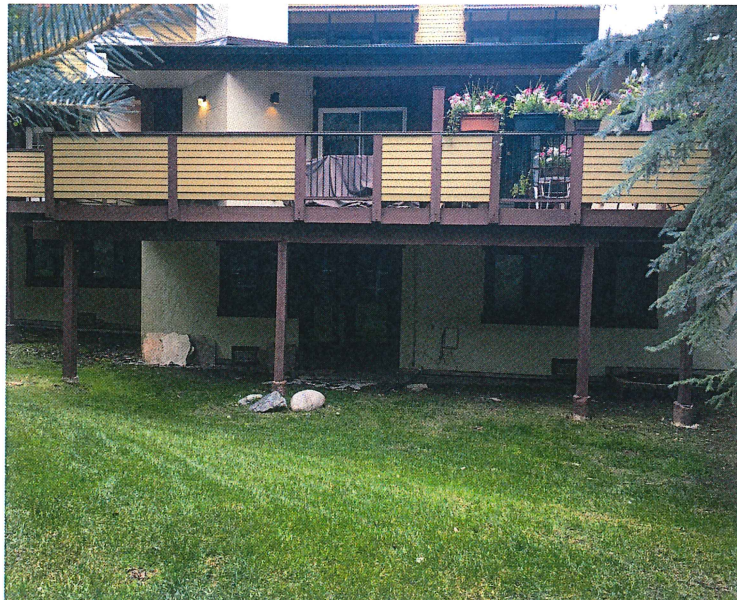
(Image A, Unit 1 & 2)

Building F consists of six units and staggers two units at a time from the northeast towards the southwest approximately 12 feet starting with units F1 and F2. The exterior decks are located on the east side of the building and are approximately 9 to 10 feet above the finished grade. They extend approximately 10 feet from the building and the lengths of the decks vary from unit to unit. There is a framed partition wall that divides the decks in half. This partition wall appears to be located between the two units at the party wall. The decks are accessed by an exterior door located on the east side of each individual unit and an exterior set of stairs for Unit F2. The exterior decks appear to be framed with 2x wood decking on a combination of 2x8 dimensional lumber joists, timber or glulam beams and posts. (See Image A, B, C and attached layouts)
