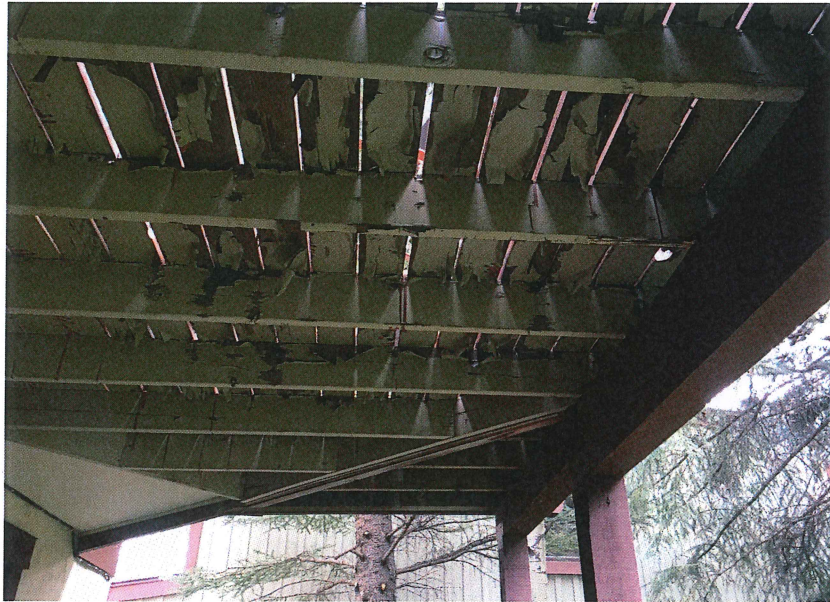
(Image D)

Unit F1: A section of this deck appears to have been remodeled at some point in time. The deck is connected to unit F2 and is separated in the middle by a framed partition wall. A small triangular section of this deck located to the north of the cantilevered floor above appears newer than the remainder of the deck. The newer section appears to be framed with treated 2x8 deck joists spaced at 16" on center with 2x6 decking. Most of the joists bear on mechanical steel hangers on the west end and cantilever approximately 8" on the east. The west end hangers are nailed to a 3x8 that is on an approximate 45 degree angle to the deck joists and appears to be lagged to an older 2x8 rim board. (See Attached Layout) The cantilevered ends of the joists bear on dropped 6x8 beam. The 6x8 beam spans continuously over two separate 6x6 posts that are spaced out approximately 5'-1". At the top of the 6x6 posts there appears to be a steel mechanical cap on one side where the 6x8 bears. Both of the 6x6 posts bear on concrete circular piers and do not appear to have a mechanical steel base plate. The remainder of the deck for unit F1 appears to be framed with 2x8 deck joists spaced at 20" on center with 2x6 decking. The paint that was applied to the underside of this decking and joists has mostly peeled away. Most of the joists bear on mechanical steel hangers or are toe-nailed on the west end and cantilever approximately 8" on the east. The west end hangers are nailed to either a 2x8 ledger that is perpendicular with the deck joists or toe-nailed to a 2x8 ledger that is on an approximate 45 degree angle to the deck joists. The ledgers appear to be nailed to the side of the building. The cantilevered ends of the joists bear on a dropped 5 1/8 x 12 glulam beam that supports some of the deck for unit F2. Some of the nails appear to be weathered and show signs of rust. Some of the deck joists are cracking and appear to be rotting on the top in areas and they also appear to be taking on a blackish/gray weathered look. The 5 1/8 x 12 glulam beam spans continuously over two separate 6x6 posts that are spaced apart approximately 16'-0". The 6x6 post to the north supports both the glulam beam and the 6x8 beam described above. The 6x6 post to the south supports both the glulam beam and (3)-2x12 treated beam that is described in unit F2 and does not have a mechanical steel cap nor does it appear to have a base plate connection where it bears on a circular pier. (See Image D & E)

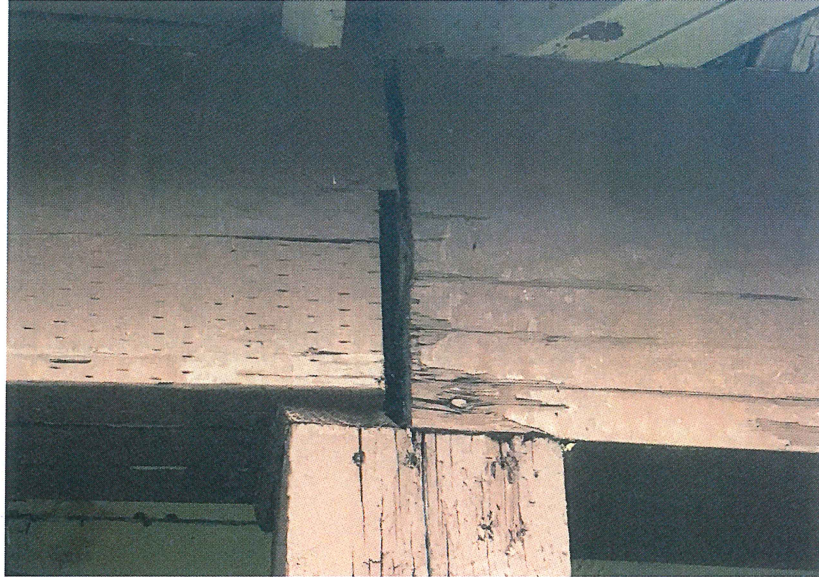
(Image F)

Unit F2: A section of this deck appears to have been remodeled and repaired at some point in time. The deck is connected to unit F1 and is separated in the middle by a framed partition wall. The deck is framed with 2x8 deck joists spaced at 20" on center with 2x6 decking. The paint that was applied to the underside of this decking and joists has mostly peeled away. Most of the joists bear on mechanical steel hangers or are toe-nailed on the west end and cantilever approximately 8" on the east. The west end hangers are nailed to either a 2x8 ledger that is perpendicular with the deck joists or toe-nailed to a 2x8 ledger that is on an approximate 45 degree angle to the deck joists. The ledgers appear to be nailed to the side of the building. The cantilevered ends of the joists bear on a dropped 5 1/8 x 12 glulam beam as described above in unit F1 and also supports some of the deck for that unit. Some of the nails appear to be weathered and show signs of rust. Some of the deck joists are cracking and appear to be rotting on the top in areas and they also appear to be taking on a blackish/gray weathered look. The remainder of the deck is to the south of the cantilevered floor from above and appears to have been remodeled and repaired at some point in time. This section of deck appears to be framed with 2x8 deck joists spaced at 16" on center with 2x6 decking. Some of the 2x8 joists have been doubled up. (See Attached Layout) Most of the joists bear on mechanical steel hangers on the west end and cantilever approximately 8" on the east. The west end hangers are nailed to either a 2x8 ledger that is perpendicular with the deck joists or toe-nailed to a (2)-2x8 that is on an approximate 45 degree angle to the deck joists. The ledgers appear to be nailed to the side of the building. The cantilevered ends of the joists bear on a dropped treated (3)-2x12 beam that is supported on two 6x6 post that are spaced approximately 11'-11" apart. At the top of the 6x6 posts there does not appear to be a steel mechanical cap where the (3)-2x12 beam bears. Both of the 6x6 posts bear on concrete circular piers and do not appear to have a mechanical steel base plate. The top of the concrete pier to the south is approximately 3" above the finished grade. (See Image F & G)

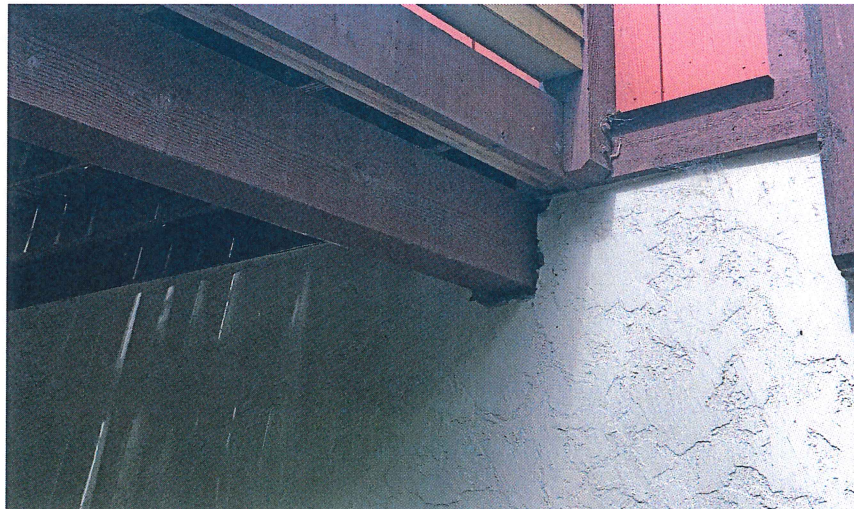
(Image H)

Unit F3: The deck for this unit appears to have been remodeled at some point in time. This unit deck is connected to unit F4 and is separated in the middle by a framed partition wall. The deck to the north of the cantilevered floor from above and appears to have been remodeled and repaired at some point in time. This section of deck appears to be framed with treated 2x8 deck joists spaced at 16" on center with 2x6 decking. The remainder of the deck appears to be the original deck and is framed with 2x8's spaced at 20" on center with 2x6 decking. The paint that was applied to the underside of the original decking and joists has mostly peeled away. Most of the joists bear on mechanical steel hangers or are toe-nailed on the west end and cantilever approximately 8" on the east. The west end hangers are nailed to either a 2x8 ledger that is perpendicular with the deck joists or toe-nailed to a 4x8 ledger that is on an approximate 45 degree angle to the deck joists. The 2x8 ledger appears to be nailed to the side of the building and the 4x8 ledger appears to be lagged into the cantilevered floor from above with one lag. The cantilevered ends of the joists bear on either a dropped 6x12 beam or a dropped 5 1/8 x 12 glulam beam that supports some of the deck for unit F4. Some of the nails appear to be weathered and show signs of rust. Some of the original deck joists are cracking and appear to be rotting on the top in areas and they also appear to be taking on a blackish/gray weathered look. The dropped 6x12 beam spans approximately 12'-0" and bears on a 6x6 post to the south end and appears to bear in the exterior wall of unit F2 on the north end. The 6x6 post has a vertical crack in it. This post does not appear to have a mechanical steel cap where the beams bear on it nor does it appear to have a base plate connection where it bears on a circular pier. (See Image H & I)
