## Observation Report

September 11, 2019

Re: Meadow Creek Condominiums, Vail, CO  
(Building G)  
Project No. 0307-19 D

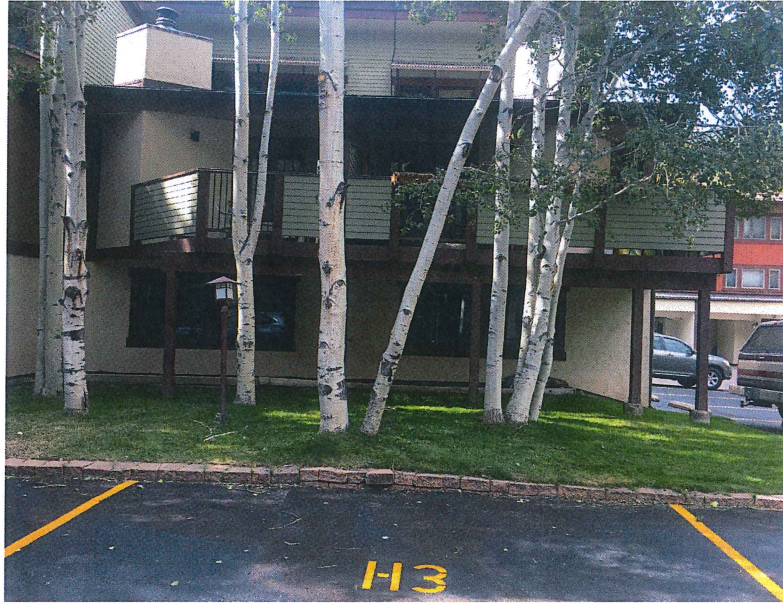
(Image A)

Building G consists of four units and staggers two units at a time from the northwest towards the southeast approximately 12 feet starting with units G1 and G2 on the northwest side. The exterior decks are located on the east side of the building and are approximately 8 feet above the finished grade. They extend approximately 10 feet from the building and the lengths of the decks vary from unit to unit. There is a framed partition wall that divides the decks in half. This partition wall appears to be located between the two units at the party wall. The decks are accessed by an exterior door located on the east side of each individual unit. The exterior decks appear to be framed with 2x wood decking on a combination of 2x8 dimensional lumber joists, glulam or timber beams and posts. (See Image A, B and attached layouts)

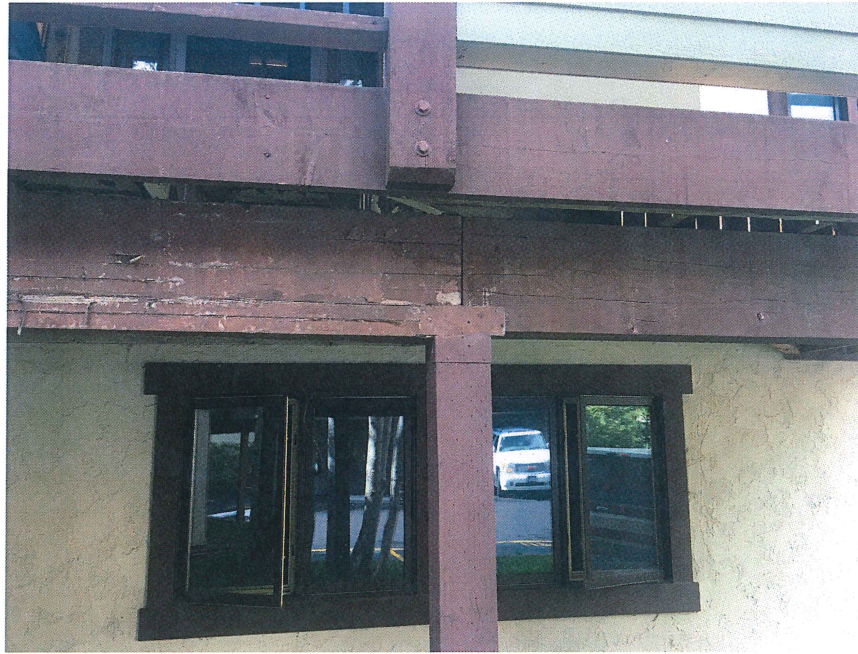
(Image C)

Unit G1: A section of this deck appears to have been remodeled at some point in time. The deck is connected to unit G2 and is separated in the middle by a framed partition wall. A small section of this deck located to the north of the cantilevered floor above appears newer than the remainder of the deck. The newer section appears to be framed with treated 2x8 deck joists spaced at 16" on center with 2x6 decking. Most of the joists bear on mechanical steel hangers on the west end and cantilever approximately 8" on the east. The west end hangers are nailed to a 2x8 ledger that is perpendicular with the deck joists or a 4x8 that is on an approximate 45 degree angle to the deck joists that appears to be lagged to an older 2x8 rim board. (See Attached Layout) The cantilevered ends of the joists bear on dropped 6x12 beam. The 6x12 beam spans continuously over three separate 6x6 posts that are spaced out approximately 3'-5" and 8'-6". Starting from the north, located at the top of the first two 6x6 posts there appears to be a steel mechanical cap on one side where the 6x12 bears. Both of these 6x6 posts bear on concrete circular piers and do appear to have a mechanical steel base plate. The third 6x6 post located to the south supports the end of the 6x12 and a 5 1/8 x 12 glulam beam. (See Image C) Located at the top of the 6x6 posts it appears that there is a steel mechanical cap on each side of the beam. The bottom of this post appears as though it is bearing on the ground and is showing signs of rot. (See Image D) The remainder of the deck for unit F1 appears to be framed with 2x8 deck joists spaced at 20" on center with 2x6 decking. The paint that was applied to the underside of this decking and joists has mostly peeled away. Most of the joists bear on mechanical steel hangers or are toe-nailed on the west end and cantilever approximately 8" on the east. The west end hangers are nailed to either a 2x8 ledger that is perpendicular with the deck joists or toe-nailed to a 2x8 ledger that is on an approximate 45 degree angle to the deck joists. The ledgers appear to be nailed to the side of the building. The cantilevered ends of the joists bear on a dropped 5 1/8 x 12 glulam beam that supports some of the deck for unit G2. Some of the nails appear to be weathered and show signs of rust. Some of the deck joists are cracking and appear to be rotting on the top in areas and they also appear to be taking on a blackish/gray weathered look. (See Image E) The 5 1/8 x 12 glulam beam spans continuously over two separate 6x6 posts that are spaced apart approximately 16'-4". The paint that was applied to the glulam beam looks weathered and is peeling away. There also appears to be some separation between the laminates of glulam beam. Where the glulam beam bears on the 6x6 post to the north there appears to be mechanical steel caps on both sides. This 6x6 post also supports both the glulam beam and the 6x12 beam described above. (See Image C)

I feel that the 6x6 post for unit G1 and G2 that is showing signs of rot at the bottom will lose its structural integrity over time and it should be replaced. I feel that the 5 1/8 x 12 glulam beam for unit G4 and G5 is well below the size it should be. This beam should be replaced per the following recommendations.

4. Replace all deck joists that are showing signs of rot along the top with new ones.
5. For unit G1 and G2, replace the 6x6 post that is showing rot at the bottom and provide a cap and base plate as described above.

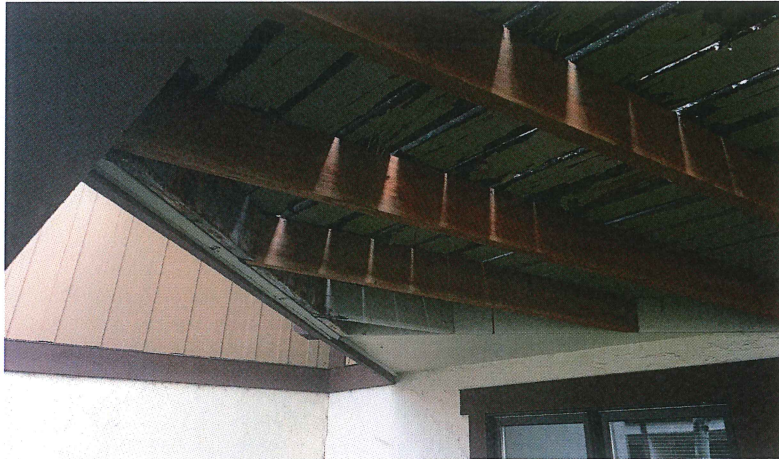
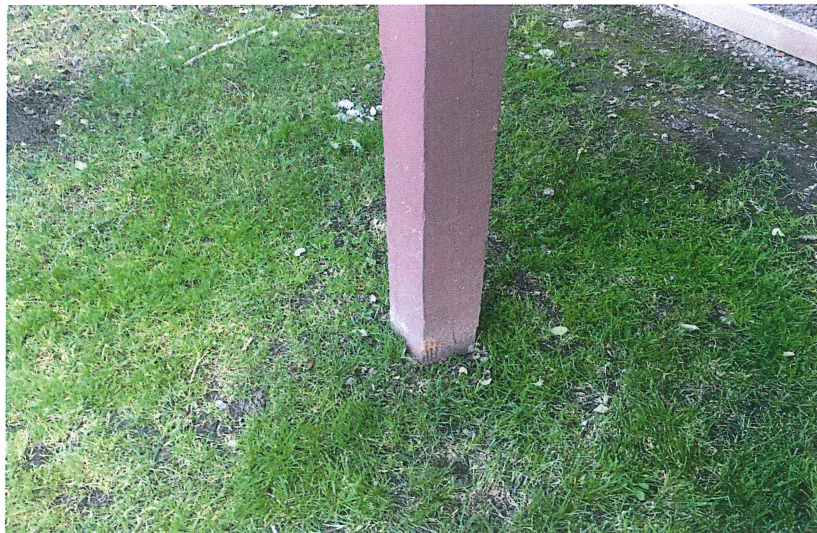
Unit G2: A section of this deck appears to have been repaired at some point in time. The deck is connected to unit G1 and is separated in the middle by a framed partition wall. The deck is framed with newer 2x8 deck joists spaced at 20" on center with 2x6 decking. Most of the joists bear on mechanical steel hangers or are toe-nailed on the west end and cantilever approximately 8" on the east. The west end hangers are nailed to either a 2x8 ledger that is perpendicular with the deck joists or toe-nailed to a 2x8 ledger that is on an approximate 45 degree angle to the deck joists. The ledgers appear to be nailed to the side of the building. The cantilevered ends of the joists bear on a dropped 5 1/8 x 12 glulam beam as described above in unit G1. This beam also supports some of the deck for that unit. Located at the top of the 6x6 posts it appears that there is a steel mechanical cap on each side of the beam. The bottom of this post appears as though it is bearing on the ground. (See Image F and G)

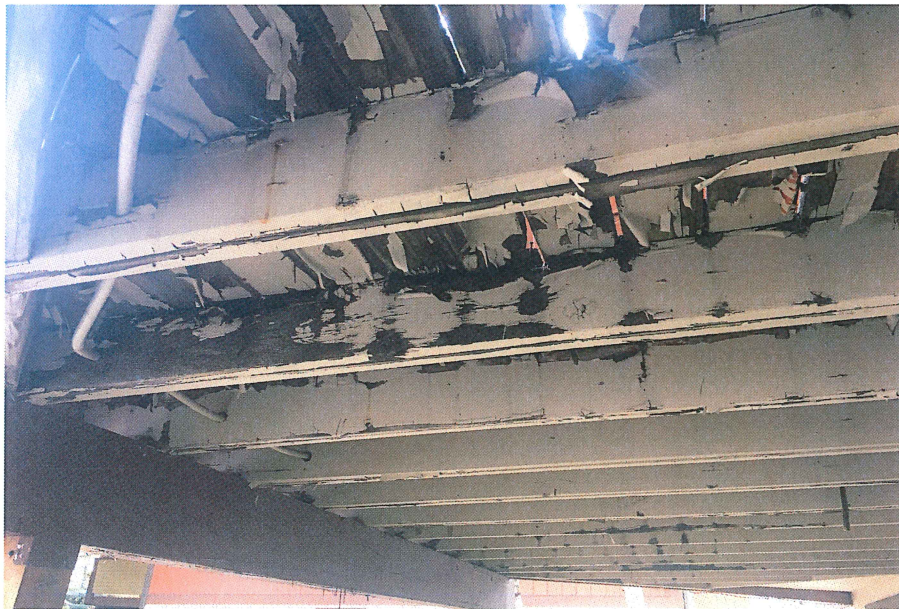
(Image H)

Unit G3: The deck for this unit appears to have been remodeled at some point in time. This unit deck is connected to unit G4 and is separated in the middle by a framed partition wall. The deck is framed with (2)-2x8 deck joists spaced at 20" on center with 2x6 decking. The paint that was applied to the underside of this decking and joists has mostly peeled away. (See image H) Most of the joists bear on mechanical steel hangers or are toe-nailed on the west end and cantilever approximately 8" on the east. The west end hangers are nailed to either a 2x8 ledger that is perpendicular with the deck joists or toe-nailed to a 2x8 ledger that

is on an approximate 45 degree angle to the deck joists. The ledgers appear to be nailed to the side of the building. The cantilevered ends of the joists bear on a dropped 5 1/8 x 12 glulam beam that supports some of the deck for unit G4. Some of the nails appear to be weathered and show signs of rust. Some of the deck joists are cracking and appear to be rotting on the top in areas and they also appear to be taking on a blackish/gray weathered look. The 5 1/8 x 12 glulam beam spans continuously over two separate 6x6 posts that are spaced apart approximately 15'-4". The paint that was applied to the glulam beam looks weathered and is peeling away. There also appears to be some separation between the laminates of glulam beam. Where the glulam beam bears on a 6x6 post to the north there appears to be a mechanical steel cap on one side and some toe-screws on the other. (See Image I) The 6x6 post to the north appears to be newer and appears to be bearing on a circular concrete pier. There are three metal L-clips at the bottom of the 6x6 post where it bears on the concrete pier. The top of the concrete pier is sloping to the south and is approximately one inch above the finished grade. This deck also has a hot tub on it that is approximately 6'-6"x6'-6" in size. (See Image J and attached layout)

7. For unit G3, replace the (2)-2x8 deck joists with either treated (3)-2x8 or treated (2)-2x10 deck joists spaced at 16" on center.

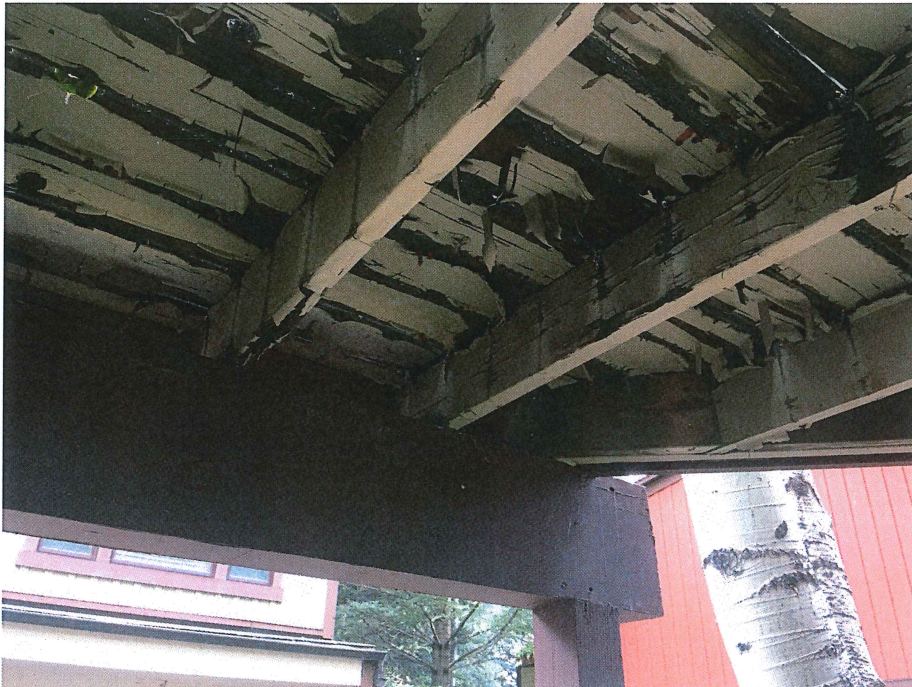
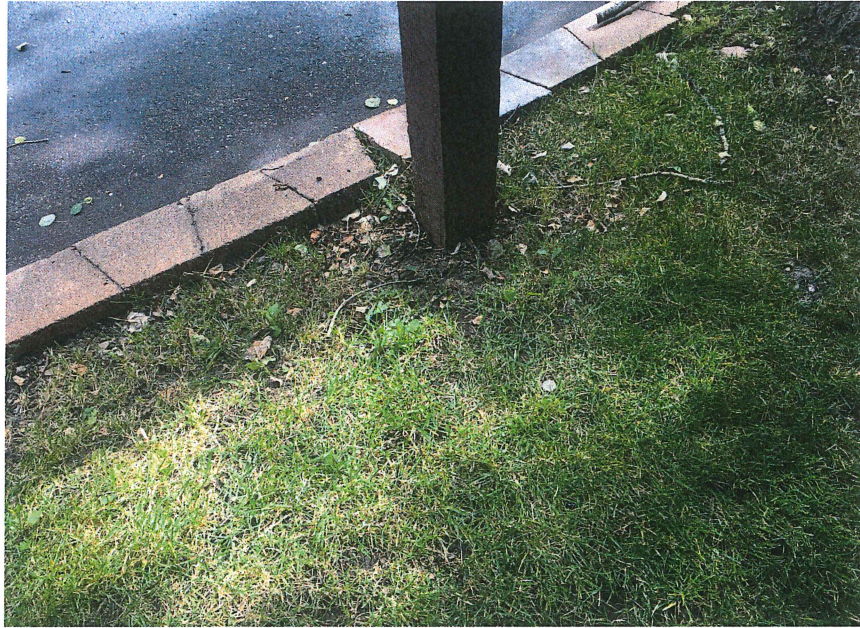
Unit G4: This deck appears to be of the original design. The deck is connected to unit G3 and is separated in the middle by a framed partition wall. The deck is framed with 2x8 deck joists spaced at 20" on center with 2x6 decking. Most of the joists bear on mechanical steel hangers or are toe-nailed on the west end and cantilever approximately 8" on the east. The west end hangers are nailed to either a 2x8 ledger that is perpendicular with the deck joists or toe-nailed to a 2x8 ledger that is on an approximate 45 degree angle to the deck joists. The ledgers appear to be nailed to the side of the building. The cantilevered ends of the joists bear on a dropped 5 1/8 x 12 glulam beam as described above in unit G3. This beam also supports some of the deck for that unit. Where the glulam beam bears on the 6x6 post to the south it does not appear that there is a steel mechanical cap. The bottom of this post appears as though it is bearing on the ground. (See Image K and L)

6. For unit G3 and G4, replace the 5 1/8 x 12 glulam beam with a 5 1/8 x15 glulam beam or a 6 3/4 x 12 glulam beam. A second option is to provide a 6x6 post at the mid-span of the existing beam. This post should bear on a concrete pier and should have the correct cap and base plate as described above.
