## Observation Report

September 17, 2019

Re: Meadow Creek Condominiums, Vail, CO  
(Building H)  
Project No. 0307-19 F

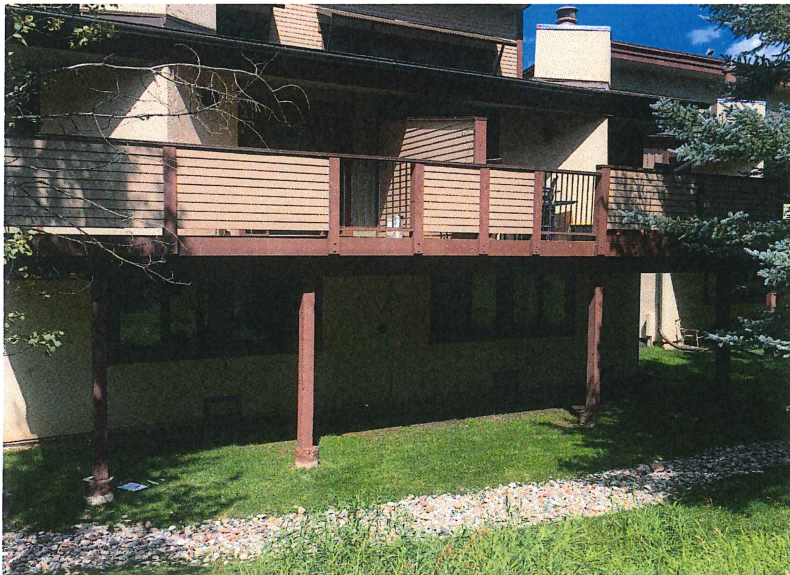
(Image A, Unit 1 & 2)

Building H consists of six units and staggers two units at a time from the northeast towards the southwest approximately 12 feet starting with units H1 and H2. The exterior decks are located on the east side of the building and are approximately 10 feet above the finished grade. They extend approximately 10 feet from the building and the lengths of the decks vary from unit to unit. There is a framed partition wall that divides the decks in half. This partition wall appears to be located between the two units at the party wall. The decks are accessed by an exterior door located on the east side of each individual unit. The exterior decks appear to be framed with 2x wood decking on a combination of 2x8 and 2x12 dimensional lumber joists, timber or glulam beams and posts. (See Image A, B, C and attached layouts)

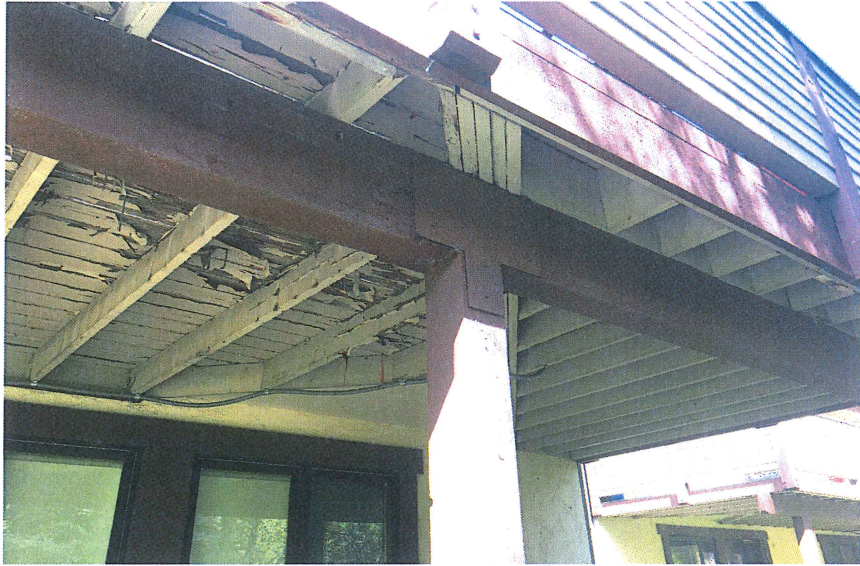
(Image D)

Unit H1: A section of this deck appears to have been remodeled at some point in time. The deck is connected to unit H2 and is separated in the middle by a framed partition wall. A section of this deck located to the north of the cantilevered floor above appears newer than the remainder of the deck. The newer section appears to be framed with treated 2x12 deck joists spaced at 12" on center with 2x6 decking. Most of the joists bear on mechanical steel hangers on the west end and cantilever approximately 12" on the east. The west end hangers are nailed to (4)-2x12's that is on an approximate 45 degree angle to the deck joists and appears to be nailed to a rim board. (See Attached Layout) The cantilevered ends of the joists bear on a dropped 5 1/8" x 12" glulam beam. The glulam beam spans continuously over two separate posts that are spaced out approximately 9'-8" and cantilevers to the north approximately 2'-6". The post to the north is a 6x8 and the post to the south is a 6x6. At the top of the 6x8 posts there does not appear to be a steel mechanical cap. At the top of the 6x6 post there appears to be a custom steel T-shaped cap. (See Image D) This post also supports a 5 1/8" x 12" glulam beam that also supports some of the deck for unit H2. Both of the 6x posts bear on concrete circular piers and do not appear to have a mechanical steel base plate. The remainder of the deck for unit H1 appears to be framed with 2x8 deck joists spaced at 20" on center with 2x6 decking. The paint that was applied to the underside of this decking and joists has mostly peeled away. Most of the joists bear on mechanical steel hangers or are toe-nailed on the west end and cantilever approximately 12" on the east. The west end hangers are nailed to either a 2x8 ledger that is perpendicular with the deck joists or toe-nailed to a 2x8 ledger that is on an approximate 45 degree angle to the deck joists. The ledgers appear to be nailed to the side of the building. The cantilevered ends of the joists bear on a dropped 5 1/8 x 12 glulam beam that supports some of the deck for unit H2. Some of the nails appear to be weathered and show signs of rust. Some of the deck joists are cracking and appear to be rotting on the top in areas and they also appear to be taking on a blackish/gray weathered look. (See Image E) The 5 1/8 x 12 glulam beam spans continuously over two separate 6x6 posts that are spaced apart approximately 16'-1". The paint that was applied to the glulam beam looks weathered and is peeling away. There also appears to be some separation between the laminates of glulam beam. The 6x6 post to the north supports both the glulam beams described above. The 6x6 post to the south supports both the glulam beam and 6x12 beam that is described in unit H2 and does not have a mechanical steel cap nor does it appear to have a base plate connection where it bears on a circular pier. This deck also has a hot tub on it that is approximately 6'-0" diameter in size. (See Image J and attached layout)

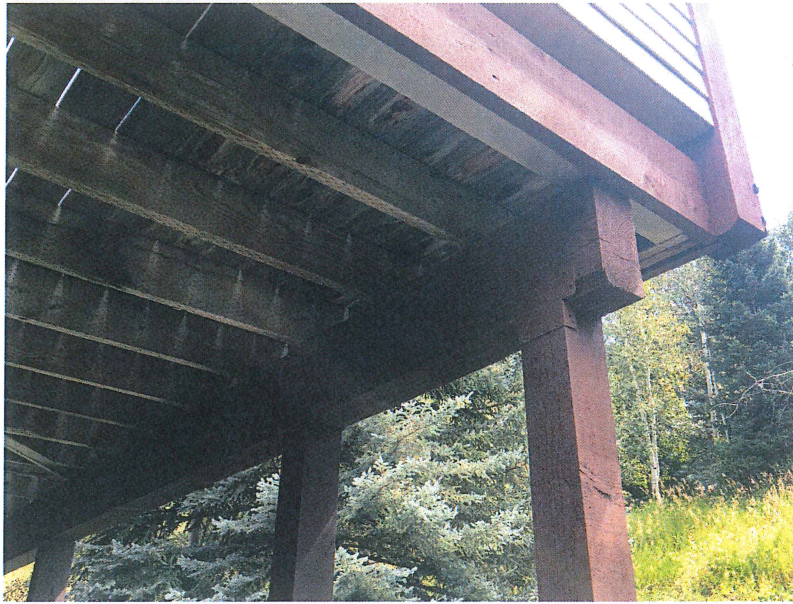
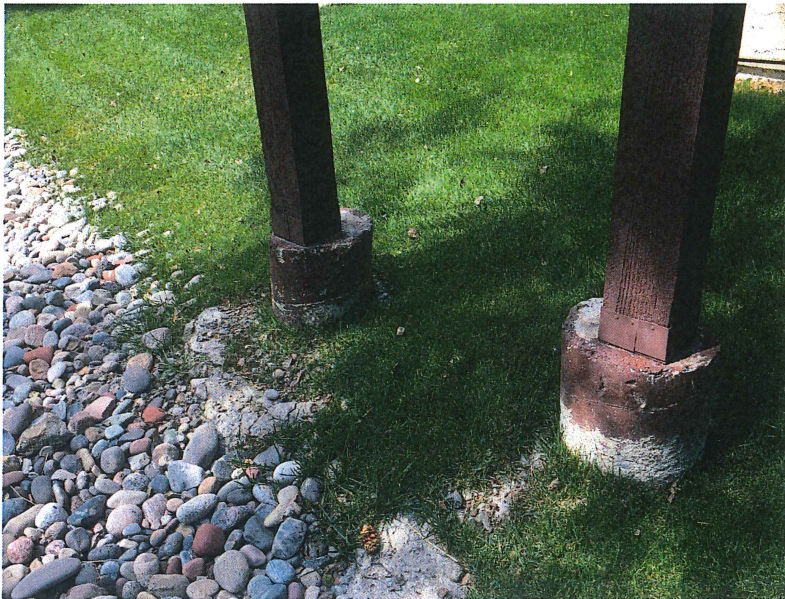
Unit H2: A section of this deck appears to have been remodeled at some point in time. The deck is connected to unit H1 and is separated in the middle by a framed partition wall. The deck is framed with 2x8 deck joists spaced at 20" on center with 2x6 decking. The paint that was applied to the underside of this decking and joists has mostly peeled away. Most of the joists bear on mechanical steel hangers or are toe-nailed on the west end and cantilever approximately 12" on the east. The west end hangers are nailed to either a 2x8 ledger that is perpendicular with the deck joists or toe-nailed to a 2x8 ledger that is on an approximate 45 degree angle to the deck joists. The ledgers appear to be nailed to the side of the building. The cantilevered ends of the joists bear on a dropped 5 1/8 x 12 glulam beam as described above in unit H1 and also supports some of the deck for that unit. Some of the nails appear to be weathered and show signs of rust. Some of the deck joists are cracking and appear to be rotting on the top in areas and they also appear to be taking on a blackish/gray weathered look. (See Image F) The remainder of the deck is to the south of the cantilevered floor from above and appears to have been remodeled at some point in time. This section of deck appears to be framed with treated 2x8 deck joists spaced at 16" on center with 2x6 decking. (See Attached Layout) Most of the joists bear on mechanical steel hangers on the west end and cantilever approximately 12" on the east. The west end hangers are nailed to either a 2x8 ledger that is perpendicular with the deck joists or toe-nailed to a 4x8 that is on an approximate 45 degree angle to the deck joists. The ledgers appear to be lagged at the end that is closes to the exterior wall of the building. The cantilevered ends of the joists bear on a dropped 6x12 beam that is supported on three 6x6 posts that are spaced approximately 8'-1" and 3'-6" apart. At the top of the 6x6 post to the north, there does not appear to be a steel mechanical cap where both the 5 1/8" x 12" glulam and the 6x12 beams bear. At the top of the other two 6x6 posts, there appear to be a mechanical steel cap on one side. All of the 6x6 posts bear on concrete circular piers and only the two to the south appear to have a mechanical steel base plate. (See Image F & G)

1. Provide Simpson ABU66Z base plates and Simpson PC6Z cap plates to all 6x6 posts.
2. Add (3)-4" x 3/16" diameter Timber-Lok screws at 16" on center to all existing 2x8 ledgers that are attached to the building rim-board.
3. Replace all deck joists that are showing sign of rot along the top with new ones.

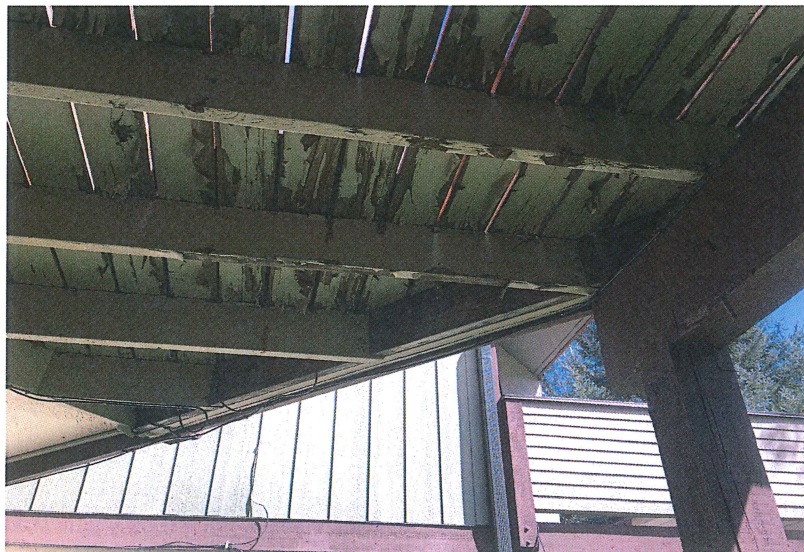
(Image H)

Unit H3: This deck appears to be the original deck. The deck is connected to unit H4 and is separated in the middle by a framed partition wall. The deck is framed with 2x8 deck joists spaced at 20" on center with 2x6 decking. The paint that was applied to the underside of this decking and joists has mostly peeled away. Most of the joists bear on mechanical steel hangers or are toe-nailed on the west end and cantilever approximately 12" on the east. The west end hangers are nailed to either a 2x8 ledger that is perpendicular with the deck joists or toe-nailed to a 2x8 ledger that is on an approximate 45 degree angle to the deck joists. The ledgers appear to be nailed to the side of the building. The cantilevered ends of the joists bear on a dropped 5 1/8 x 12 glulam beam that supports some of the deck for unit H4. Some of the nails appear to be weathered and show signs of rust. Some of the deck joists are cracking and appear to be rotting on the top in areas and they also appear to be taking on a blackish/gray weathered look. (See Image H) The 5 1/8 x 12 glulam beam spans continuously over two separate 6x6 posts that are spaced apart approximately 15'-7". The paint that was applied to the glulam beam looks weathered and is peeling away. There also appears to be some separation between the laminates of glulam beam. Where the glulam beam bears on the 6x6 post to the north, there appears to be mechanical steel caps on both sides. The 6x6 post bears on concrete circular piers and does not appear to have a mechanical steel base plate. (See Image I)

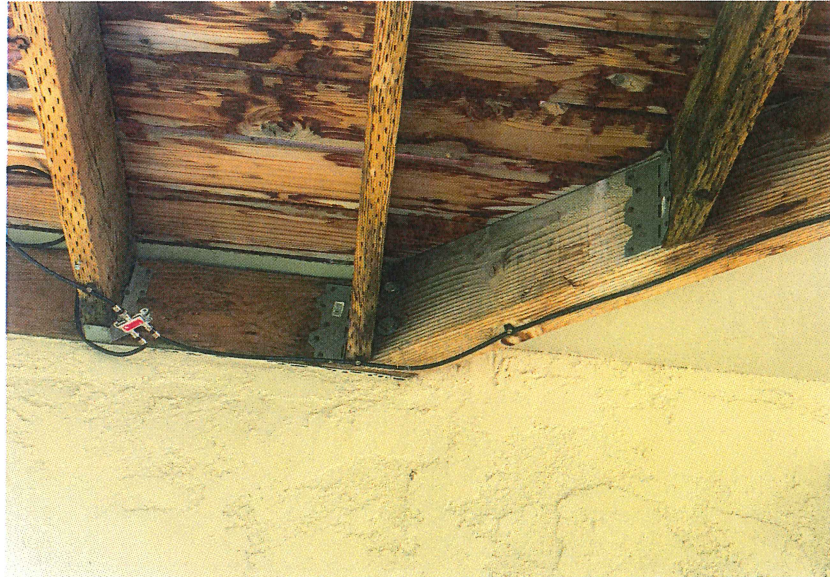
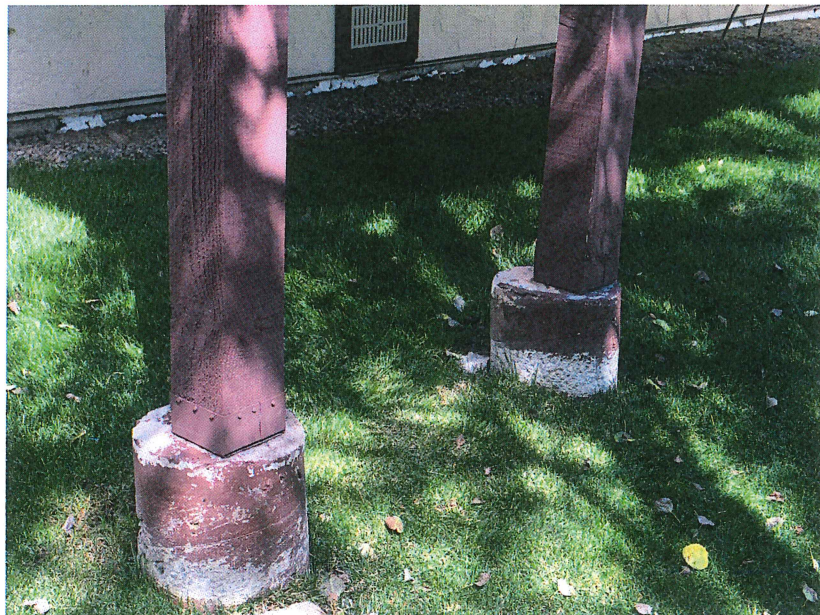
Unit H4: A section of this deck appears to have been remodeled at some point in time. The deck is connected to unit H3 and is separated in the middle by a framed partition wall. The deck is framed with 2x8 deck joists spaced at 20" on center with 2x6 decking. The paint that was applied to the underside of this decking and joists has mostly peeled away. Most of the joists bear on mechanical steel hangers or are toe-nailed on the west end and cantilever approximately 12" on the east. The west end hangers are nailed to either a 2x8 ledger that is perpendicular with the deck joists or toe-nailed to a 2x8 ledger that is on an approximate 45 degree angle to the deck joists. The ledgers appear to be nailed to the side of the building. The cantilevered ends of the joists bear on a dropped 5 1/8 x 12 glulam beam as described above in unit H3 and also supports some of the deck for that unit. Some of the nails appear to be weathered and show signs of rust. Some of the deck joists are cracking and appear to be rotting on the top in areas and they also appear to be taking on a blackish/gray weathered look. (See Image J) The remainder of the deck is to the south of the cantilevered floor from above and appears to have been remodeled at some point in time. This section of deck appears to be framed with treated 2x8 deck joists spaced at 16" on center with 2x6 decking. (See Attached Layout) Most of the joists bear on mechanical steel hangers on the west end and cantilever approximately 12" on the east. The west end hangers are nailed to either a 2x8 ledger that is perpendicular with the deck joists or toe-nailed to a 4x8 that is on an approximate 45 degree angle to the deck joists. The ledgers appear to be lagged at the end

that is closest to the exterior wall of the building. The cantilevered ends of the joists bear on a dropped 6x12 beam that is supported on three 6x6 posts that are spaced approximately 8'-6" and 3'-6" apart. At the top of the 6x6 post to the north, there appears to be a steel mechanical cap on both sides where both the 5 1/8" x 12" glulam and the 6x12 beams bear. At the top of the other two 6x6 posts, there appears to be a mechanical steel cap on one side. All of the 6x6 posts bear on concrete circular piers and only the two to the south appear to have a mechanical steel base plate. (See Image K & L)

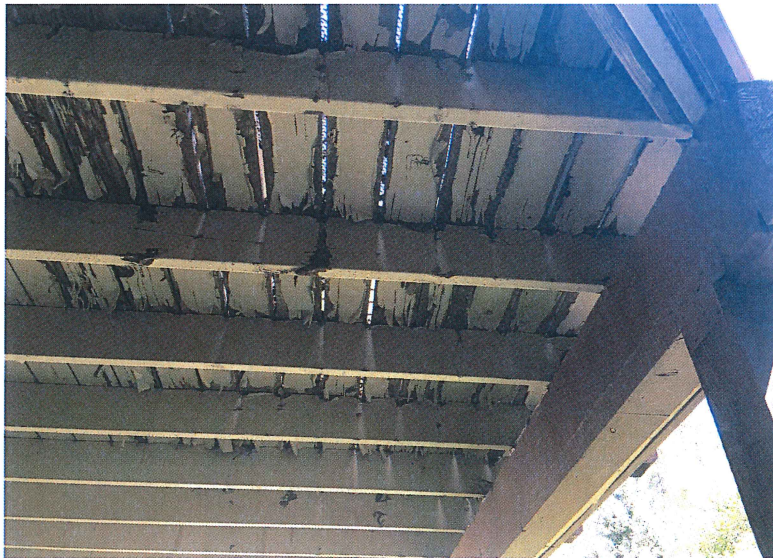
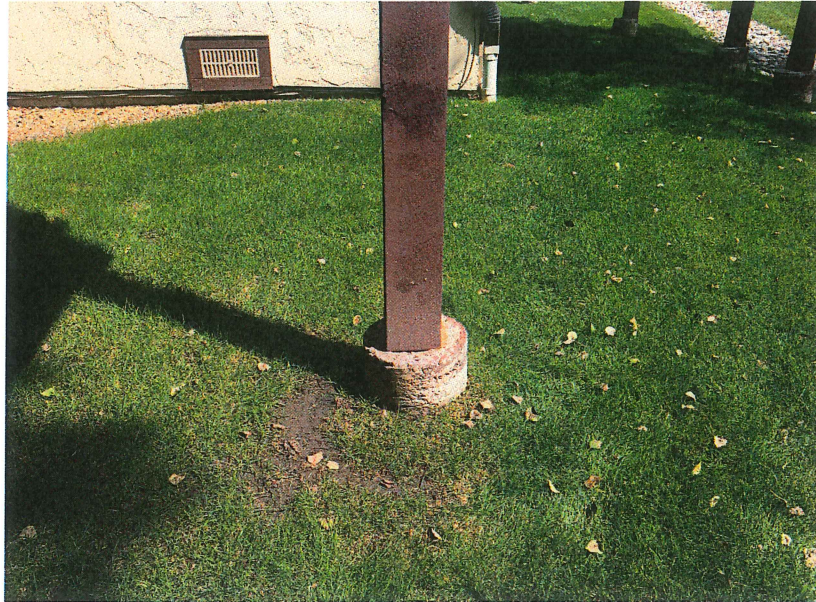
Unit H5 & H6: These decks appear to be of the original design. The decks are connected to each other and are separated in the middle by a framed partition wall. The decks are framed with 2x8 deck joists spaced at 20" on center with 2x6 decking. Most of the joists bear on mechanical steel hangers or are toe-nailed on the west end and cantilever approximately 12" on the east. The west end hangers are nailed to either a 2x8 ledger that is perpendicular with the deck joists or toe-nailed to a 2x8 ledger that is on an approximate 45 degree angle to the deck joists. The ledgers appear to be nailed to the side of the building. The cantilevered ends of the joists bear on a dropped 5 1/8 x 12 glulam beam. Some of the nails appear to be weathered and show signs of rust. Some of the deck joists are cracking and appear to be rotting on the top in areas and they also appear to be taking on a blackish/gray weathered look. The 5 1/8 x 12 glulam beam spans continuously over two separate 6x6 posts that are spaced apart approximately 15'-10". The paint that was applied to the glulam beam looks weathered and is peeling away. There also appears to be some separation between the laminates of glulam beam. Where the glulam beam bears on the 6x6 posts, there appears to be mechanical steel caps on one side. The 6x6 posts bear on concrete circular piers and do not appear to have a mechanical steel base plate. (See Image M and N)
