Observation Report

September 24, 2019

Re: Meadow Creek Condominiums, Vail, CO
(Building J)
Project No. 0307-19 J

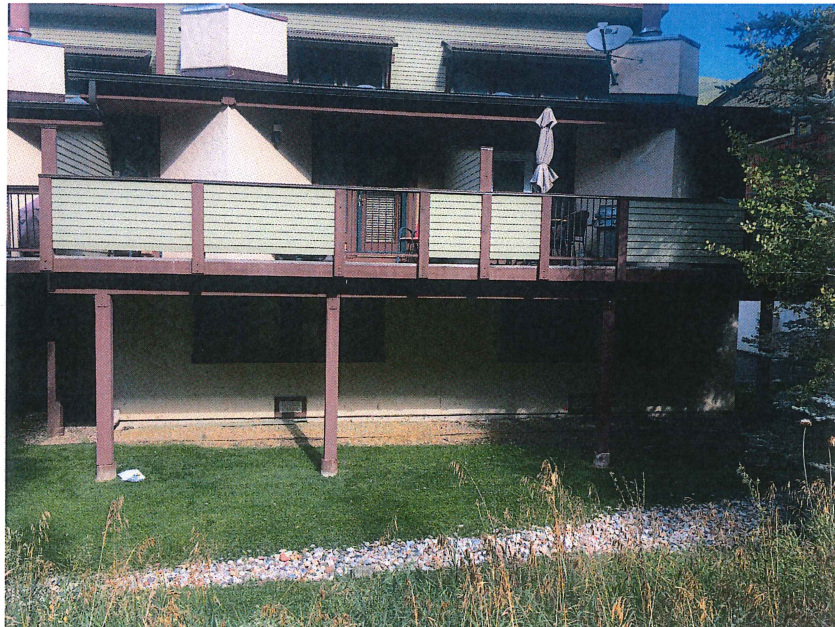
(Image A, Unit 1 & 2)

Building J consists of four units and staggers two units at a time from the northeast towards the southwest approximately 8 feet starting with units J1 and J2. The exterior decks are located on the east side of the building and are approximately 10 feet above the finished grade. They extend approximately 10 feet from the building and the lengths of the decks vary from unit to unit. There is a framed partition wall that divides the decks in half. This partition wall appears to be located between the two units at the party wall. The decks are accessed by an exterior door located on the east side of each individual unit and an exterior set of stairs for Unit J3. The exterior decks appear to be framed with 2x wood decking on a combination of 2x8 dimensional lumber joists, timber or glulam beams and posts. (See Image A, B and attached layouts)

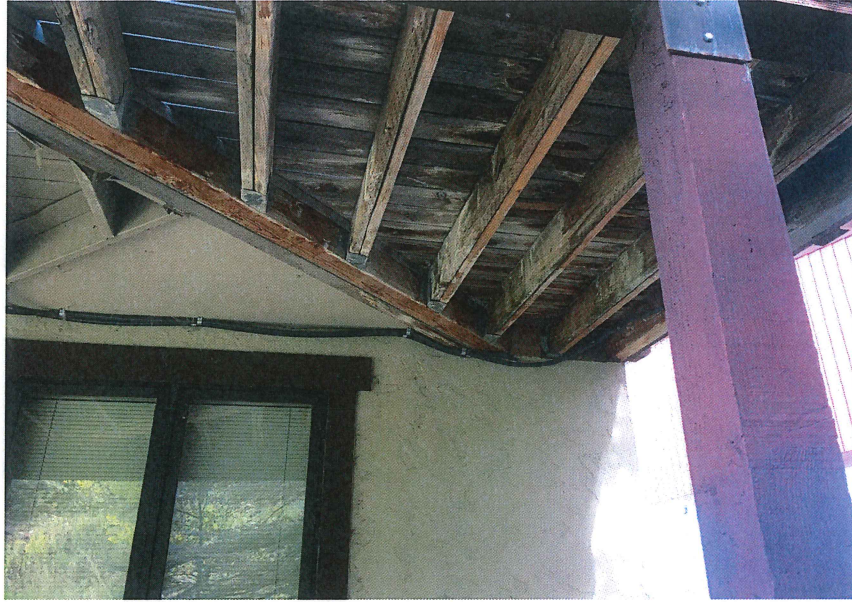
(Image C)

Unit J1: A section of this deck appears to have been remodeled at some point in time. The deck is connected to unit J2 and is separated in the middle by a framed partition wall. A section of this deck located to the north of the cantilevered floor above appears newer than the remainder of the deck. This deck also has a hot tub on it that is approximately 6'-0" x 6'-0" in size. (See layout for location) The newer section appears to be framed with (2)-2x8 deck joists spaced at 16" on center with 2x6 decking. One of the (2)-2x8 deck joists appears to be treated and the other does not. Most of the joists bear on mechanical steel hangers on the west end and cantilever approximately 12" on the east. The west end hangers are nailed to 5x8 that appears to be screwed to a 4x8 ledger that is on an approximate 45 degree angle to the deck joists. (See Image C and Attached Layout) The cantilevered ends of the joists bear on a dropped 6x12 beam. The beam spans continuously over three separate posts that are spaced out approximately 3'-8" and 9'-0" and cantilevers to the north approximately 6". The two posts to the north are 6x6's and the post to the south is a 6x8. At the top of the 6x6 posts, there appears to be a steel vertical plate to the outside that is lagged to the post and dropped timber beam. There also appears to be a steel mechanical cap located on the insides of the posts. (See Image D) Both of the 6x6 posts bear on concrete circular piers and appear to have a mechanical steel base plate. At the top of the 6x8 post located to the south, there appears to be a custom steel T-shaped cap. (See Image E) This post also supports a 5 1/8" x 12" glulam beam that also supports some of the deck for unit J2. The 6x8 post bears on concrete circular pier and does not appear to have a mechanical steel base plate. The remainder of the deck for unit J1 appears to be framed with 2x8 deck joists spaced at 20" on center with 2x6 decking. Some of the paint that was applied to the underside of this decking and joists has peeled away. Most of the joists bear on mechanical steel hangers or are toe-nailed on the west end and cantilever approximately 12" on the east. The west end hangers are nailed to either a 2x8 ledger that is perpendicular with the deck joists or toe-nailed to a 2x8 ledger that is on an approximate 45 degree angle to the deck joists. The ledgers appear to be nailed to the side of the building. The cantilevered ends of the joists bear on a dropped 5 1/8 x 12 glulam beam that supports some of the deck for unit J2. Some of the nails appear to be weathered and show signs of rust. Some of the deck joists are cracking and appear to be rotting on the top in areas and they also appear to be taking on a blackish/gray weathered look. (See Image F) The 5 1/8 x 12 glulam beam spans continuously over two separate 6x8 posts that are spaced apart approximately 14'-2". The 6x8 post to the north supports both the timber and glulam beams described above. The 6x8 post to the south supports two separate glulam beams that is described in unit J2 and appears to have a custom steel T-shaped cap located on the outside and does not appear to

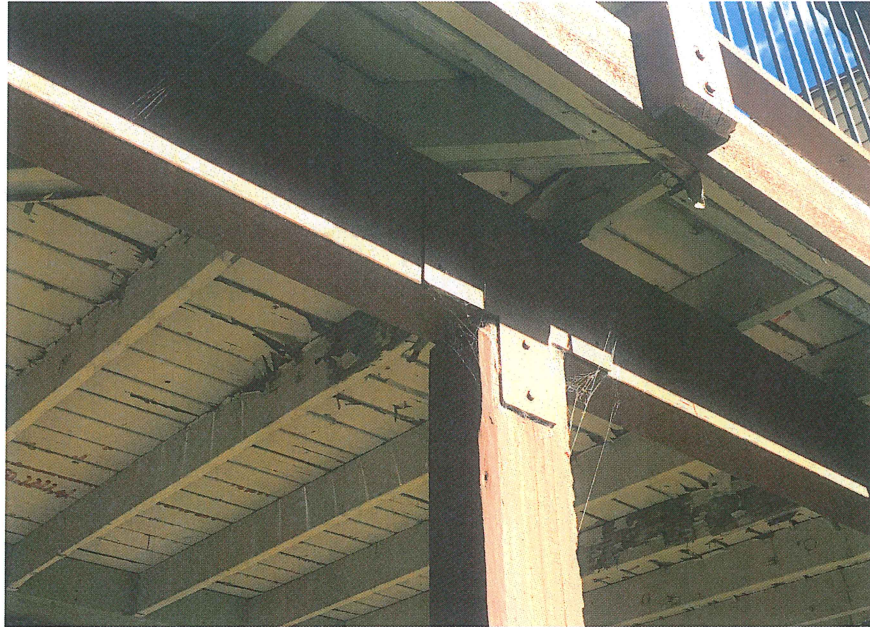
(Image J)

have a base plate connection where it bears on a circular pier. (See Image J and attached layout)
