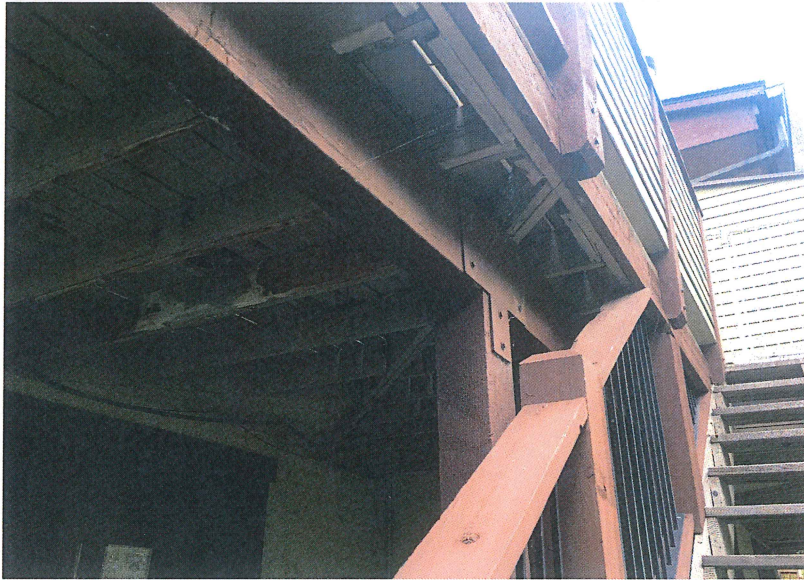
(Image M)

Unit J3: The deck for this unit appears to have been remodeled at some point in time. This unit deck is connected to unit J4 and is separated in the middle by a framed partition wall. This deck also has a hot tub on it that is approximately 5'-6" x 6'-6" in size and appeared to have a slow leak which created a small puddle on the ground. (See layout for location) The section of deck located to the north of the cantilevered floor above appears to have been added on at some point in time. It is framed with 2x8 deck joists spaced at 16" on center with 2x6 decking. Some of the paint that was applied to the underside of this decking and joists has peeled away. The joists bear on mechanical steel hangers on the west end and cantilever approximately 12" on the east except for the northerly three joists, which cantilever approximately 5'-0". These northerly cantilevered joists support the top of the stair stringers and the landing. The west end hangers are nailed to either a 2x8 ledger that is perpendicular with the deck joists or to a 2x8 ledger that is on an approximate 45 degree angle to the deck joists. The ledger perpendicular to the joists appears to be lagged or bolted to the side of the building. The ledger that is on the 45 degree angle appears to be nailed to the side of the building. The cantilevered ends of the joists bear on a dropped 5 1/8 x 12 glulam beam. Some of the nails appear to be weathered and show signs of rust. Some of the deck joists are cracking and appear to be rotting on the top in areas and they also appear to be taking on a blackish/gray weathered look. The 5 1/8 x 12 glulam beam spans continuously over two separate 6x8 posts that are spaced apart approximately 11'-0" and cantilevers to the north approximately 2'-3". The 6x8 posts appear to have a custom steel T-shaped cap located on the

outside and do not appear to have a base plate connection where it bears on a circular pier. (See Image M) This unit has a set of stairs that lead down to the grade below. The stairs appear to be framed with three separate stair stringers with 2x6 decking for treads. The two stringers on the outsides of the stairs appear to be (2)-2x12 stringers, and one located in the middle appears to be (1)-2x12. The stair stringers appear to have no visible connection to the (2)-2x8 cantilevered deck joist at the top. The (2)-2x8 cantilevered deck joist appear to have some rot at the top where they bear on the glulam beam. The stair landing at the top is approximately 3'-0" x 5'-0" in size and appears to be sagging to the east. (See Image N) All of the stringers appear to bear on a cast in place concrete slab landing at the bottom. At the bottom of the two outside stair stringers, there were 6x6 newel posts that are bolted or lagged to them. These newel posts appear to be the support for the open steel railing of each side of the stairs. The stairs also move significantly upon putting any force on them. (See Image O) The remainder of the deck appears to be framed with 2x8 or (2)-2x8 deck joists spaced at 20" on center with 2x6 decking. The (2)-2x8 deck joists appear to be located below the hot tub. The paint that was applied to the underside of this decking and joists has mostly peeled away. Most of the joists bear on mechanical steel hangers or are toe-nailed on the west end and cantilever approximately 12" on the east. The west end hangers are nailed to either a 2x8 ledger that is perpendicular with the deck joists or toe-nailed to a 2x8 ledger that is on an approximate 45 degree angle to the deck joists. The ledger perpendicular to the joists appears to be lagged or bolted to the side of the building. The ledger that is on the 45 degree angle appears to be nailed to the side of the building. The cantilevered ends of the joists bear on a dropped 5 1/8 x 12 glulam beam that supports some of the deck for unit J4. Some of the nails appear to be weathered and show signs of rust. Some of the deck joists are cracking and appear to be rotting on the top in areas and they also appear to be taking on a blackish/gray weathered look. (See Image P) The 5 1/8 x 12 glulam beam spans continuously over two separate 6x8 posts that are spaced apart approximately 14'-4". Where the glulam beam bears on the 6x8 post to the north, it also supports the 5 1/8 x 12 glulam beam described above and appears to have a custom steel T-shaped cap. The 6x8 post to the south also supports a 6x12 timber beam that supports the remainder of the deck for unit J4. The 6x8 posts bear on concrete circular piers and do not appear to have a mechanical steel base plate. (See Image Q)

1. Provide Simpson ABU66Z base plates and Simpson PC6Z cap plates to all 6x6 posts.
2. Add (3)-4" x 3/16" diameter Timber-Lok screws at 16" on center to all existing 2x8 ledgers that are attached to the building rim-board.
