Observation Report

October 1, 2019

Re: Meadow Creek Condominiums, Vail, CO
(Building K)
Project No. 0307-19 K

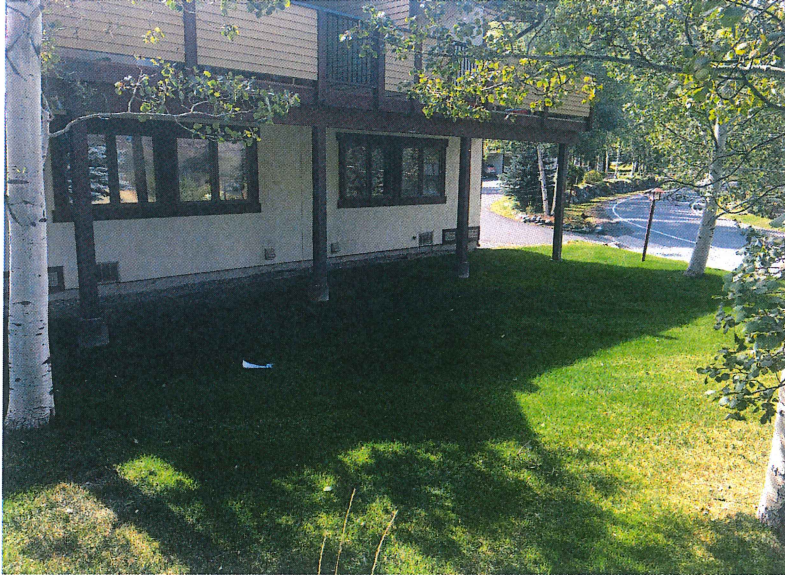
(Image A, Unit 1 & 2)

Building K consists of four units and staggers two units at a time from the northeast towards the southwest approximately 4 feet starting with units K4 and K3. The decks appear to have been remodeled at some point in time. The exterior decks are located on the west side of the building and are approximately 10'-9" above the finished grade. They extend approximately 9'-6" from the building and the span the length of the K building. There is a framed partition wall that divides the decks in half. This partition wall appears to be located between the two units at the party wall. The decks are accessed by an exterior door located on the west side of each individual unit. The exterior decks appear to be framed with 2x wood decking on 2x8 deck joists spaced at 19.2" apart. Most of the joists bear on mechanical steel hangers or are toe-nailed on the east end and cantilever approximately 8" on the west. The east end hangers are nailed to either a 2x8 ledger that is perpendicular with the deck joists or toe-nailed to a 2x8 ledger that is on an approximate 45 degree angle to the deck joists. The ledgers appear to be nailed to the side of the building. The cantilevered ends of the joists bear on a dropped 3 1/8 x 12 glulam beam. Some of the deck joists and nails appear to be weathered and show signs of rust. (See Image A, B, C, D and attached layouts)

Units K1 and K2: The glulam beam for these units spans continuously over four 6x6 rough sawn posts. The largest span appears to be on unit K1 and is approximately 12'-4" in length. The largest cantilevered span appears to be on unit K2 and is approximately 2'-4" in length. The post to the north of unit K1 appears to have a vertical crack along the length of the post. The top of all the posts appear to have a notch at the top where the glulam beam bears. There does not appear to be a mechanical steel cap or any type of bolts connecting the two members together. All of the posts bear on concrete circular piers and do not appear to have a mechanical steel base plate. The concrete pier to the south of unit K1 appears to be only 3 to 4 inches above the finished grade. (See Image E & F)

1. Provide Simpson ABU66Z base plates to all 6x6 posts.
2. Add (3)-4" x 3/16" diameter Timber-Lok screws at 16" on center to all existing 2x8 ledgers that are attached to the building rim-board.
3. Replace all deck joists that are showing any signs of rot with new ones.
4. Add (2)-1/2" diameter through bolts to the glulam and the top of the 6x6 posts spaced six inches apart from the center of the beam.
5. For unit K1, replace the 6x6 post that has the vertical crack in it and provide a base plate and bolts as described above.

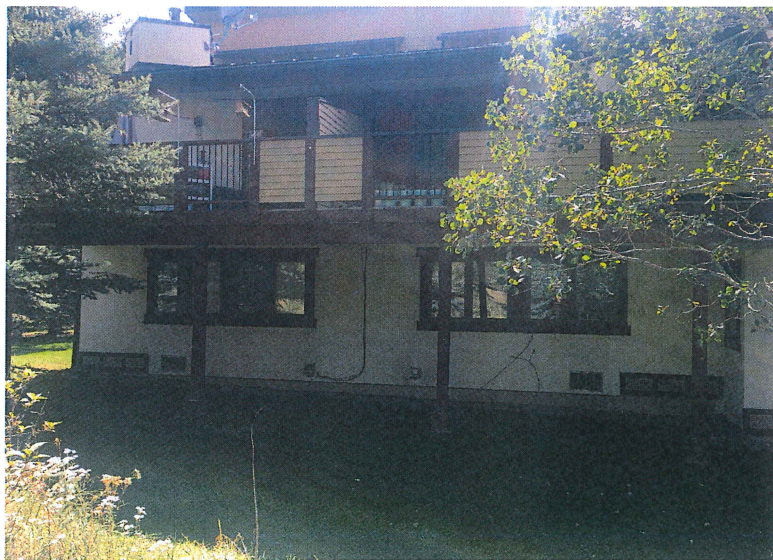
(Image B, Unit 3 & 4)

Units K3 and K4: The glulam beam for these units spans continuously over four 6x6 rough sawn posts. The largest span appears to be between both units and is approximately 12'-7" in length. The largest cantilevered span appears to be on unit K3 and is approximately 2'-9" in length. The top of all the posts appear to have a notch at the top where the glulam beam bears. There does not appear to be a mechanical steel cap or any type of bolts connecting the two members together. All of the posts bear on concrete circular piers and do not appear to have a mechanical steel base plate.
