## Observation Report

November 18, 2019

**Re: Meadow Creek Condominiums, Vail, CO**  
**(Building M)**  
**Project No. 0307-19 M**

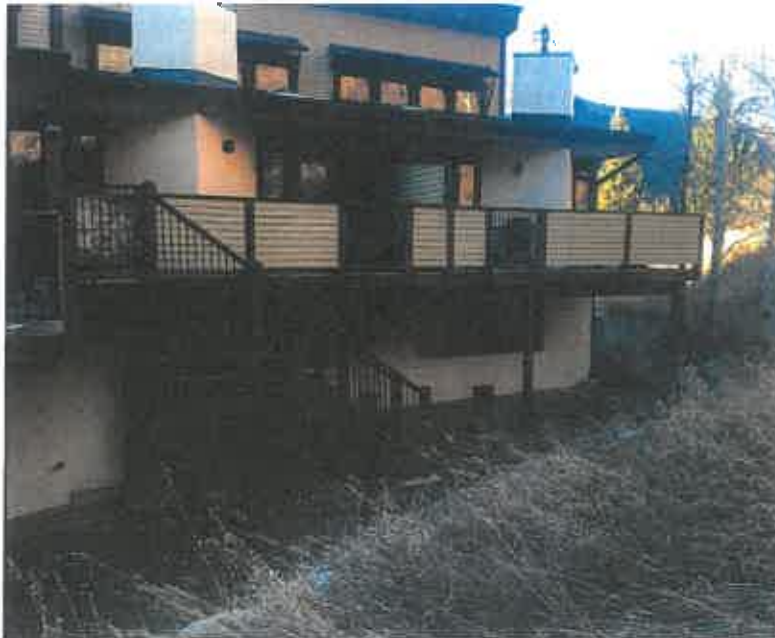
**(Image A, Unit 1 & 2)**

Building M consists of six units that stagger two units at a time from the northwest towards the southeast approximately 8 feet starting with units M1 and M2. The decks appear to have been remodeled at some point in time. The exterior decks are located on the east side of the building and are approximately 10'-0" above the finished grade. They extend approximately 9'-10" from the building and span the length of the M building. There is a framed partition wall located between the two units that divides the decks in half. The decks are accessed by an exterior door located on the west side of each individual unit and an exterior set of stairs for units M2, M3 and M6. The exterior decks appear to be framed with 2x wood decking on a combination of 2x8 dimensional lumber joists, glulam beams, timber beams and timber posts. (See Image A, B, C, and attached layouts)

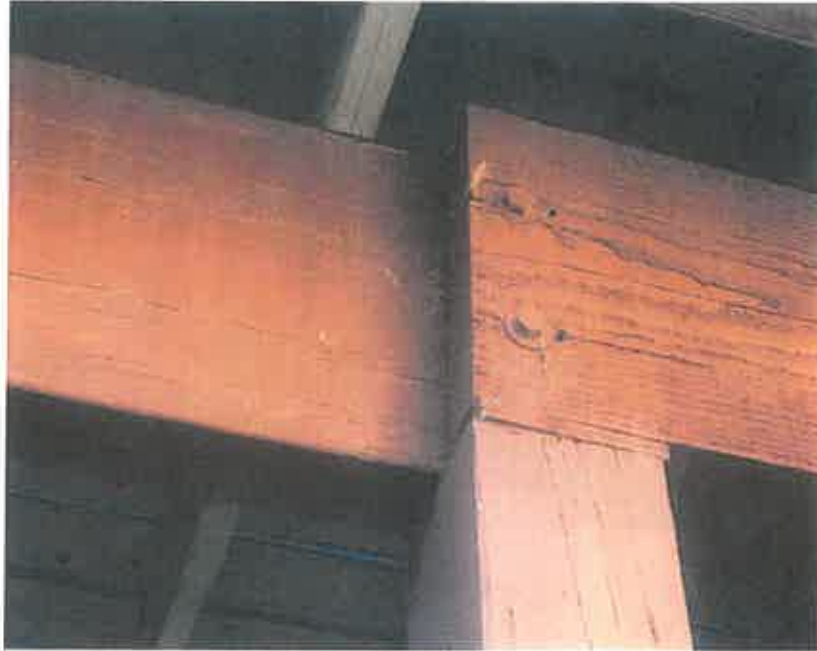
(Image D)

**Unit M1:** A section of this deck appears to have been remodeled at some point in time. The deck is connected to unit M2 and is separated in the middle by a framed partition wall. A small section of this deck located to the north of the cantilevered floor above appears newer than the remainder of the deck. The newer section appears to be framed with treated 2x8 deck joists spaced at 16" on center with 2x6 decking. Most of the joists bear on mechanical steel hangers on the west end and cantilever approximately 8" on the east. The west end hangers are nailed to a 2x8 ledger that is perpendicular with the deck joists or a 4x8 that is on an approximate 45 degree angle to the deck joists that appears to be lagged to an older 2x8 rim board. (See attached layout) The cantilevered ends of the joists bear on a dropped 6x12 beam. The 6x12 beam spans continuously over two separate 6x6 posts that are spaced out approximately 13'-0" and cantilevers to the north 6". Starting from the north, located at the top of the first 6x6 post there appears to be a steel mechanical cap on one side where the 6x12 bears. The next 6x6 post located to the south supports the end of the 6x12 and a 3 1/8 x 12 glulam beam. (See Image D) The beams appear to be lapped over the 6x6 post and connected together with two lag bolts. The 6x6 post also appears to have numerous vertical cracks along the length of the post. (See Image E) Both of the 6x6 posts bear on concrete circular piers and only the northerly one appears to have a mechanical steel base plate. The remainder of the deck for unit M1 appears to be framed with 2x8 deck joists spaced at 16" on center with 2x6 decking. Some of the paint that was applied to the underside of this decking and joists has peeled away. Most of the joists bear on mechanical steel hangers or are toe-nailed on the west end and cantilever approximately 8" on the east. The west end hangers are nailed to either a 2x8 ledger that is perpendicular with the deck joists or toe-nailed to a 2x8 ledger that is on an approximate 45 degree angle to the deck joists. The ledgers appear to be nailed to the side of the building. The cantilevered ends of the joists bear on a dropped 3 1/8 x 12 glulam beam that supports some of the deck for unit M2. Some of the nails appear to be weathered and show signs of rust. Some of the deck joists are cracking and appear to be rotting on the top in areas and they also appear to be taking on a blackish/gray weathered look. One of the deck joists appears to have a couple of 2x6 members nailed to the side along the top and bottom of the joist. (See Image F) The 3 1/8 x 12 glulam beam spans continuously over two separate 6x6 posts that are spaced apart approximately 14'-1". The paint that was applied to the glulam beam has become weathered and is peeling away in areas. The glulam beam bears on the 6x6 post to the south that is described in unit M2.

8. Replace all the 6x6 posts that have a vertical crack and provide a base plate and bolts as described above.
9. For unit M1 and M2, the 3 1/8 x 12 glulam beam is undersized and should be replaced with 5 1/8 x 12 glulam beam.

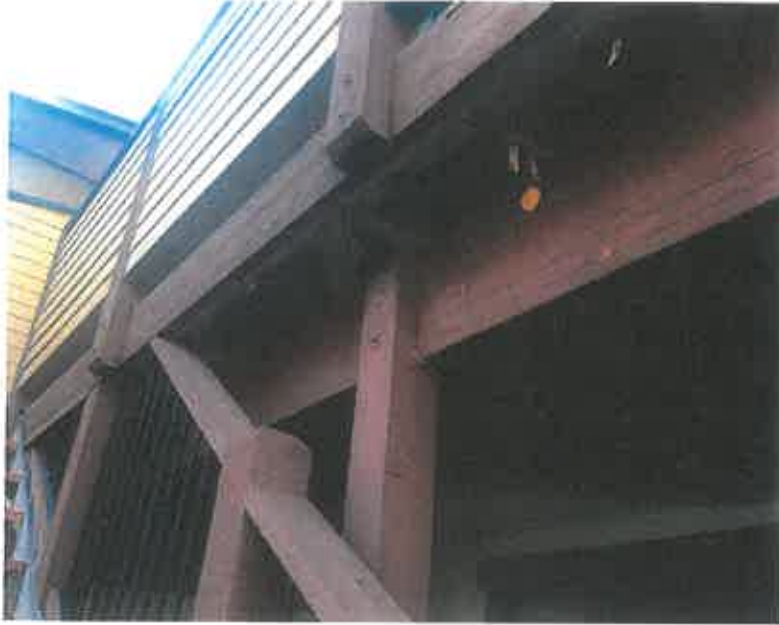
(Image G)

**Unit M2:** The deck for this unit appears to have been remodeled at some point in time. This unit deck is connected to unit M1 and is separated in the middle by a framed partition wall. The deck appears to be framed with 2x8 deck joists spaced at 16" on center with 2x6 decking. Some of the paint that was applied to the underside of this decking and joists has peeled away. Most of the joists bear on mechanical steel hangers or are toe-nailed on the west end and cantilever approximately 8" on the east. The west end hangers are nailed to either a 2x8 ledger that is perpendicular with the deck joists or toe-nailed to a (3)-2x8 ledger that is on an approximate 45 degree angle to the deck joists. The ledgers appear to be nailed to the side of the building. The cantilevered ends of the joists bear on dropped 3 1/8 x 12 glulam beam as described in unit M1 or a 3x12 dropped beam. Some of the deck joists are cracking in areas and they appear to be taking on a blackish/gray weathered look. The 3x12 beam to the south spans continuously over two 6x6 posts that are spaced apart approximately 9'-7" and cantilevers to the south 3'-0". The 6x6 post that supports the north end of the 3x12 beam also supports the south end of the 3 1/8 x 12 glulam beam described in unit M1. The top of this post appears to be notched where the two beams butt up against each other and it appears that there are two lag bolts that penetrate both of the beams. (See Image G) The 6x6 post that support the south of the 3x12 beam also has a notch at the top and appears to have two 1/4" diameter through bolts that connect the members together. (See Image H) This post appears to have numerous vertical crack along the length of it.

7. For unit M2, the 2x plate should be replaced with a treated 2x12 plate that is fully supported on a concrete slab or post. This plate should also be properly anchored to the concrete supporting member.

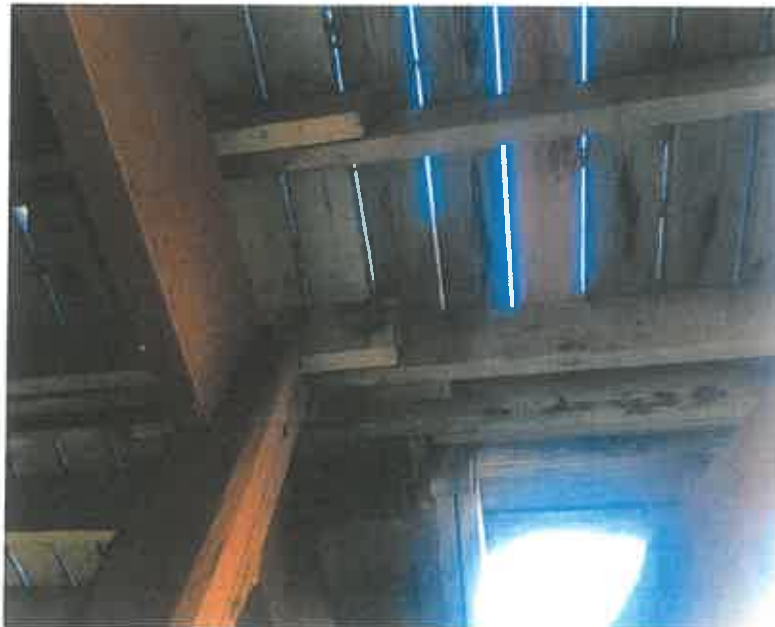
(Image H)

The 6x6 posts bear on concrete circular piers and only the southerly one appear to have a mechanical steel base plate. (See Image I) This unit has a set of stairs that lead down to the grade below. They appear to be framed with three separated stair stringers. The two stringers on the outsides of the stairs appear to be (3)-2x12 stringers, and one located in the middle appears to be (1)-2x12, with 2x decking treads. None of the stringers appear to be attached to the cantilevered deck joist at the landing with a mechanical hanger. There also appears to be a 2x8 angled brace that is attached with a series of random nails to the southerly 6x6 post mentioned above and is sandwiched at the top between some of the cantilevered deck joist for the landing above. (See Image J & K) The stringers all appear to bear on a treated 2x plate at the bottom that does not appear to be anchored to a concrete slab on grade landing. At the bottom of the two outside stair stringers there were 6x6 newel posts that are bolted or lagged to them. These newel posts appear to be the support for the open steel railing on each side of the stairs. The stair landing at the top is approximately 3'-0" x 4'-6" in size. The landing appears to be framed from 2x8's that have been nailed on to the cantilevered ends of the 2x8 deck joists mentioned above. The south end of this landing appears to be connected to the deck of unit M3. The stairs also move significantly when putting force on them. (See Image H & L)

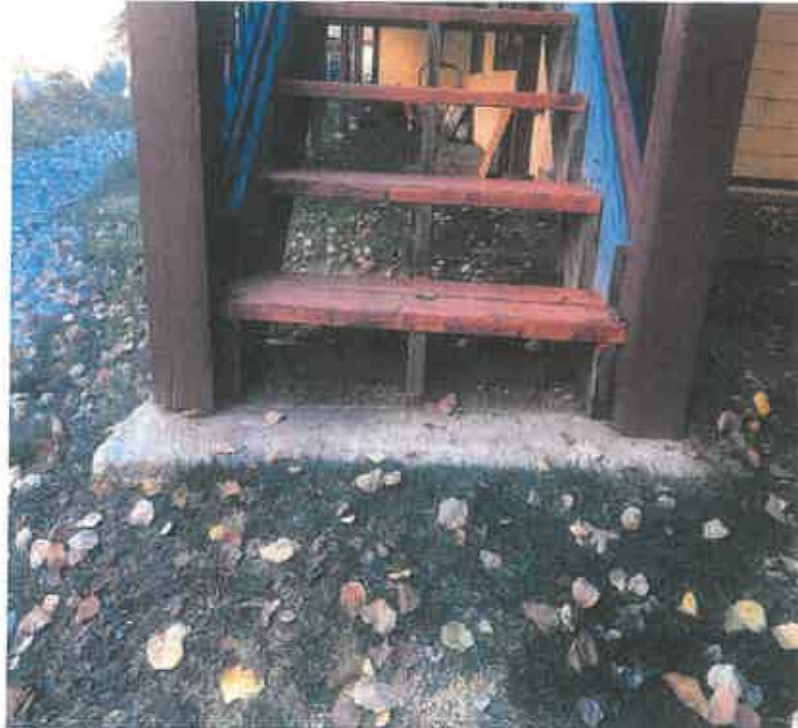
(Image L)

The stairs and stair railings of M2, M3 and M6 show signs of structural instability and should be attended to as soon as possible. I feel that the cantilevered deck joists that are supporting the top of the stair stringers are not structurally adequate and should have some remedial work completed on per our recommendations.

5. For unit M2, M3 and M6, add a new 6x6 post under the west cantilevered end of the existing (2)-2x8's and provide a new concrete pier and footing to support it. All of the joists that support the landing should be doubled up. The landing should not be larger than a 4'-0" cantilever. Lastly, replace any of the 2x8 deck joists that show signs of rot.

6. For unit M2, M3 and M6 provide a Simpson LSC to the middle stair stringer at the top and provide (2)-Simpson LSC to each side of the outside stringers. Verify that existing stairs meet current building code requirements.

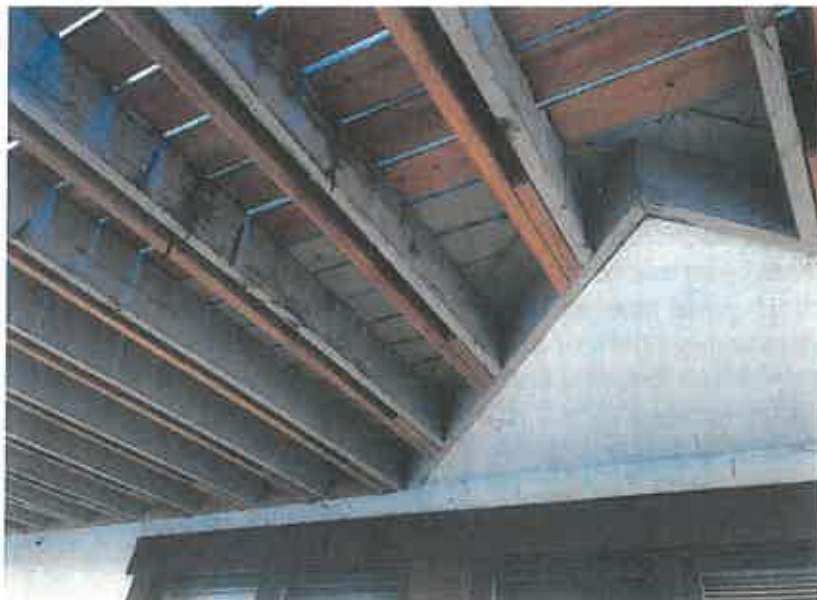
(Image M)

Unit M3: The deck for this unit appears to have been remodeled at some point in time. This unit deck is connected to unit M4 and is separated in the middle by a framed partition wall. The section of deck located to the north of the cantilevered floor above appears to have been added on at some point in time. The deck appears to be framed with (2)-2x8 deck joists spaced at 16" on center with 2x6 decking. Most of the joists bear on mechanical steel hangers or are toe-nailed on the west end and some cantilever approximately 4'-6" on the east end, where the landing for the stairs are located. The landing is approximately 4'-6" x 3'-6" in size and appears to be sagging to the east. The remainder of the joist in this location cantilever approximately 10" to the east. The remainder of the deck to the south of the cantilevered floor is built up (2)-2x8's with a 1 1/2" gap between them spaced at 16" on center. (See Image M) Some of the original deck joists are cracking and appear to be taking on a blackish/gray weathered look. Most of these joists bear on mechanical steel hangers or are toe-nailed on the west end and cantilever approximately 10" to the east. The west end hangers are nailed to either a 2x8 ledger that is perpendicular with the deck joists or toe-nailed to a 2x8 ledger that is on an approximate 45 degree angle to the deck joists. The ledgers appear to be

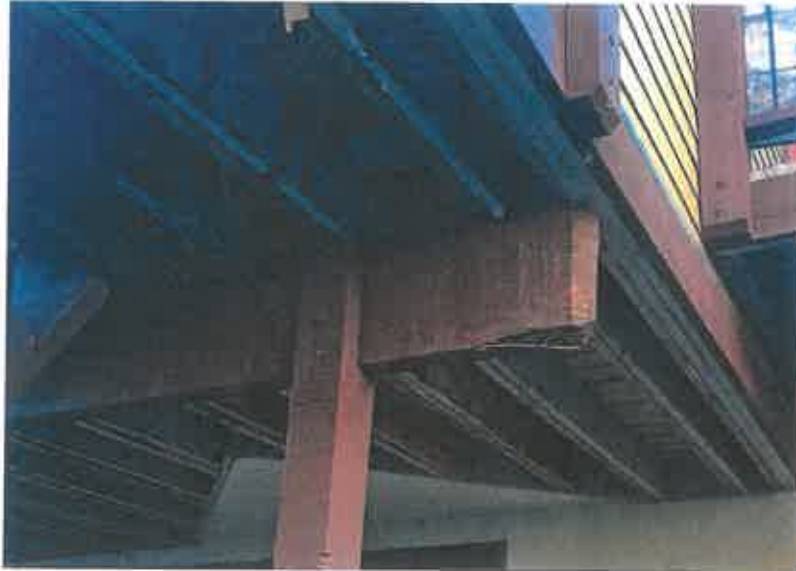
(Image N)

nailed to the side of the building. The cantilevered ends of the joists bear on a dropped 3 1/8 x 12 glulam beam. Some of the original deck joists are cracking and appear to be taking on a blackish/gray weathered look. The 3 1/8 x 12 glulam beam spans continuously over three separate 6x6 posts that are spaced apart approximately 12'-4", 11'-10" and cantilevers to the north 3'-6". This beam also supports some of the deck for unit M4. The paint that was applied to the glulam beam has become weathered and is peeling away in areas. The bottom section of the cantilevered end of the glulam also appears to be showing signs of rot. The top of the 6x6 posts appear to have a notch at the top where the glulam beam bears. There appear to be two lag bolts connecting the two members together. (See Image N) The posts bear on concrete circular piers and do not appear to have a mechanical steel base plate. The most northerly concrete pier appears to flush with the finished grade. (See Image I) This unit also has a set of stairs that lead down to the grade below. The stairs appear to be framed with three separate stair stringers. The stringers appear to be 3x12's with 2x decking treads. The stringers appear to be attached to the timber with lag bolts into the end grain of the stringers. I was unable to determine how this timber was attached to the cantilevered deck joist at the landing mentioned above. (See Image O) The stringers all appear to bear on a concrete slab on grade landing at the bottom. At the bottom of the two outside stair stringers there were 6x6 newel posts that are bolted or lagged to them. These newel posts appear to be the support for the open steel railing on each side of the stairs. The stairs also move significantly when putting force on them. (See Image P & Q)

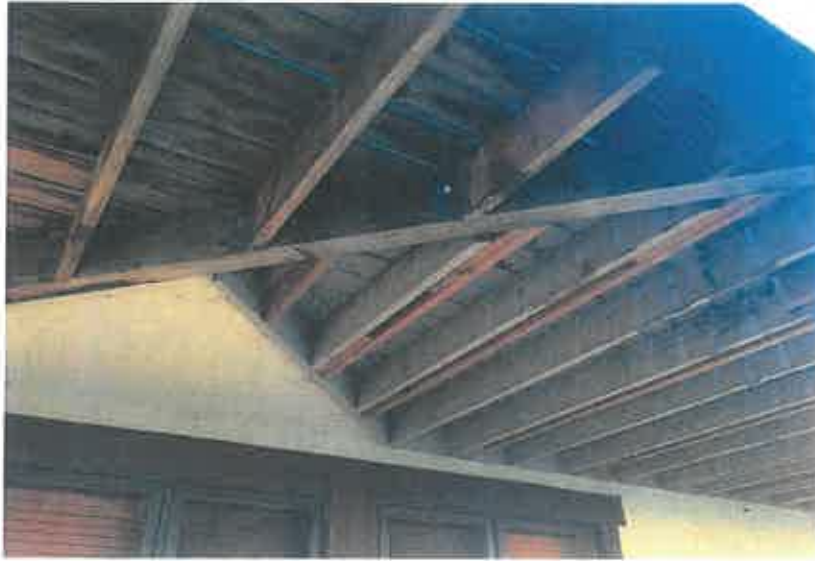
(Image R)

**Unit M4:** A section of this deck appears to have been remodeled at some point in time. The deck is connected to unit M3 and is separated in the middle by a framed partition wall. The section of this deck located to the south of the cantilevered floor above appears newer than the remainder of the deck. The newer section of deck is framed with 2x8 deck joists spaced at 16" on center with 2x6 decking. The joists bear on mechanical steel hangers on the west end and cantilever approximately 10" on the east. The west end hangers are nailed to either a 2x8 ledger that is perpendicular with the deck joists or to a 4x8 ledger that is on an approximate 45 degree angle to the deck joists. The ledgers appear to be lagged or bolted to the side of the building. (See Image R) The cantilevered ends of the joists bear on a dropped 6x12 beam that spans continuously over three separate 6x6 posts that are spaced apart approximately 9'-7", 3'-3" and cantilevers to the south approximately 10". At the top of the 6x6 posts to the south, there appears to be a steel mechanical cap on one side where the 6x12 bears. The remainder of the deck appears to be the original framing that had some remedial work done to it. The deck is framed with 2x8 deck joists spaced at 16" on center with 2x6 decking. Some of the joists have an additional 2x8 screwed to it with a 1 1/2" gap between them as described on unit M3. The paint that was applied to the original deck joists and underside of this decking has peeled away in areas. Most of the joists bear on mechanical steel hangers or are toe-nailed on the west end and cantilever approximately 10" on the east. The west end hangers are nailed to either a 2x8 ledger that is perpendicular with the deck joists or toe-nailed to a 2x8 ledger that is on an approximate 45 degree angle to the deck joists. The ledgers appear to be nailed to the side of the building. The cantilevered ends of the joists bear on a dropped 3 1/8 x 12 glulam beam as described above in unit M3. Some of the deck joists are cracking and appear to be rotting on the top in areas and they also appear to be taking on a blackish/gray weathered look. (See Image S) The 6x6 post to the north supports both the glulam beam and the 6x12 beam. The beams appear to be lapped over the 6x6 post and connected together with two lag bolts. (See Image T)

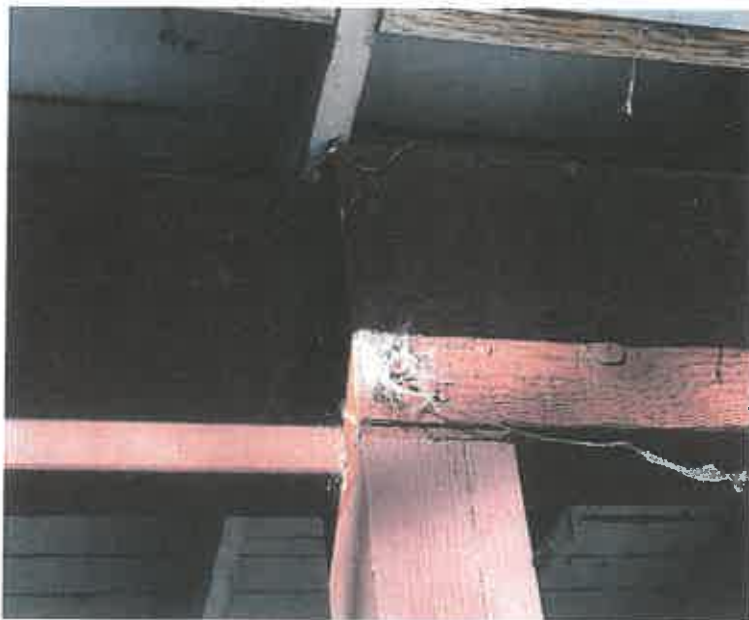
(Image U)

Unit M5: A section of this deck appears to have been remodeled at some point in time. The deck is connected to unit M6 and is separated in the middle by a framed partition wall. A small section of this deck located to the north of the cantilevered floor above appears newer than the remainder of the deck. The newer section appears to be framed with 2x8 deck joists spaced at 16" on center with 2x6 decking. Most of the joists bear on mechanical steel hangers on the west end and cantilever approximately 10" on the east. The west end hangers are nailed to a 2x8 ledger that is perpendicular with the deck joists or a 4x8 that is on an approximate 45 degree angle to the deck joists that appears to be lagged to the side of the cantilever building from above. The cantilevered ends of the joists bear on dropped 6x12 beam. The 6x12 beam spans continuously over three separate 6x6 posts that are spaced out approximately 9'-0", 3'-6" and cantilevers to the north 6". Starting from the north, at the top of the first two 6x6 posts, there appears to be a steel mechanical cap on one side where the 6x12 bears. Both of these 6x6 posts bear on concrete circular piers and do appear to have a mechanical steel base plate. The third 6x6 post located to the south supports the end of the 6x12 and a 3 1/8 x 12 glulam beam. The beams appear to be lapped over the 6x6 post and connected together with two lag bolts. (See Image U) This 6x6 post bears on a concrete circular pier and does not appear to have a mechanical steel base plate. The remainder of the deck for unit M5 appears to be framed with 2x8 deck joists spaced at 20" on center with 2x6 decking. Some of the paint that was applied to the underside of this decking and joists has peeled away. Most of the joists bear on mechanical steel

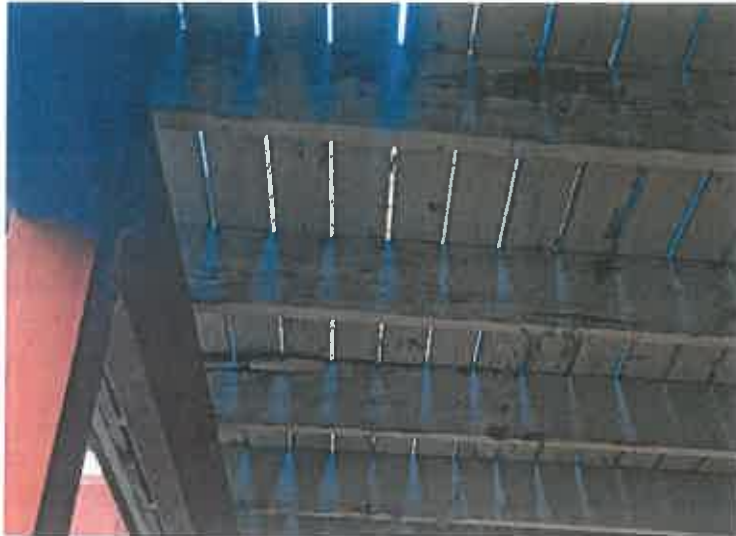
(Image V)

hangers or are toe-nailed on the west end and cantilever approximately 10" on the east. The west end hangers are nailed to either a 2x8 ledger that is perpendicular with the deck joists or toe-nailed to a 2x8 ledger that is on an approximate 45 degree angle to the deck joists. The ledgers appear to be nailed to the side of the building. The cantilevered ends of the joists bear on a dropped 3 1/8 x 12 glulam beam that supports some of the deck for unit M6. Some of the deck joists are cracking and appear to be rotting on the top in areas and they also appear to be taking on a blackish/gray weathered look. (See Image V) The 3 1/8 x 12 glulam beam spans continuously over two separate 6x6 posts that are spaced apart approximately 12'-1". The 6x6 post located to the south supports the end of the 3 1/8 x 12 glulam beam described above and a 3 1/8 x 12 glulam beam that support the deck for M6. The glulam beams appear to lab on top of each other where they bear on the 6x6 post to the south and are connected together with two lag bolts. (See Image W)

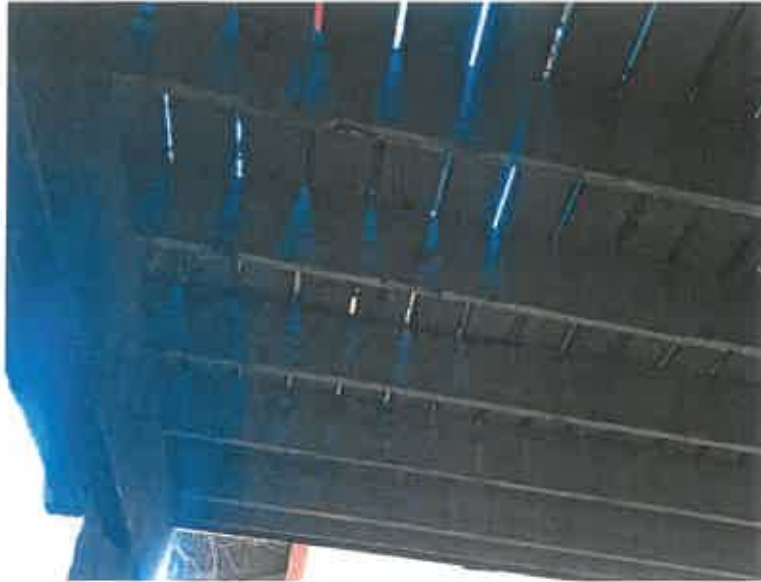
(Image X)

**Unit M6:** The deck for this unit appears to have been remodeled at some point in time. This unit's deck is connected to unit M5 and is separated in the middle by a framed partition wall. The section of deck located to the south of the cantilevered floor above appears to have been added on at some point in time. The entire deck appears to be framed with 2x8 deck joists spaced at 20" on center with 2x6 decking. The paint that was applied to the deck joists and underside of this decking has peeled away in areas. Most of the joists bear on mechanical steel hangers or are toe nailed on the west end and cantilever approximately 10" on the east except for the northerly four joists, which cantilever approximately 4'-5" to the east where and landing for the stairs are located. The west end hangers are nailed to either a 2x8 ledger that is perpendicular with the deck joists or toe-nailed to a 2x8 ledger that is on an approximate 45 degree angle to the deck joists. The ledgers appear to be nailed to the side of the building. The cantilevered ends of the joists bear on two separate dropped 3 1/8 x 12 glulam beams. Some of the deck joists are cracking and appear to be taking on a blackish/gray weathered look. (See Image X) The glulam beam to the north spans continuously over two separate 6x6 posts as described in unit M5 and supports some of the deck for M5. The glulam beam to the south spans continuously over two separate 6x6 posts that are spaced out approximately 12'-6" and cantilevers to the south 2'-6". The top of the post to the north appear to have a notch at the top as described in unit M5. The post to the south appears to be notched where the glulam beam bears. There appear to be one lag bolt connecting the two members together. The posts bear on concrete circular piers and do not appear to have a mechanical steel base plate. The top of the concrete pier to the south appears to be flush with the finished grade. (See Image Y) This unit has a set of stairs that lead down to the grade below. The stairs appear to be framed with three separate stair stringers. The two stringers on the outsides of the stairs appear to be (3)-2x12 stringers, and one located in the middle appears to be (1)-2x12, with 2x decking treads. The stringers do not appear to be attached to the (2)-2x8 cantilevered deck joist at the landing with a mechanical hanger. The stair landing at the top is approximately 4'-5" x 4'-0" in size and appears to be sagging to the east. The majority of the landing appears to be framed from 2x8's that have been nailed on to the cantilevered ends of the 2x8 deck joists. (See Image Z) The stringers all appear to bear on a treated 2x treated plate at the bottom that does not appear to be anchored to a concrete slab on grade landing. The 2x plate appears to overhang on the west side of the concrete slab on grade landing where one of the stringers bears. At the bottom of the two outside stair stringers there were 6x6 newel posts that are bolted or lagged to them. These newel posts appear to be the support for the open steel railing on each side of the stairs. The stairs appear to be twisted and also move significantly when putting force on them. (See Image Y)
