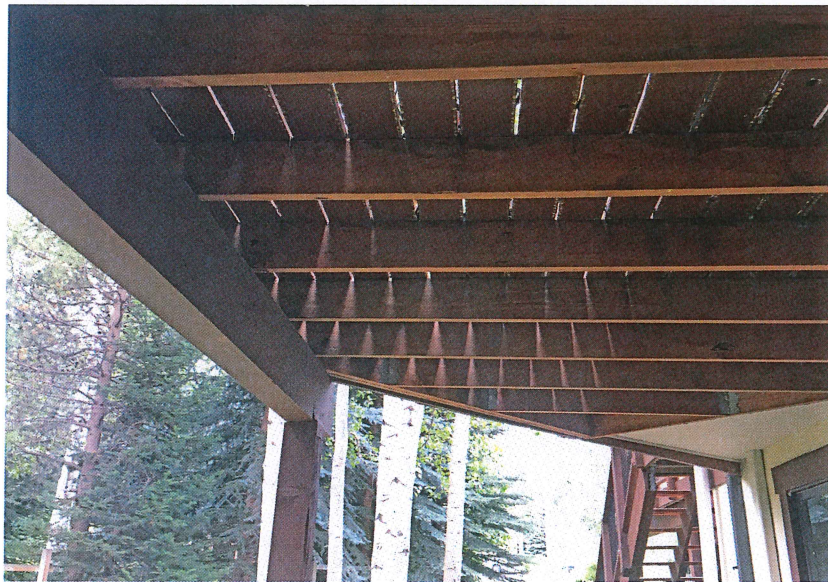
(Image J)

Unit F5: The deck for this unit appears to have been remodeled and repaired at some point in time. This unit deck is connected to unit F6 and is separated in the middle by a framed partition wall. It appears that the deck joists are 2x8's spaced at 20" on center with 2x6 wood decking. The paint that was applied to the underside of this decking and joists has mostly peeled away. Most of the joists bear on mechanical steel hangers or are toe-nailed on the west end and cantilever approximately 8" on the east. The west end hangers are nailed to either a 2x8 ledger that is perpendicular with the deck joists or toe-nailed to a 2x8 ledger that is on an approximate 45 degree angle to the deck joists. The ledgers appear to be nailed to the side of the building. The cantilevered ends of the joists bear on either a dropped 3x12 rough sawn beam or a dropped 5 1/8 x 12 glulam beam that supports some of the deck for unit F6. Some of the nails appear to be weathered and show signs of rust. Some of the deck joists are cracking and appear to be rotting on the top in areas and they also appear to be taking on a blackish/gray weathered look. The dropped 3x12 rough sawn beam spans approximately 12'-0" and bears on a twisted 6x6 post to the south end and appears to bear in the exterior wall of unit F4 on the north end. The 6x6 post to the south does not appear to have a mechanical cap plate nor a base plate connection where it bears on a circular pier that is approximately five inches above the grade. On this unit there is also a set of stairs that lead down to the grade below. The stairs appear to be framed with three separated stair stringers with 2x6 decking for treads. The two stringers on the outsides of the stairs appear to be (3)-2x12 stringers, and one located in the middle appears to be (1)-

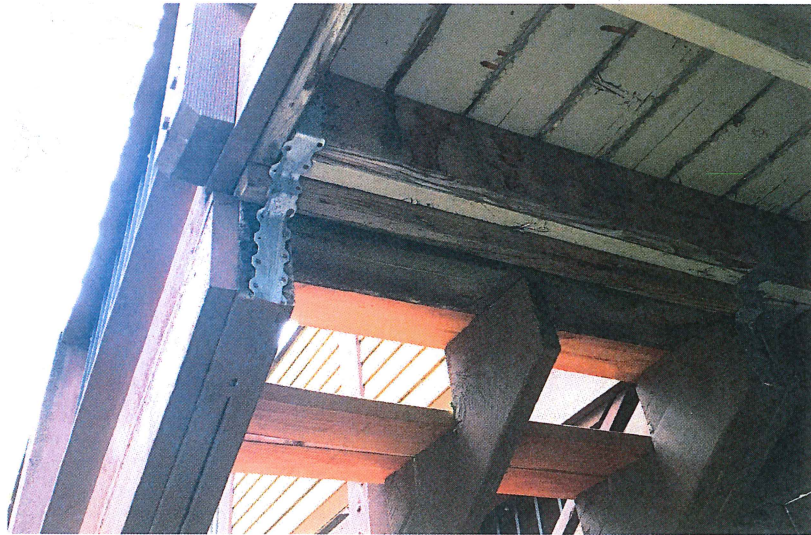
(Image K)

2x12. The middle 2x12 stringer appears to have no visible connection to the (3)-2x8 cantilevered deck joist at the top. The two outside stringers appear to be attached to the (3)-2x8 cantilevered deck joist with a mechanical steel strap at the top. (See Image K) The (3)-2x8 cantilevered deck joist appear to have some rot at the top where they bear on the 3x12 beam. The stair landing at the top is approximately 3'-0" x 3'-6" in size and appears to be sagging to the east 1" over the 3'-6" cantilevered end. (See Image L) The landing appears to be framed from the extended cantilevered ends of the 2x8 deck joists. All of the stringers appear to bear on a ground at the bottom. At the bottom of the two outside stair stringers there were 6x6 newel posts that are bolted or lagged to them. The stairs also move significantly upon putting any force on them. (See Image M)

7. For unit F5, replace the 6x6 post that is twisted and provide a cap and base plate as described above.
8. For unit F5, provide a Simpsons LSC to the middle stair stringer at the top and provide (2)-Simpson LSC to each side of the outside stringers. All of the stringers should bear on a treated plate that should be anchored to concrete foundation or piers. Provide a solid treated blocking between all stringers so that the newel post can be properly anchored. Verify that existing stairs meet current building code requirements.

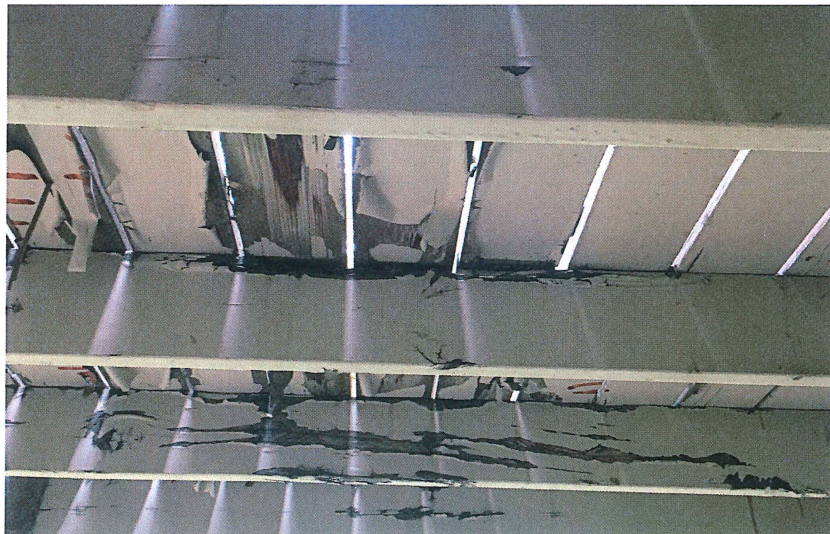
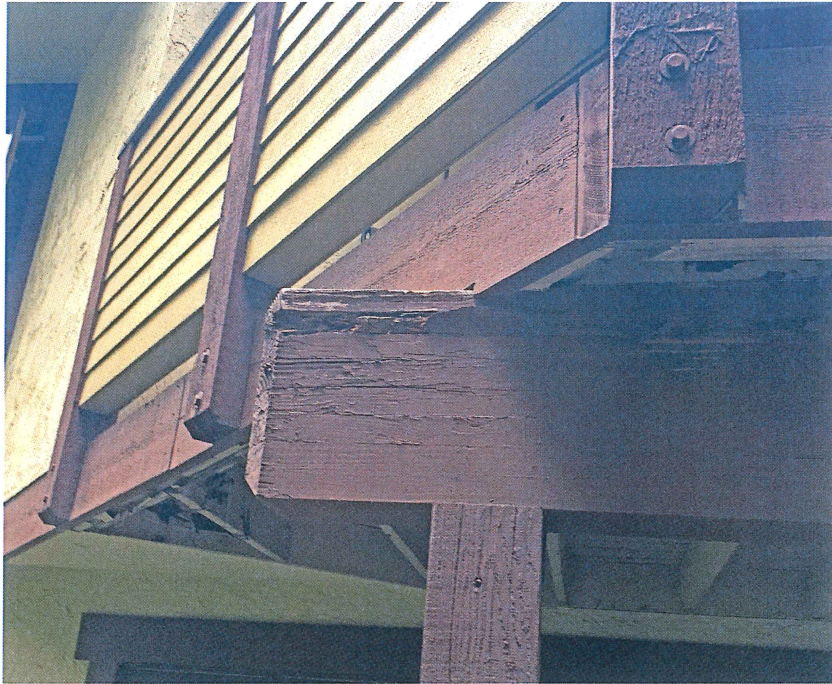
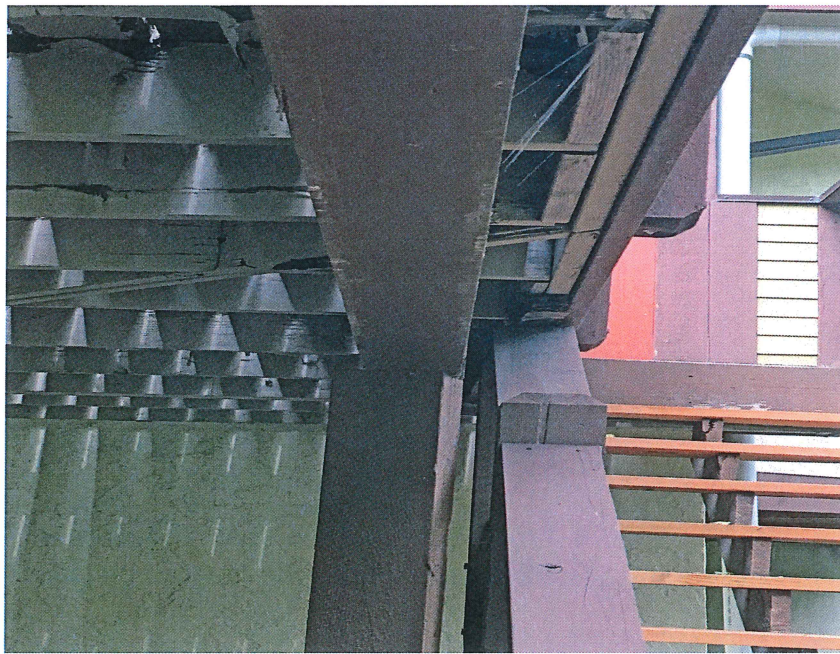
Unit F6: This deck appears to have been repaired at some point in time. The deck is connected to unit F5 and is separated in the middle by a framed partition wall. It appears that the deck joists are 2x8's spaced at 20" on center with 2x6 wood decking. The paint that was applied to the underside of this decking and joists has mostly peeled away. Most of the joists bear on mechanical steel hangers or are toe-nailed on the west end and cantilever approximately 8" on the east. The west end hangers are nailed to either a 2x8 ledger that is perpendicular with the deck joists or toe-nailed to a 2x8 ledger that is on an approximate 45 degree angle to the deck joists. The ledgers appear to be nailed to the side of the building. The cantilevered ends of the joists bear on dropped 5 1/8 x 12 glulam beam. Some of the nails appear to be weathered and show signs of rust. Some of the deck joists are cracking and appear to be rotting on the top in areas and they also appear to be taking on a blackish/gray weathered look. The 5 1/8 x 12 glulam beam spans continuously over two separate 6x6 posts and also supports some of the F5 unit deck. The top south end of the glulam beam appears to have rotted and to be getting crushed where some of the deck joists are bearing on it. The posts are spaced out approximately 16'-0" apart. The 6x6 post to the south has a mechanical steel cap on one side and it does not appear to have a base plate connection where it bears on a circular pier that is approximately three inches above the grade. The 6x6 post to the north is the twisted one that is described in unit F5. (See Image N, O, & P)
