Observation Report

Re: Meadow Creek Condominiums, Vail, CO
(Building L)
Project No. 0307-19 L

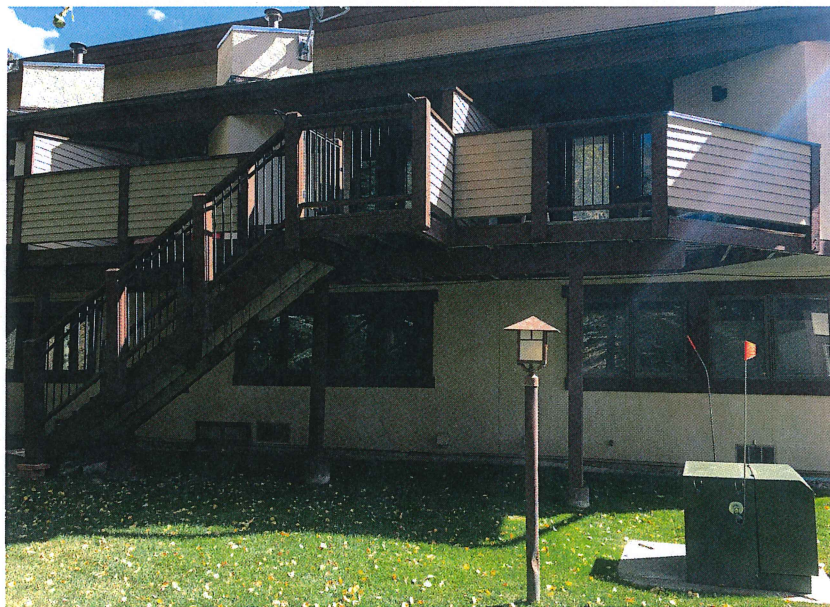
(Image A, Unit 1 & 2)

Building L consists of six units and units L5 and L6 stagger from the northwest towards the northeast approximately 16 feet from the remainder of the units. The decks appear to have been remodeled at some point in time. The exterior decks are located on the west side of the building and are approximately 10'-3" above the finished grade. They extend approximately 9'-10" from the building and the lengths of the decks vary from unit to unit. There is a framed partition wall that divides the decks in half. This partition wall appears to be located between the two units at the party wall. The decks are accessed by an exterior door located on the west side of each individual unit and an exterior set of stairs for units L2 and L4. The exterior decks appear to be framed with 2x wood decking on a combination of 2x8 dimensional lumber joists, glulam beams and timber posts. (See Image A, B, C, and attached layouts)
