Meadow Creek Condominiums (Building L), Vail, CO

#0307-19 L

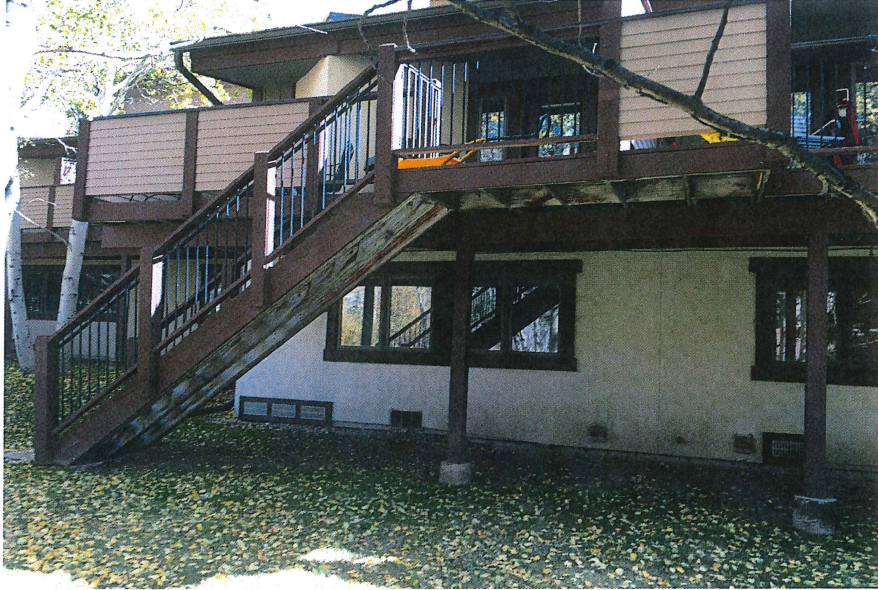
(Image K)

Unit L4: The deck for this unit appears to have been remodeled at some point in time. This unit deck is connected to unit L3 and is separated in the middle by a framed partition wall. The section of deck located to the north of the cantilevered floor above appears to have been added on at some point in time. This section of deck is framed with 2x8 deck joists spaced at 16" on center with 2x6 decking. The remainder of the deck is framed with 2x8 deck joists spaced at 20" on center with 2x6 decking. The joists bear on mechanical steel hangers on the east end and cantilever approximately 1'-2" on the west except for the southerly three joists, which are (2)-2x8's at 20" o.c. and they cantilever approximately 4'-0". These southerly cantilevered joists support the top of the stair stringers and the landing. (Refer to layout) The east end hangers are nailed to either a 2x8 ledger that is perpendicular with the deck joists or to a (2)-2x8 beam that is on an approximate 45 degree angle to the deck joists. The ledgers appear to be nailed to the side of the building. The cantilevered ends of the joists bear on two separate dropped 3 1/8 x 12 glulam beams. Some of the nails appear to be weathered and show signs of rust. Some of the deck joists are cracking and appear to be taking on a blackish/gray weathered look. The glulam beam to the south also supports some of the deck for unit L3. The glulam beam to the north only supports the deck for unit L4. The glulam beam to the south spans continuously over three separate 6x6 posts as described in unit L3. The glulam beam to the north spans continuously over two separate 6x6 posts that are spaced out 12'-4" and cantilever to the north approximately 2'-3". The top of the posts appear to have a notch at the top where the glulam beam bears. There appears to be one lag connecting the two members together on the southerly post and two lags connecting the two members together on the northerly post. The post to the north appears to have a vertical crack along the length of the post. The posts bear on concrete circular piers and do not appear to have a mechanical steel base plate. (See Image K, L, and M) This unit has a set of stairs that lead to the grade below. The stairs appear to be framed with three separate stair stringers with 2x6 decking for treads. The two stringers on the outsides of the stairs appear to be (2)-2x12 stringers with a 2x6 nailed to the inside face, and one located in the middle appears to be (1)-2x12 with a 2x6 nailed to one side. The stair stringers are supported on the cantilevered deck joist at the top and there does not appear to be any mechanical steel hangers and only nailing from the back side of the deck joist into the end grain of the stringer. (See Image N) The stair landing at the top is approximately 4'-0" x 5'-0" in size and appears to be sagging to the west. (See Image O) All of the stringers appear to bear on a cast in place concrete slab landing at the bottom. At the bottom of the two outside stair stringers, there were 6x6 newel posts that are bolted or lagged to them. These newel posts appear to be the support for the open steel railing of each side of the stairs. The stairs also move significantly upon putting any force on them.

5. For unit L2, these stairs should be removed and replaced with new stairs that can be designed by our office if requested.
6. For unit L4, add a new 6x6 post under the west cantilevered end of the existing (2)-2x8's and provide a new concrete pier and footing to support it. All of the joists that support the landing should be doubled up. The landing should not be larger than a 4'-0" cantilever. Lastly, replace any of the 2x8 deck joists that show signs of rot.

7. For unit L4, replace the 6x6 post that has the vertical crack in it and provide a base plate and bolts as described above.
8. For unit L4, provide a Simpson LSC to the middle stair stringer at the top and provide (2)-Simpson LSC to each side of the outside stringers. Provide one more 2x12 stringer to each outside stringer for a total of (3)-2x12 stringers. Verify that existing stairs meet current building code requirements.

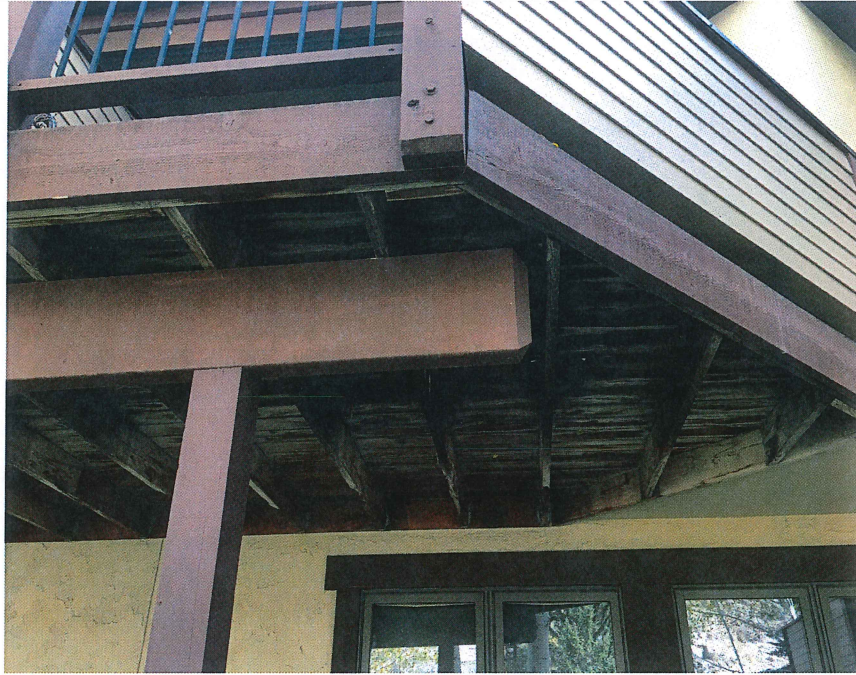
(Image P)

Unit L5 & L6: These decks appear to be of the original design. The decks are connected to each other and are separated in the middle by a framed partition wall. The decks are framed with 2x8 deck joists spaced at 20" on center with 2x6 decking. Most of the joists bear on mechanical steel hangers or are toe-nailed on the east end and cantilever approximately 1'-2" on the west. The east end hangers are nailed to either a 2x8 ledger that is perpendicular with the deck joists or toe-nailed to a 2x8 ledger that is on an approximate 45 degree angle to the deck joists. The ledgers appear to be nailed to the side of the building. The cantilevered ends of the joists bear on a dropped 3 1/8 x 12 glulam beam. Some of the nails appear to be weathered and show signs of rust. Some of the deck joists are cracking and appear to be rotting on the top in areas and they also appear to be taking on a blackish/gray weathered look. The 3 1/8 x 12 glulam beam spans continuously over two separate 6x6 posts that are spaced apart approximately 10'-4" and cantilevers to the north and south approximately 2'-6". The top of the posts appear to have a notch at the top where the glulam beam bears. There does not appear to be a mechanical steel cap or any type of bolts connecting the two members together. The posts bear on concrete circular piers and do not appear to have a mechanical steel base plate. (See Image P, Q, and R)
