Meadow Creek Condominiums (Building L), Vail, CO

#0307-19 L

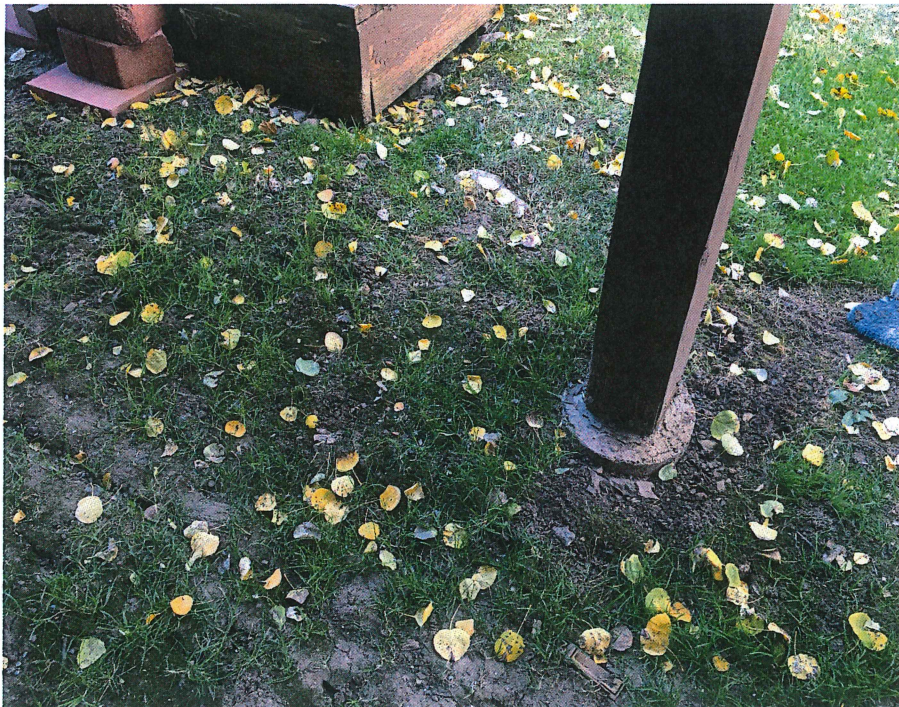
(Image D)

Unit L2: The deck for this unit appears to have been remodeled at some point in time. This unit's deck is connected to unit L1 and is separated in the middle by a framed partition wall. The section of deck located to the north of the cantilevered floor above appears to have been added on at some point in time. The deck is framed with 2x8 deck joists spaced at 20" on center with 2x6 decking. Most of the joists bear on mechanical steel hangers or are toe nailed on the east end and cantilever approximately 1'-2" on the west except for the southerly four joists, which cantilever approximately 4'-3". These southerly cantilevered joists support the top of the stair stringers and the landing. The east end hangers are nailed to either a 2x8 ledger that is perpendicular with the deck joists or toe-nailed to a 2x8 ledger that is on an approximate 45 degree angle to the deck joists. The ledgers appear to be nailed to the side of the building. The cantilevered ends of the joists bear on two separate dropped 3 1/8 x 12 glulam beams. Some of the nails appear to be weathered and show signs of rust. Some of the deck joists are cracking and appear to be taking on a blackish/gray weathered look. The glulam beam to the south also supports some of the deck for unit L1. The glulam beam to the north also supports some of the deck for unit L3. The glulam beam to the south spans continuously over two separate 6x6 posts as described in unit L1. The glulam beam to the north spans continuously over three separate 6x6 posts that are spaced out 14'-7" and 15'-3" starting from the south. The top of the posts appear to have a notch at the top where the glulam beam bears. There does not appear to be a mechanical steel cap or any type of bolts connecting the two members together. The posts bear on concrete circular piers and do not appear to have a mechanical steel base plate. The top of the concrete pier closest to the bottom of the stairs appears to be

flush with the finished grade. (See Image D) This unit has a set of stairs that lead down to the grade below. The stairs appear to be framed with three separate stair stringers with 2x6 decking for treads. The two stringers on the outsides of the stairs appear to be (2)-2x12 stringers, and one located in the middle appears to be (1)-2x12. The stair stringers appear to be connected to (2)-2x8's with mechanical steel hangers. The (2)-2x8's appear to be connected to the cantilevered end of (2)-2x8 deck joist mentioned above, with a combination of steel plates and 2x6 strips of wood. (See Image E) The (2)-2x8 cantilevered deck joist appear to have a horizontal crack along the mid-depth of the joists at the cantilevered end. The stair landing at the top is approximately 4'-0" x 4'-3" in size and appears to be sagging to the west. (See Image F) All of the stringers appear to bear on a built up wooden landing at the bottom of the stairs that appears to bear on the ground. (See Image G) At the bottom of the two outside stair stringers, there were 6x6 newel posts that are bolted or lagged to them that appear to also bear on built up concrete pavers. (See Image H) These newel posts appear to be the support for the open steel railing of each side of the stairs. The stairs also move significantly upon putting any force on them.

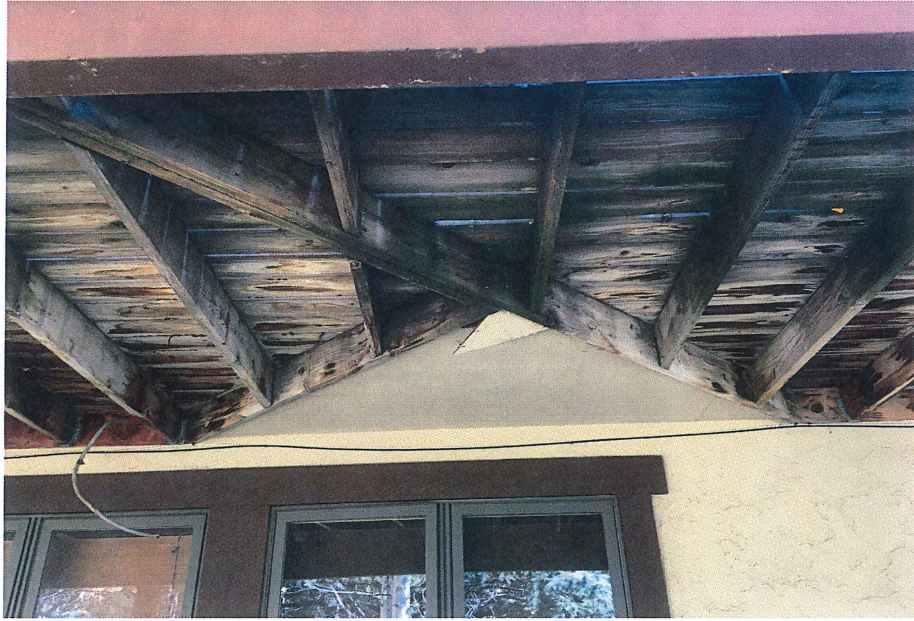
(Image I)

Unit L3: The deck for this unit appears to have been remodeled at some point in time. This unit's deck is connected to unit L2 and L4 and is separated from the other units in the middle by a framed partition wall. It is framed with 2x8 deck joists spaced at 20" on center with 2x6 decking. The joists bear on mechanical steel hangers on the east end and cantilever approximately 1'-2" on the west except for the northerly three joists, which are (2)-2x8's at 20" o.c. and they cantilever approximately 4'-0". (Refer to layout) The east end hangers are nailed to either a 2x8 ledger that is perpendicular with the deck joists or to a (2)-2x8 beam that is on an approximate 45 degree angle to the deck joists. The ledgers appear to be nailed to the side of the building. The cantilevered ends of the joists bear on two separate dropped 3 1/8 x 12 glulam beams. Some of the nails appear to be weathered and show signs of rust. Some of the deck joists are cracking and appear to be taking on a blackish/gray weathered look. The glulam beam to the south also supports some of the deck for unit L2. The glulam beam to the north also supports some of the deck for unit L4. The glulam beam to the south spans continuously over three separate 6x6 posts as described in unit L2. The glulam beam to the north spans continuously over three separate 6x6 posts that are spaced out 10'-1" and 12'-4" starting from the south. The top of the posts appear to have a notch at the top where the glulam beam bears. There is one steel T-shaped cap on the northerly post but the remainder of the posts do not appear to have any type of mechanical steel cap or any bolts connecting the two members together. The posts bear on concrete circular piers and do not appear to have a mechanical steel base plate. (See Image I and J)
