## Observation Report

August 15, 2019

Re: Meadow Creek Condominiums, Vail, CO  
(Building C)  
Project No. 0307-19 C

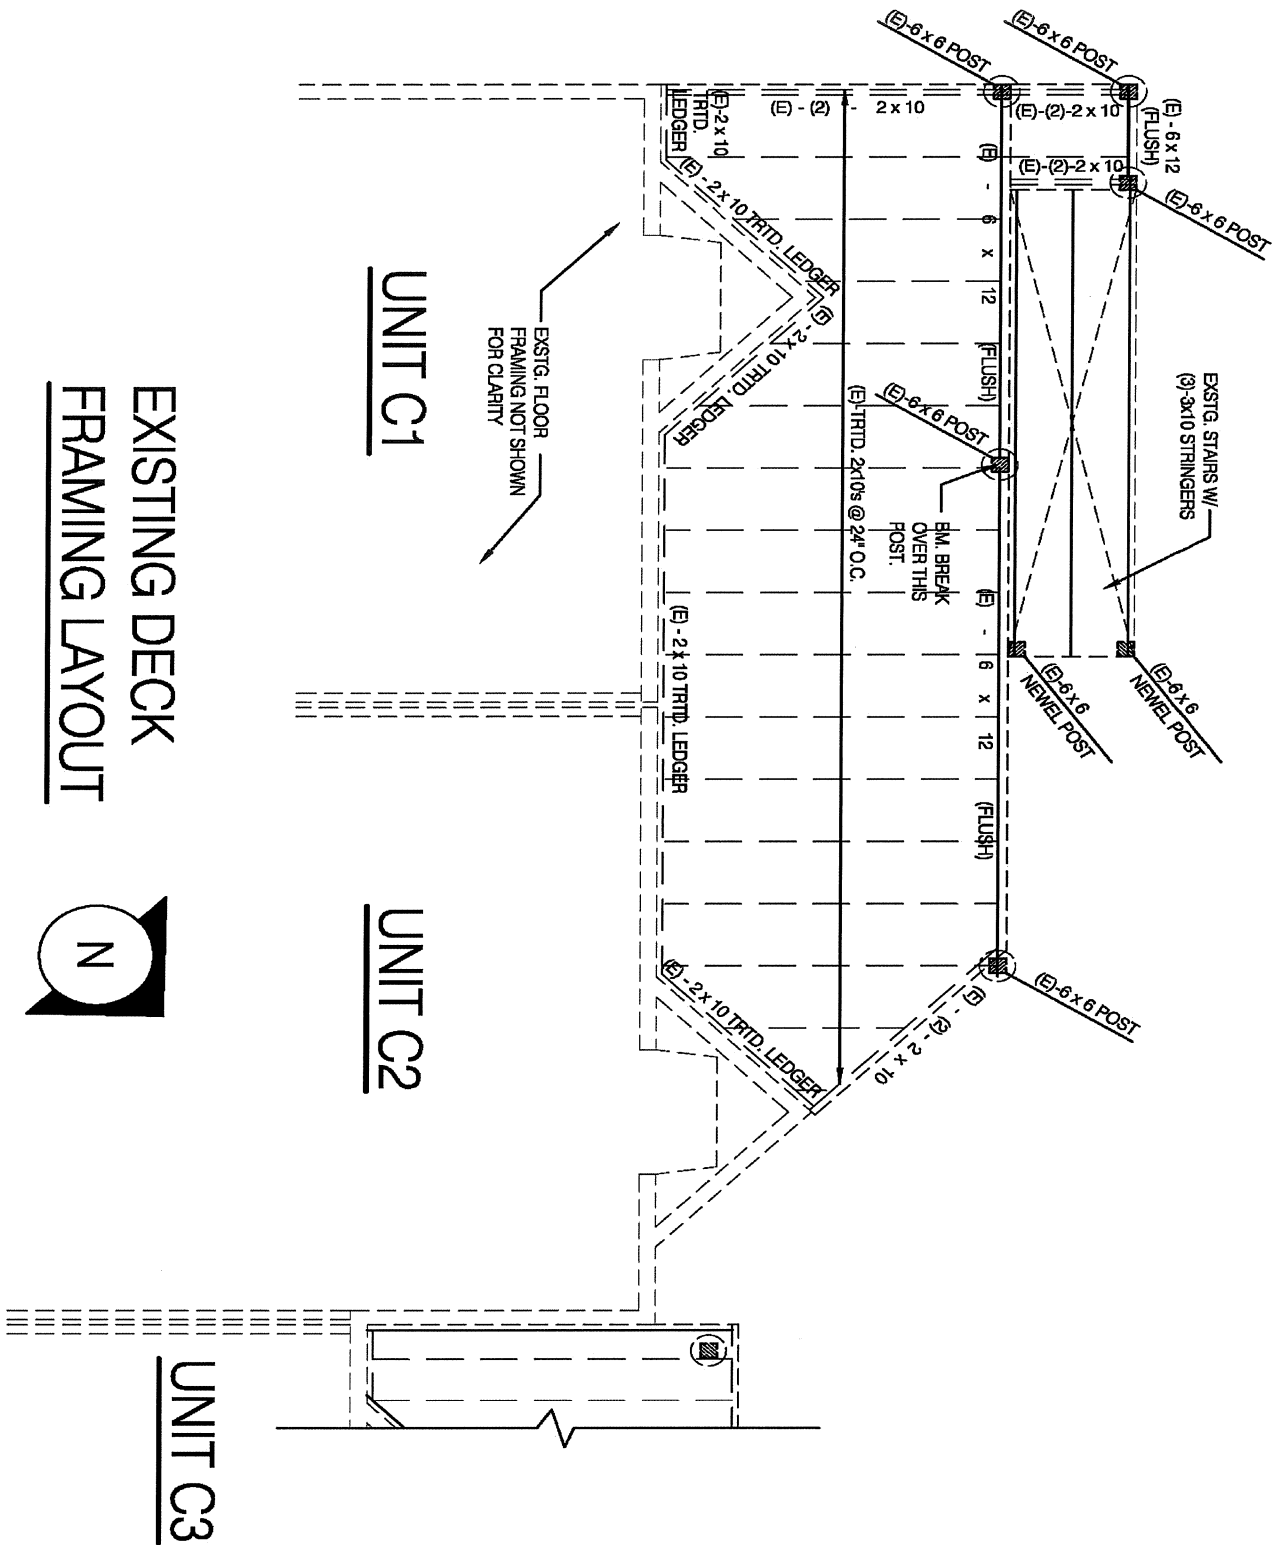
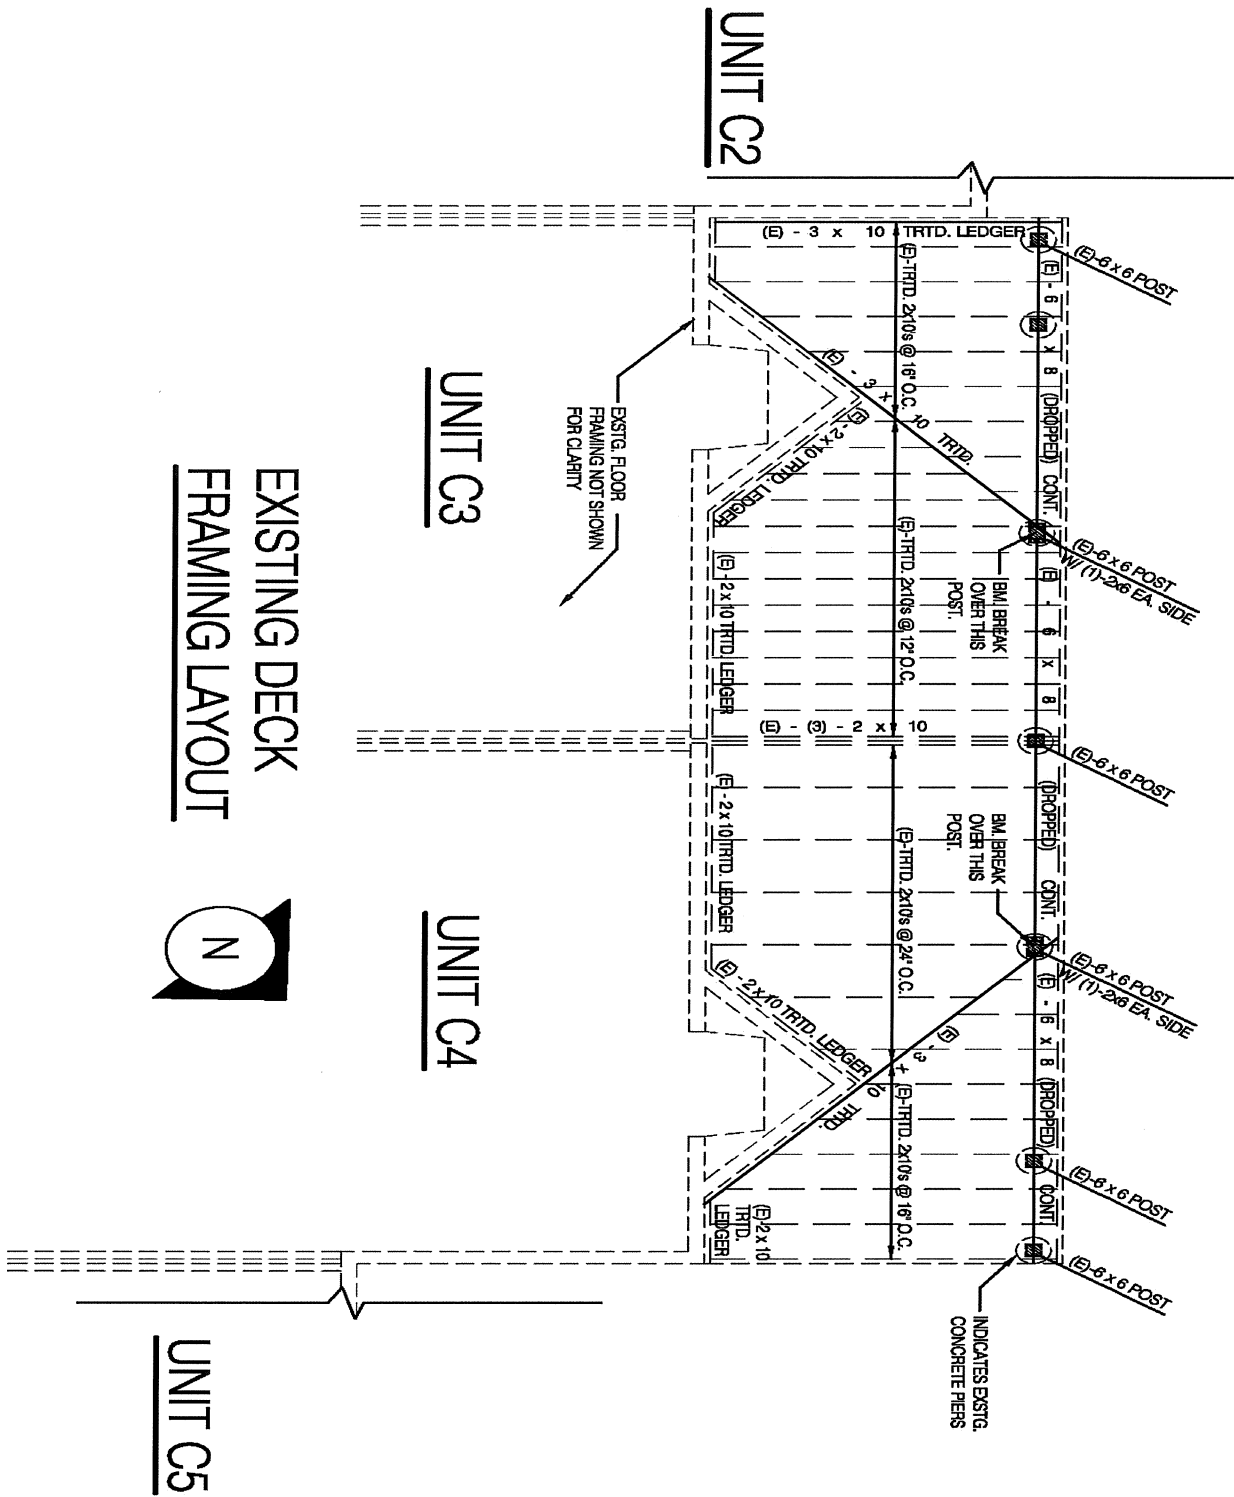
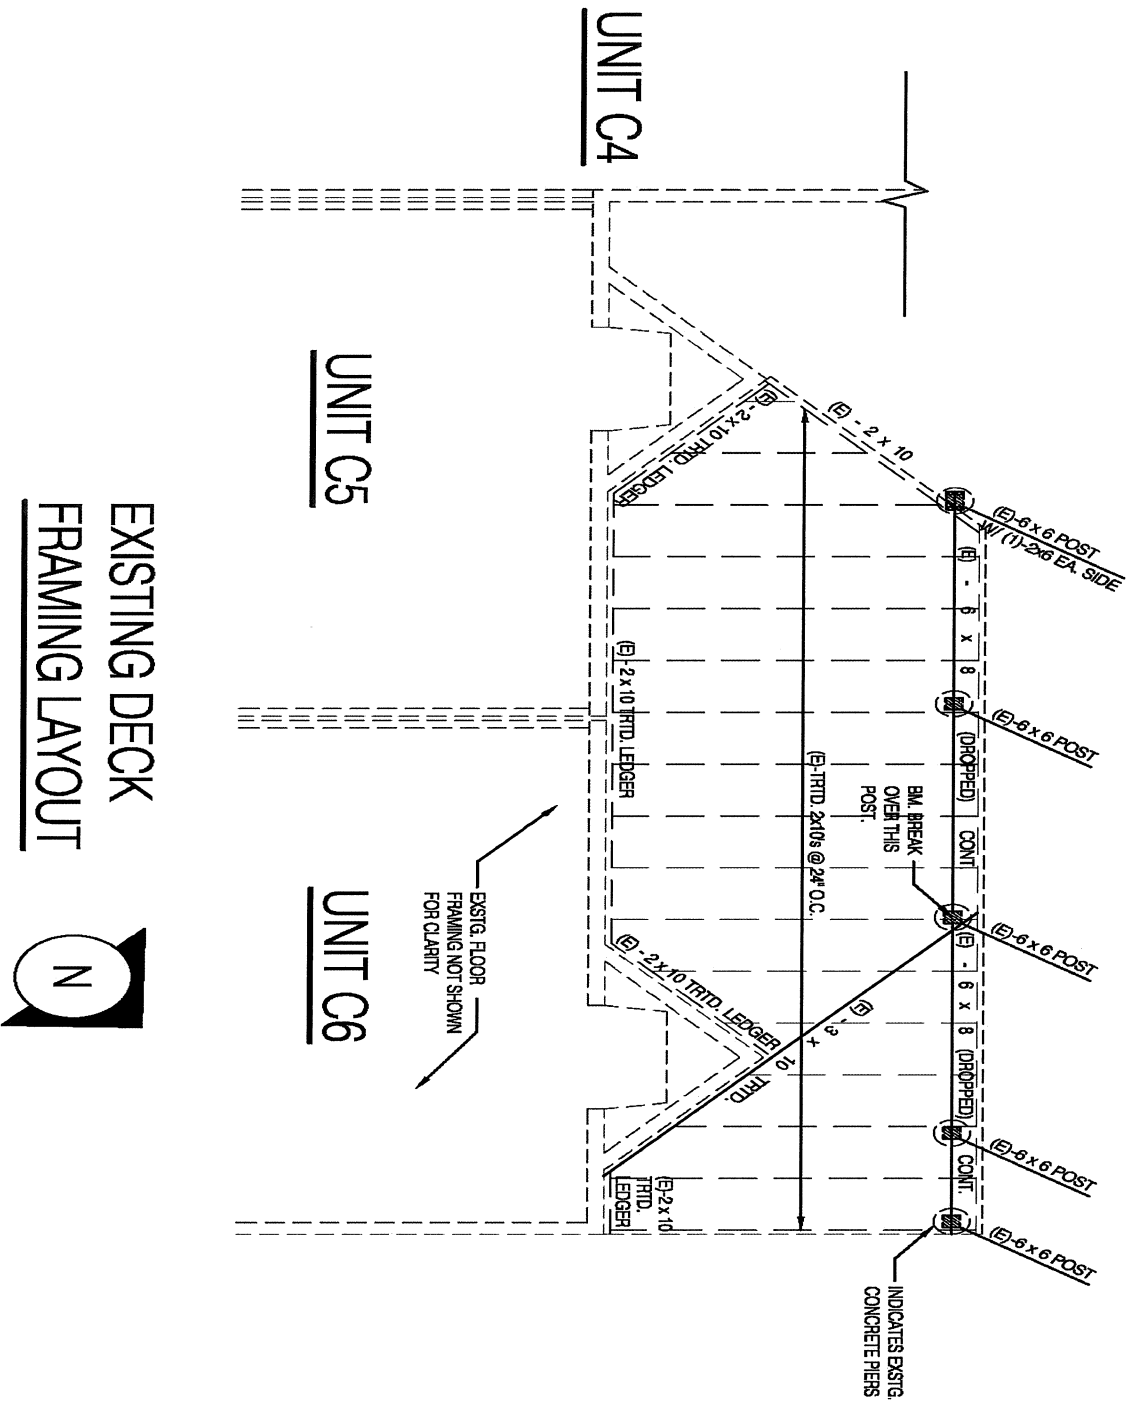
(Image A)

Unit C1 & C2: The decks for these units appear to have been remodeled at some point in time. These two unit decks are separated in the middle by a framed partition wall. The deck joists are 2x10's at 24" on center spacing with 2x6 wood decking. The deck joists bear on mechanical steel hangers. The east end hangers are nailed to either a 2x10 ledger, that is perpendicular with the deck joists or a 2x10 ledger that is on an approximate 45 degree angle to the deck joists. The 2x10 ledgers appear to be nailed to the side of the building and to the bottom of an exterior wall that is cantilevered out from above. The west sides of the joists bear on a mechanical steel hanger that are nailed to a flush framed 6x12 rough sawn timber beam. The 6x12 beam spans continuously over two separate 6x6 posts. The 6x6 posts for these units bear on circular concrete piers. The 6x6 post to the far north bears on the concrete pier to the outside edge. The spans for the 6x12 beam are approximately 15'-6" and 12'-0". The stairs appear to be framed with three 3x12 stringers, one on each side of the stairs and one located in the middle, with 2x decking treads. Two of the three stair stringers appear to be attached to a (2)-2x10 beam at the top with a mechanical steel L-bracket on one side and bear on a concrete slab landing at the bottom. On each side of the stair stringer at the bottom there are 6x6 newel posts that are bolted or lagged to them. These newel posts appear to be the support for the open steel railing on each side of the stairs. The newel post located to the east side has soil and grass around the bottom. The stair landing at the top of the stairs is approximately 3'-6" x 3'-0" in size. The landing appears to be framed with 2x10 joists and 6x12 timbers that bear on 6x6 posts at each corner of the landing. (See Images B, C, & D)

1. Provide new 2x10 deck joists to the existing framed decks so that the maximum spacing is no greater than 16" on center.
2. All load bearing 6x6 posts should bear on a concrete pier and footing. The bottom of the footing should be a minimum of 48" below grade for frost protection. The size of the footing can be determined by our office and is based on the load it is supporting and upon the soil bearing conditions. By code the bottom of a wood post should be a minimum of 8" from the finished grade or shall be of naturally durable or preservative-treated wood.
3. Add (3)-4" x 3/16" diameter Timber-Lok screws at 16" on center to all existing 2x10 ledgers that are attached to the building rim-board.
